# **CABLE GUARDRAIL WITH STRONG J-BOLTS**

## **MIDWEST ROADSIDE SAFETY FACILITY**

## **NEW YORK STATE DEPARTMENT OF TRANSPORTATION**

MwRSF Research Report No. TRP-03-299-14

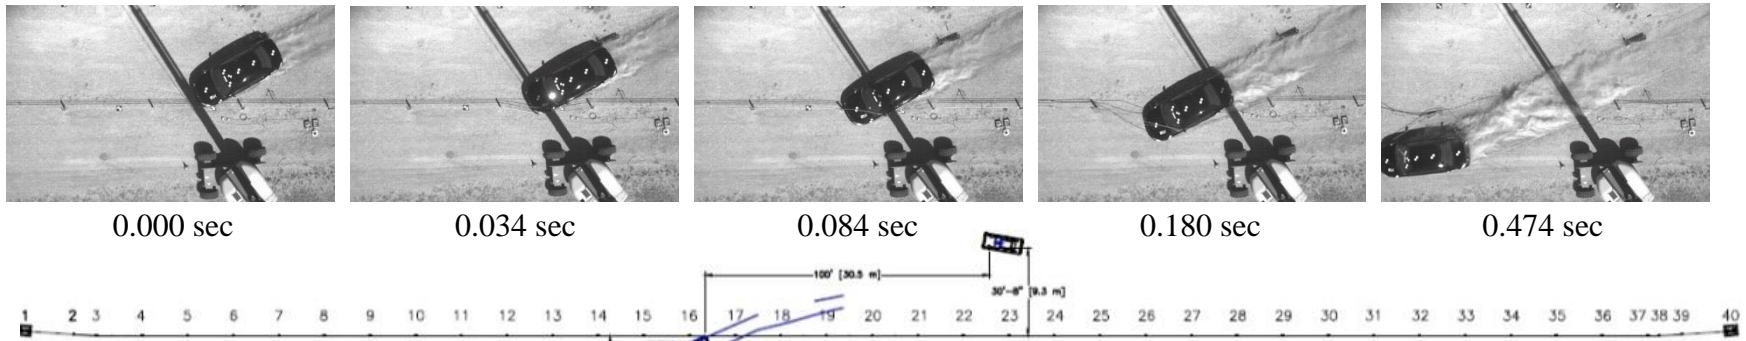
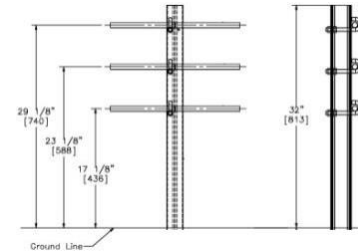
Figure 42. Summary of Test Results and Sequential Photographs, Test No. NYJ-1

- Vehicle Stability ..... Satisfactory
- Vehicle Stopping Distance..... 100 ft (30.5 m) downstream of impact  
30.7 ft (9.4 m) laterally behind system
- Vehicle Damage ..... Moderate

- VDS<sup>[11]</sup> ..... 11-FD-1
  - CDC<sup>[12]</sup> ..... 51-TYYW-3
- Test Article Damage ..... Severe

- Maximum Test Article Deflections
  - Permanent Set .....NA
  - Dynamic .....NA
  - Working Width .....NA
- Maximum Windshield Deformation ..... 6¼ in. (159 mm)
- Maximum Angular Displacements
  - Roll ..... 10.0° < 75°
  - Pitch..... 7.3° < 75°
  - Yaw .....216.9°
- Transducer Data

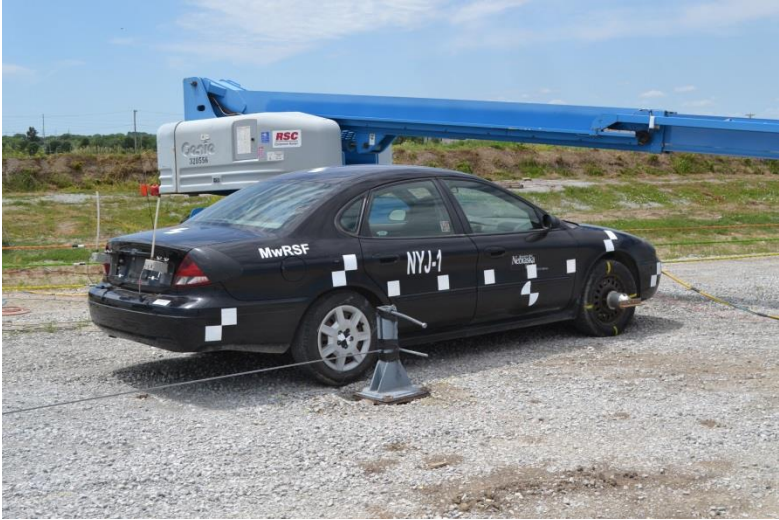
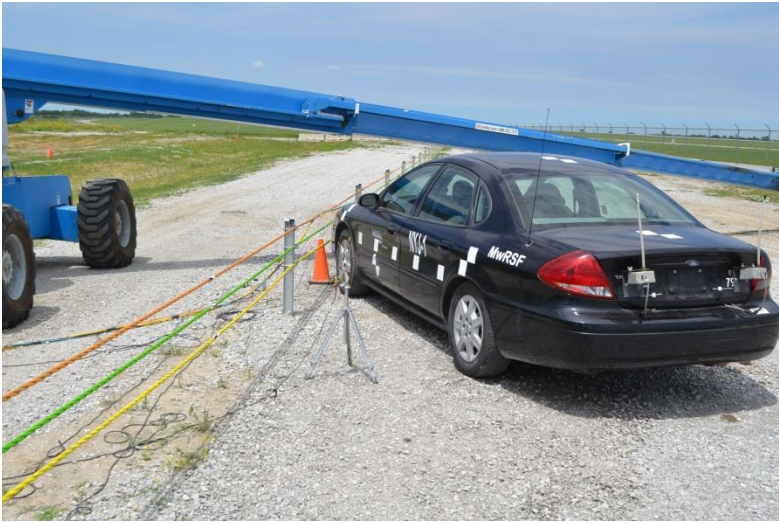
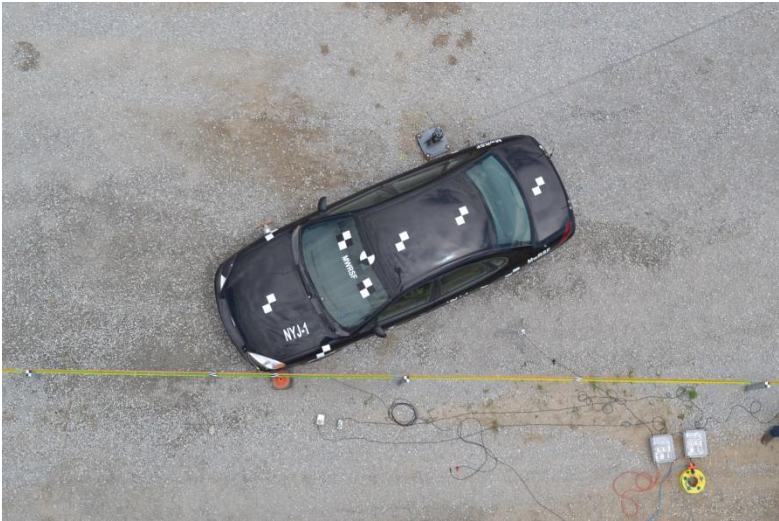
Figure 45. Impact Location, Test No. NYJ-1

Initial vehicle impact was to occur 64 in. (1,625 mm) downstream from post no. 16, as shown in Figure 45, which was selected based on previous testing [10]. The actual point of impact was 65 in. (1,651 mm) downstream from post no. 16. A sequential description of the impact events is contained in Table 6. The vehicle came to rest 100 ft (30.5 m) downstream from impact and 30 ft – 8 in. (9.4 m) laterally behind the system. The vehicle trajectory and final position are shown in Figures 42 and 46.

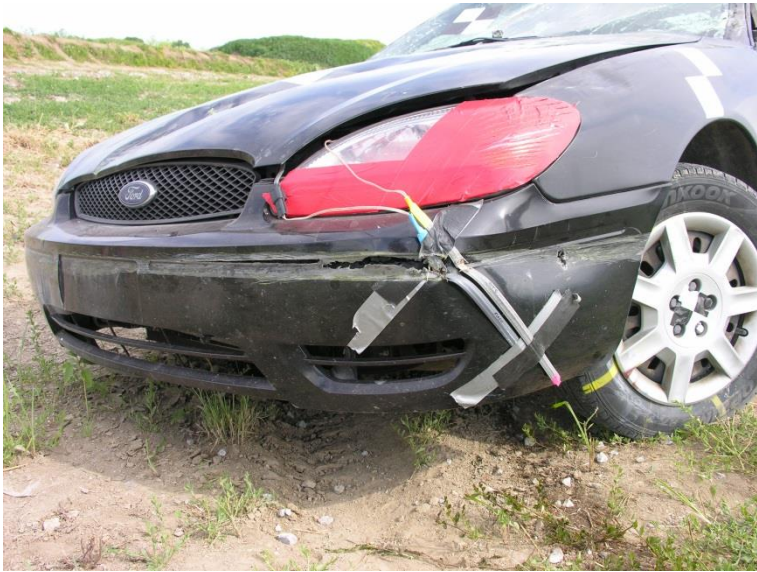
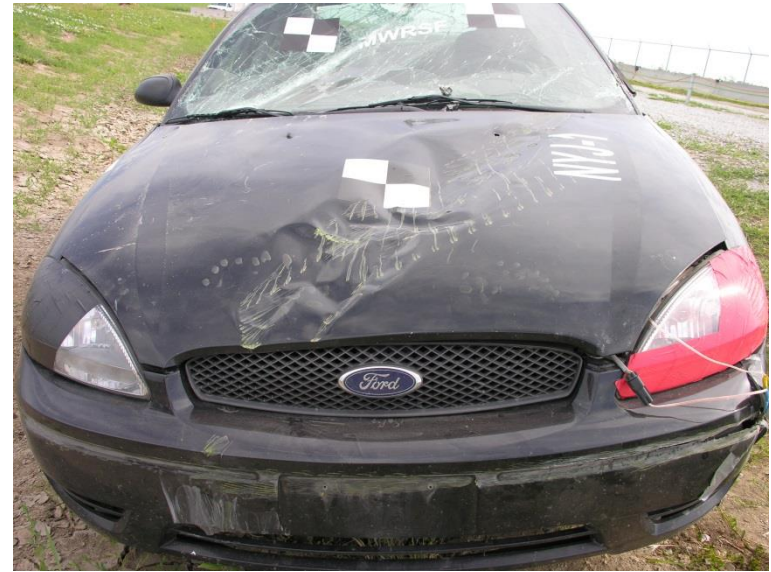
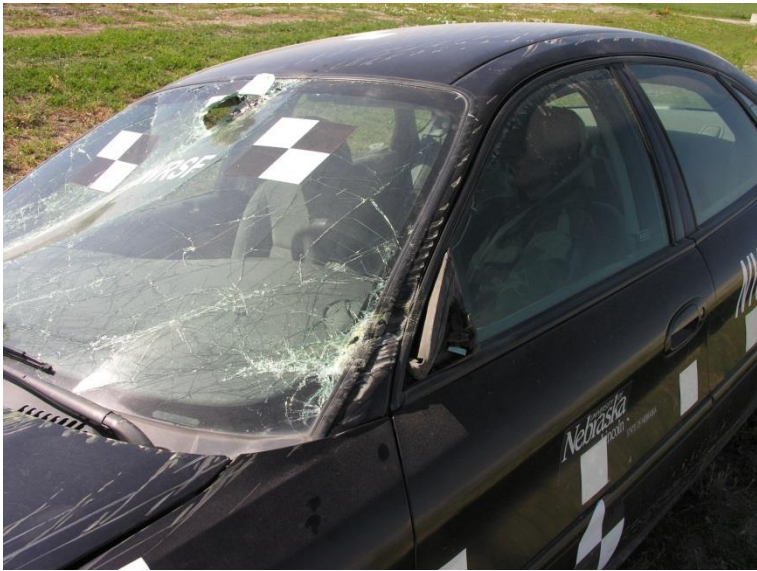
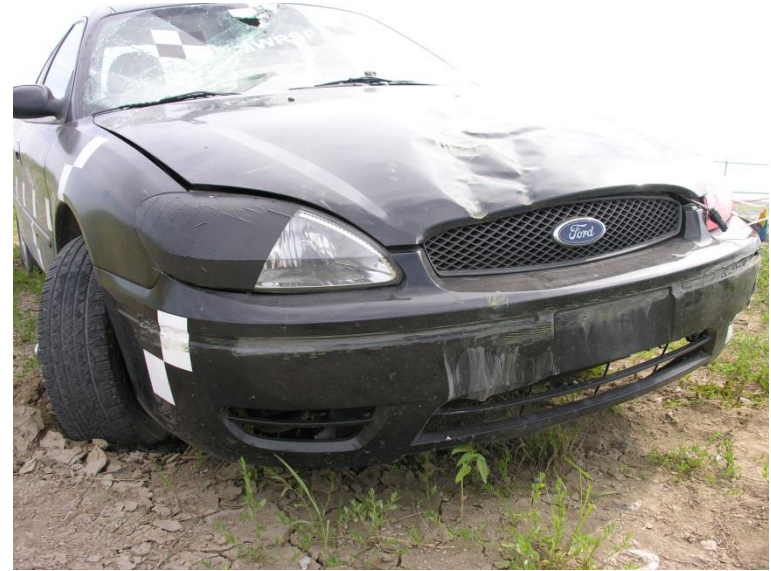
Figure 53. Vehicle Damage, Test No. NYJ-1

The damage to the vehicle was moderate, as shown in Figures 53 and 54. The maximum occupant compartment deformations are listed in Table 7 along with the deformation limits established in MASH for various areas of the occupant compartment. Note that the maximum deformation on the windshield location exceeded MASH established deformation limits. Complete occupant compartment and vehicle deformations and the corresponding locations are provided in Appendix E.

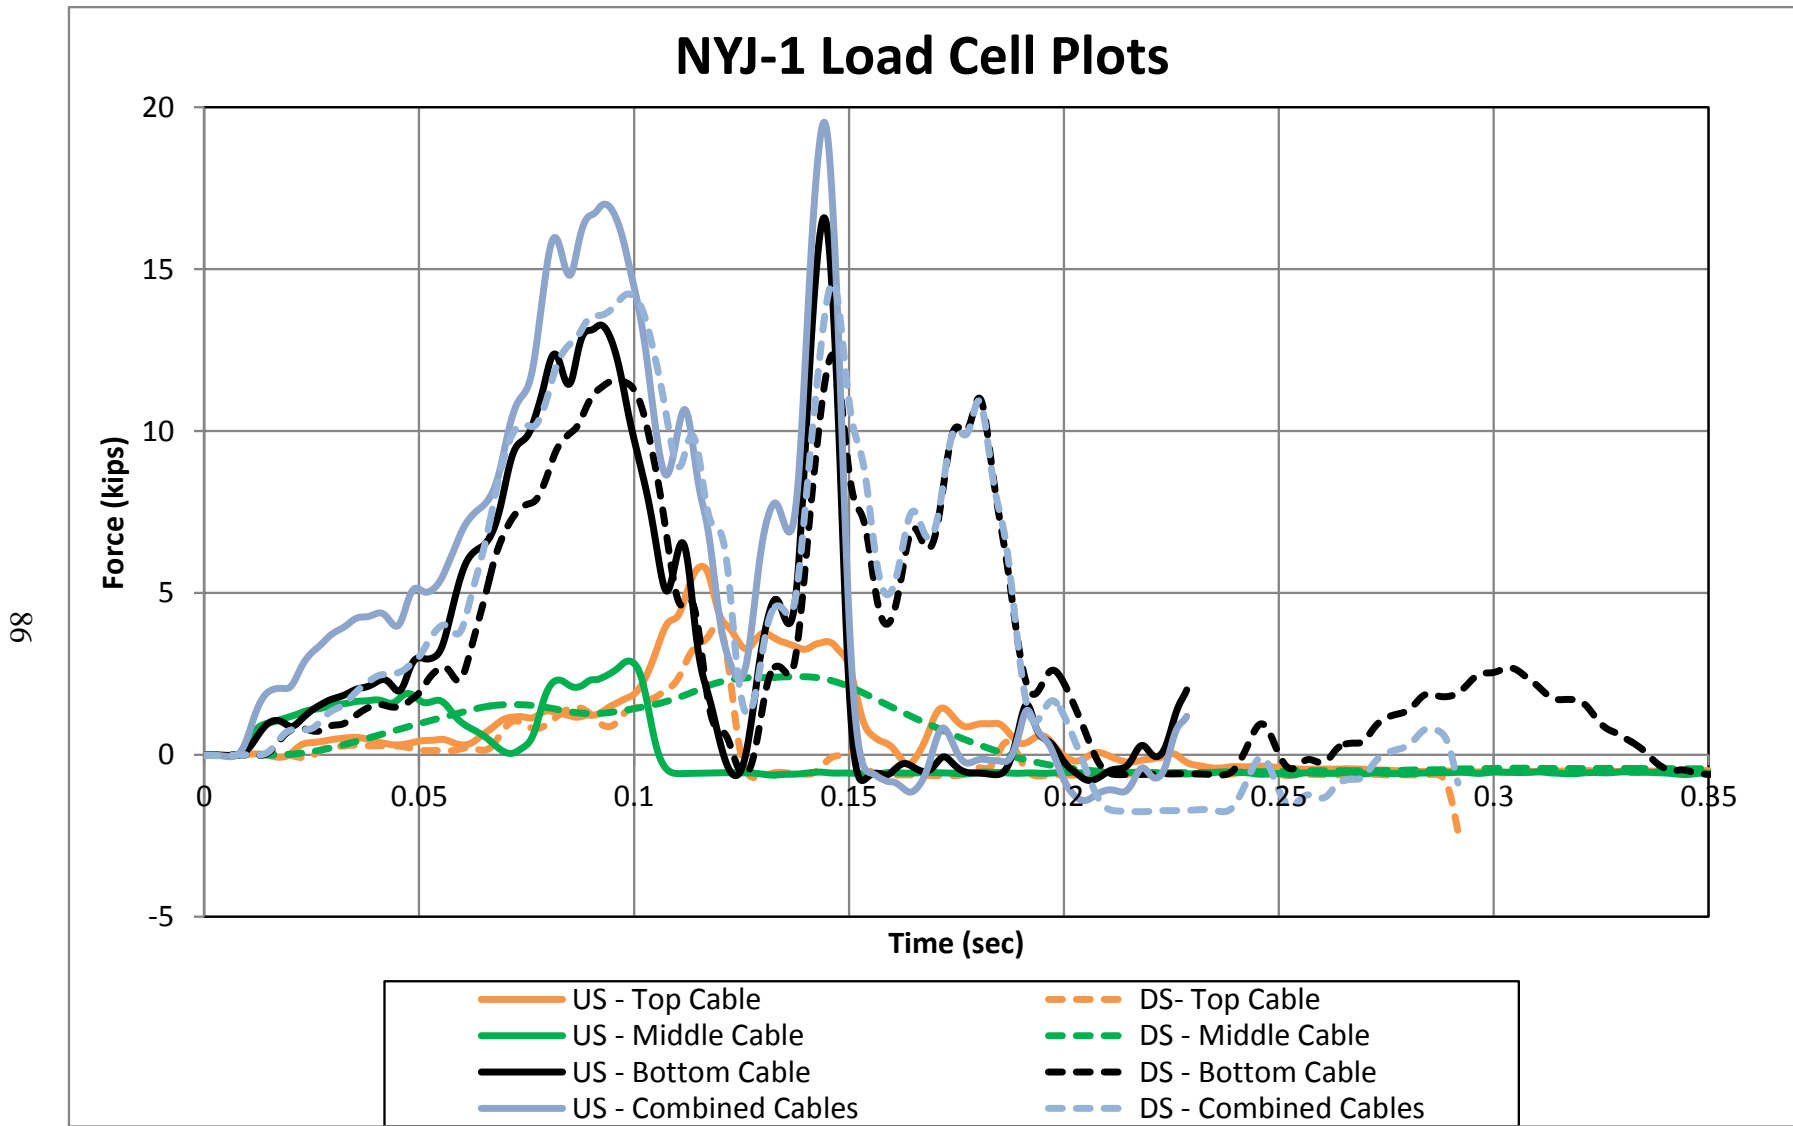
Figure 55. Cable Tension vs. Time, Test No. NYJ-1

Data was acquired by load cells near the upstream (US) and downstream (DS) anchors and later analyzed. The maximum loads measured by the transducers are summarized in Table 9. The individual cable loads were determined and are shown graphically in Figure 55.

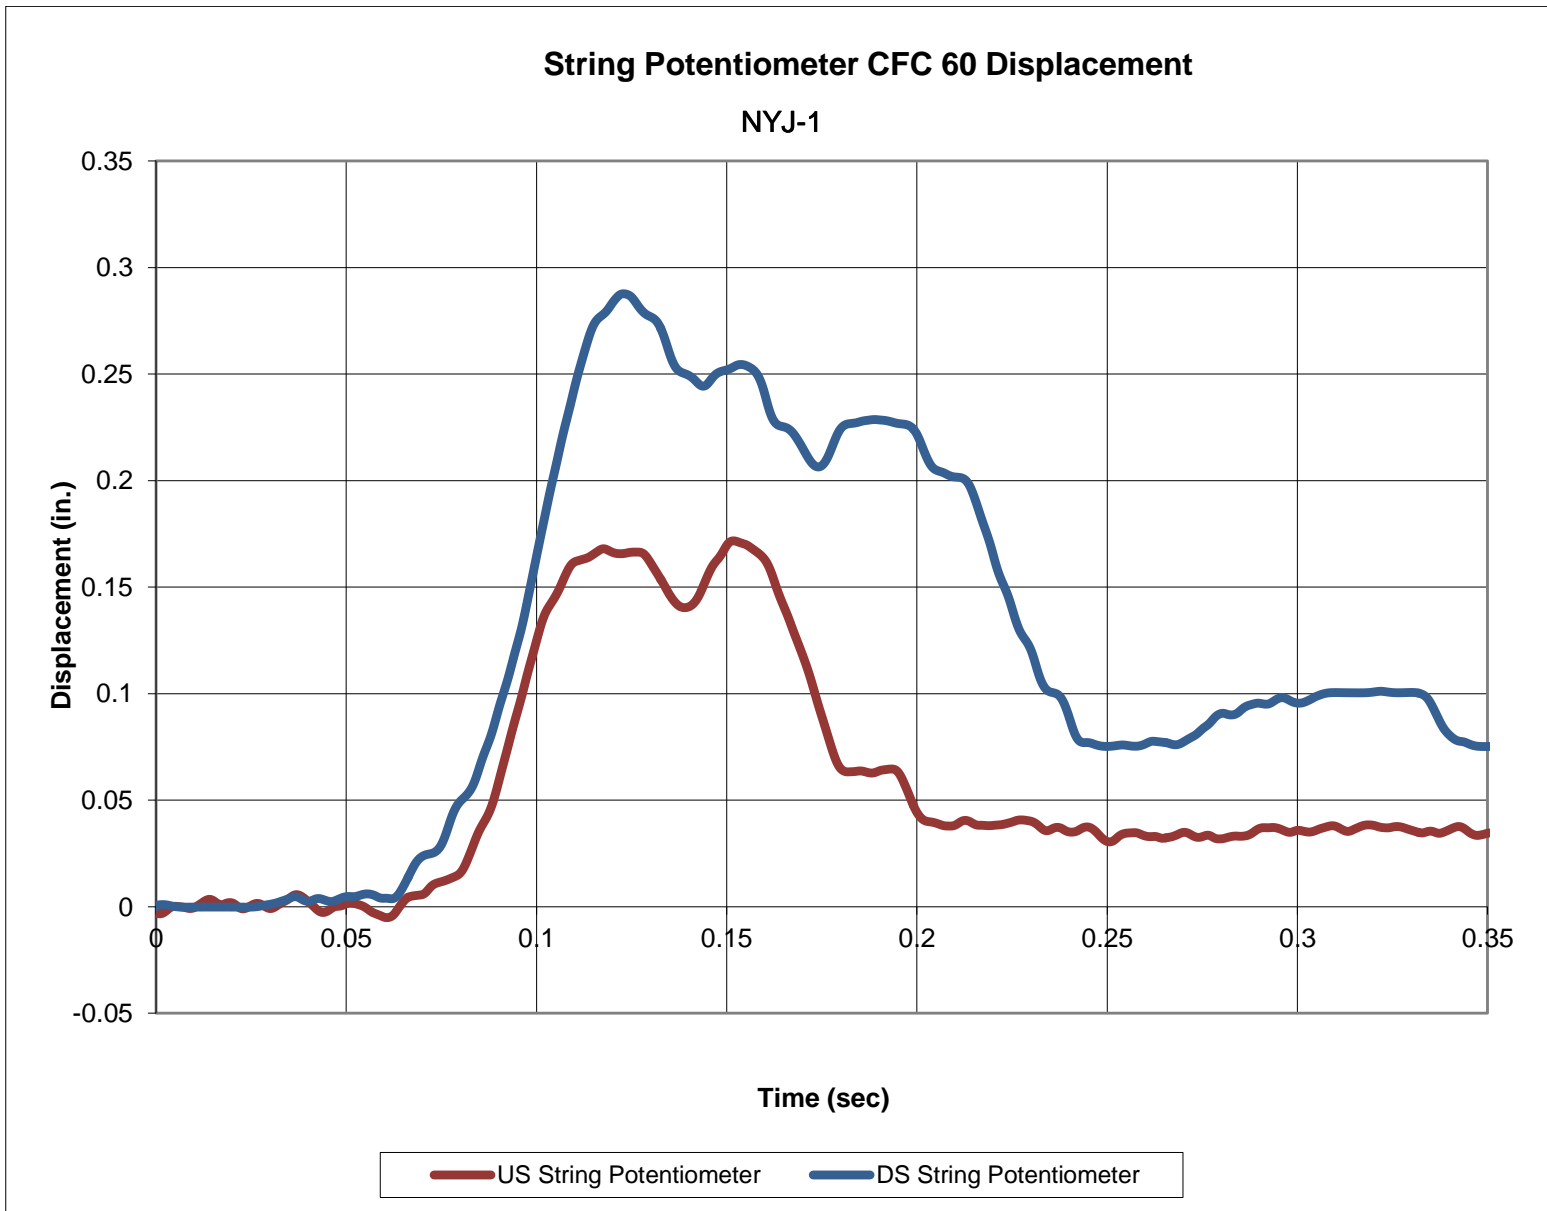
Figure 56. Displacement-Time History Plot for Anchors, Test No. NYJ-1

Anchor displacement was also of primary concern in the evaluation of the three-cable guardrail system. The displacement-time histories of the downstream and upstream anchors are shown in Figure 56. The anchor on the downstream end of the barrier had a maximum displacement of 0.29 in. (7 mm). The anchor on the upstream end had a maximum displacement of 0.17 in. (4 mm).

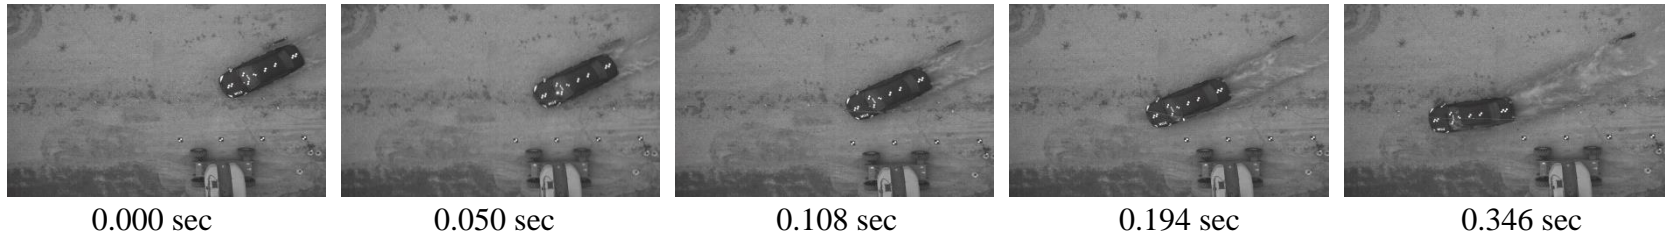
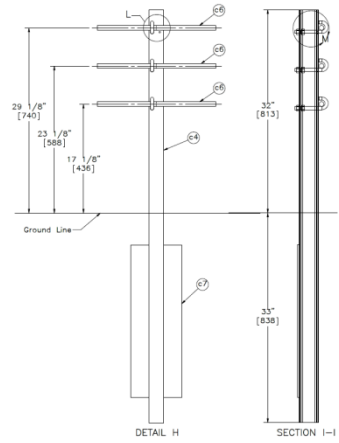
Figure 74. Summary of Test Results and Sequential Photographs, Test No. NYJ-2

The 3,254-lb (1,476-kg) passenger car impacted the cable guardrail system at a speed of 62.7 mph (100.9 km/h) and at an angle of 25.3 degrees. A summary of the test results and sequential photographs are shown in Figure 74. Additional sequential photographs are shown in Figures 75 and 76.

The results of the occupant risk analysis, as determined from the accelerometer data, are summarized in Figure 74. The recorded data from the accelerometers and the rate transducers are shown graphically in Appendix G. Due to technical difficulties, the SLICE and EDR-3 units did not collect acceleration data.

Evaluation Criteria		DTS	Mash Limit
OIV ft/s (m/s)	Longitudinal	-15.98 (-4.87)	≤ 40 (12.2)
	Lateral	-3.81 (1.16)	≤ 40 (12.2)
ORA g's	Longitudinal	-6.84	≤ 20.49
	Lateral	-10.91	≤ 20.49
THIV – ft/s (m/s)		16.37 (4.99)	not required
PHD – g's		9.08	not required
ASI		0.53	not required

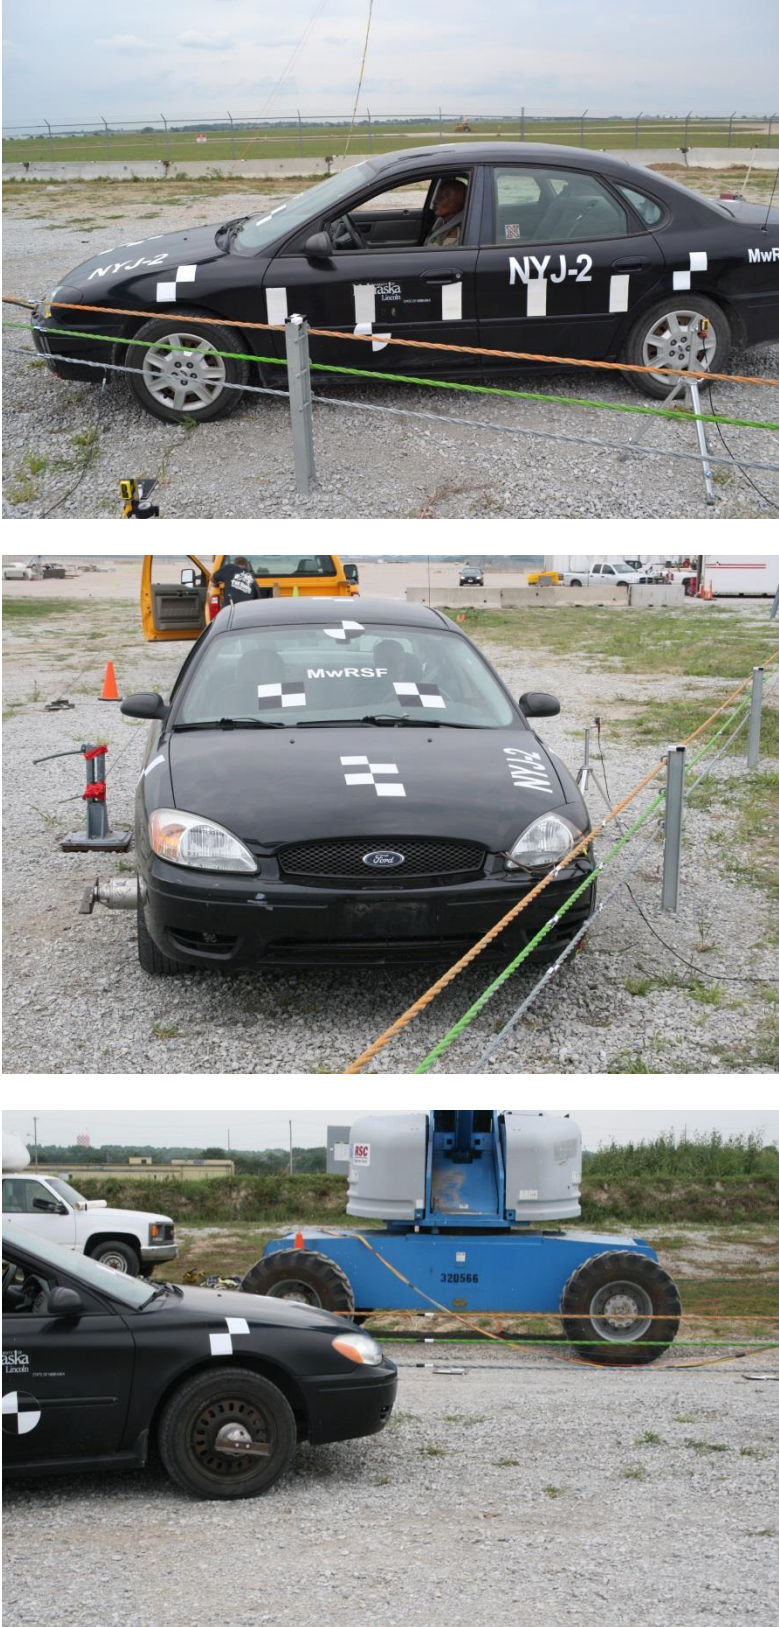
Figure 77. Impact Location, Test No. NYJ-2

Initial vehicle impact was to occur 64 in. (1,626 mm) downstream from post no. 16, as shown in Figure 77, which was selected based on previous testing [10]. The actual point of impact was 65 in. (1,651 mm) downstream from post no. 16. A sequential description of the impact events is contained in Table 11. The vehicle came to rest 82 ft – 4 in. (25.1 m) downstream from impact and 22 in. (559 mm) laterally behind the system. The vehicle trajectory and final position are shown in Figures 74 and 78.

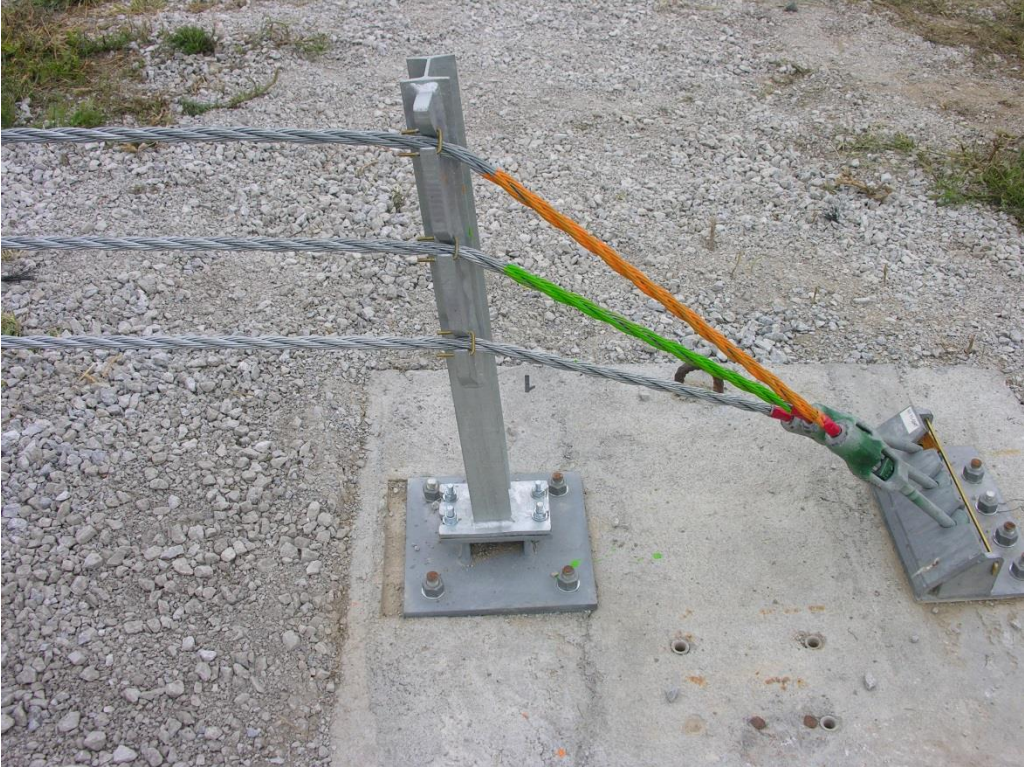
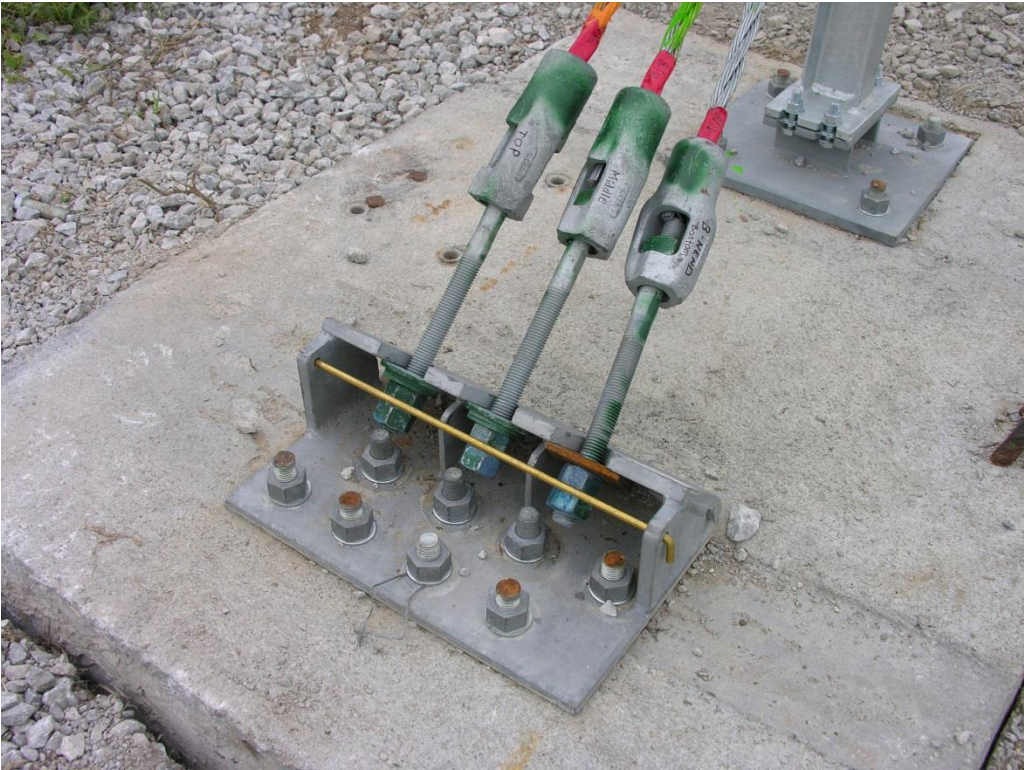
Figure 80. Downstream Anchor Damage, Test No. NYJ-2

Damage to the barrier was moderate, as shown in Figures 79 through 84. Barrier damage consisted of fractured J-bolts, deformed posts, and cables disengaged from posts. Cables disengaged from multiple posts in the system. At post no. 1, all three cables disengaged from the cable hanger bracket. At post no. 16, the top cable disengaged, and the J-bolt fractured at the top cable location. At post nos. 17 through 21, all three cables disengaged from the posts. At post no. 20, the bottom J-bolt fractured. At the upstream cable anchor, all three threaded anchor rods were bent. At the downstream cable anchor, the bottom cable threaded anchor rod was bent. Also, the downstream end of the concrete anchor block deflected and partially lifted. A  $\frac{5}{8}$ -in. (16 mm) gap was observed on the downstream side of the downstream anchor block, and a  $\frac{1}{8}$ -in. (3-mm) gap was observed on the back side of the block.

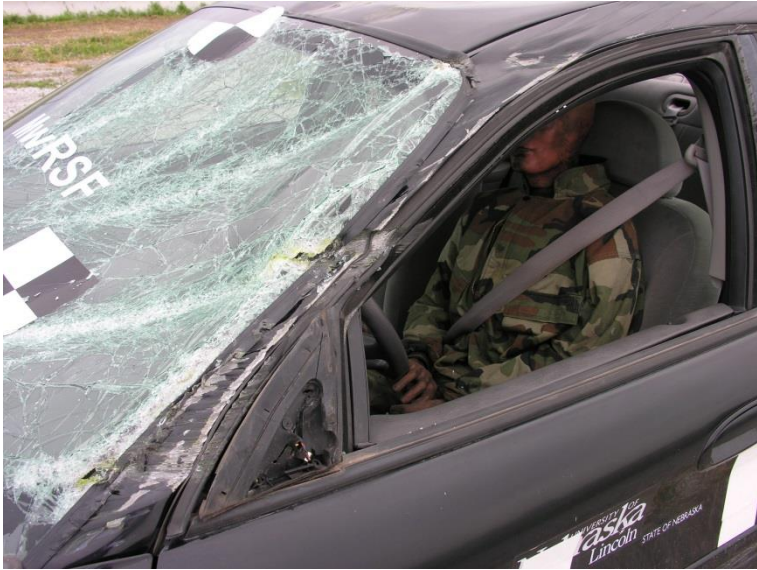
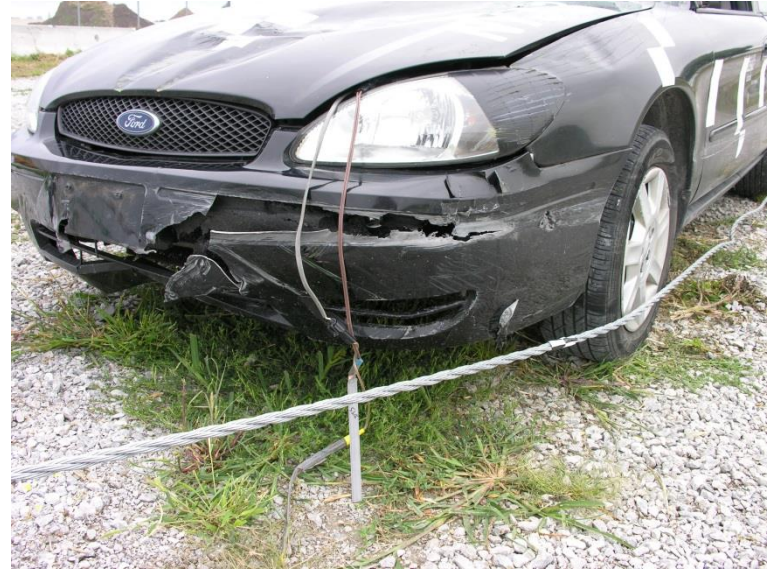
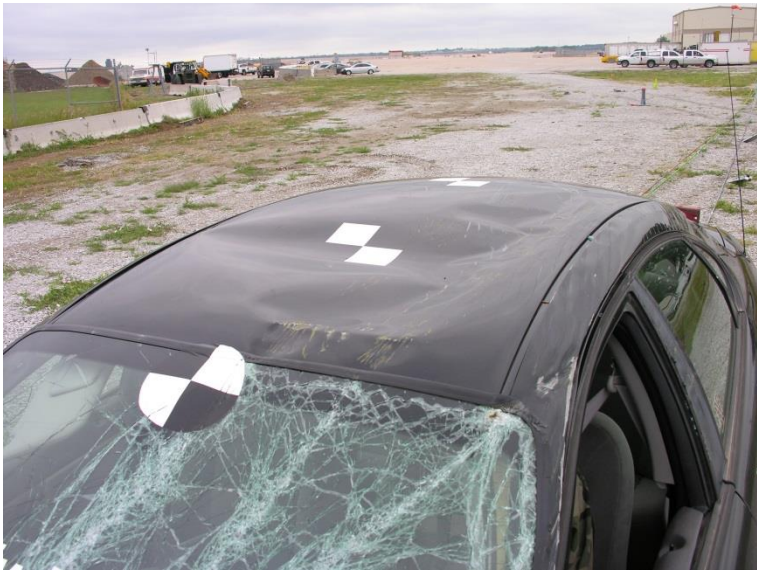
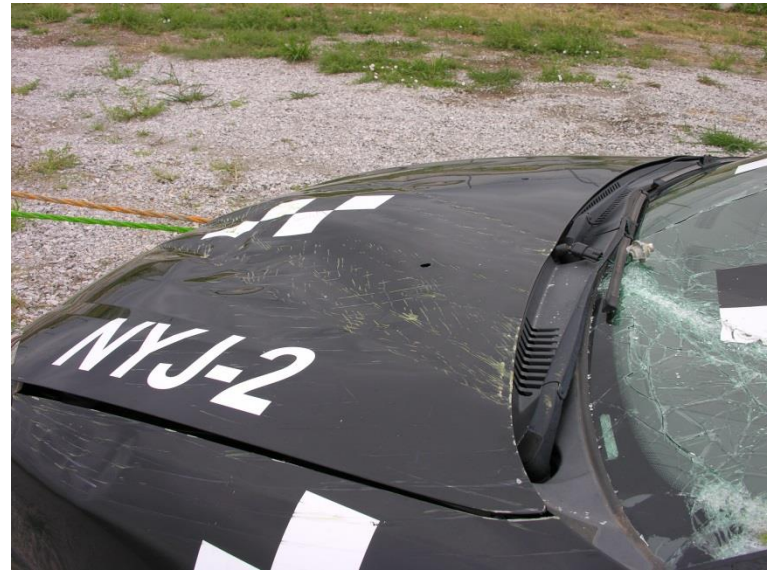
Figure 85. Vehicle Damage, Test No. NYJ-2

The damage to the vehicle was moderate, as shown in Figures 85 and 86. The maximum occupant compartment deformations are listed in Table 13 along with the deformation limits established in MASH for various areas of the occupant compartment. Note that the maximum deformation on the windshield location exceeded MASH established deformation limits. Complete occupant compartment and vehicle deformations and the corresponding locations are provided in Appendix E.

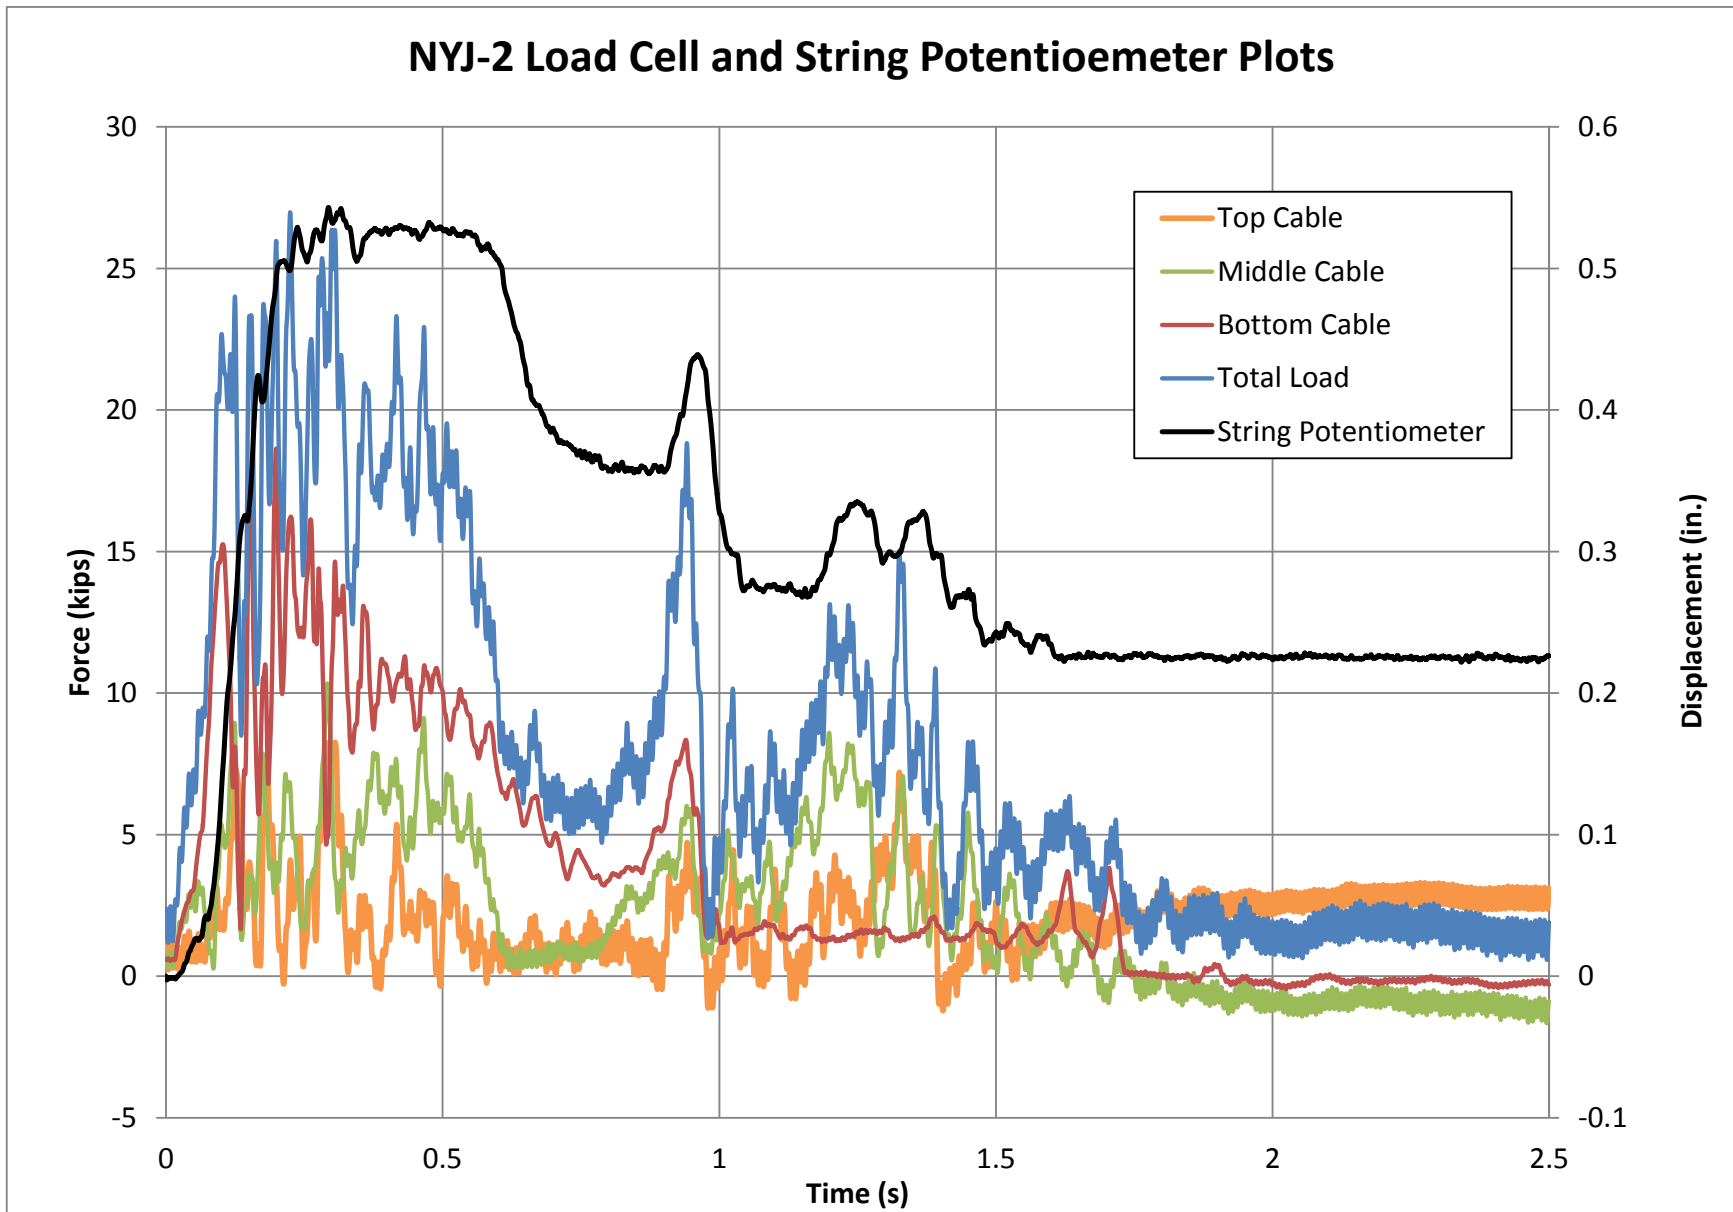
Figure 87. Load Cell and String Pot Plots, Test No. NYJ-2

Tension load cell data was processed and analyzed. The maximum load values measured by the transducers are summarized in Table 15. The individual cable loads, along with the total combined cable load imparted to the upstream end anchor, were determined and are shown graphically in Figure 87.

Anchor displacement was also of primary concern in the evaluation of the three cable guardrail system. The displacement-time history of the upstream anchor is shown in Figure 87. The anchor on the upstream end had a maximum displacement of 0.54 in. (14 mm) at 0.294 sec after impact.

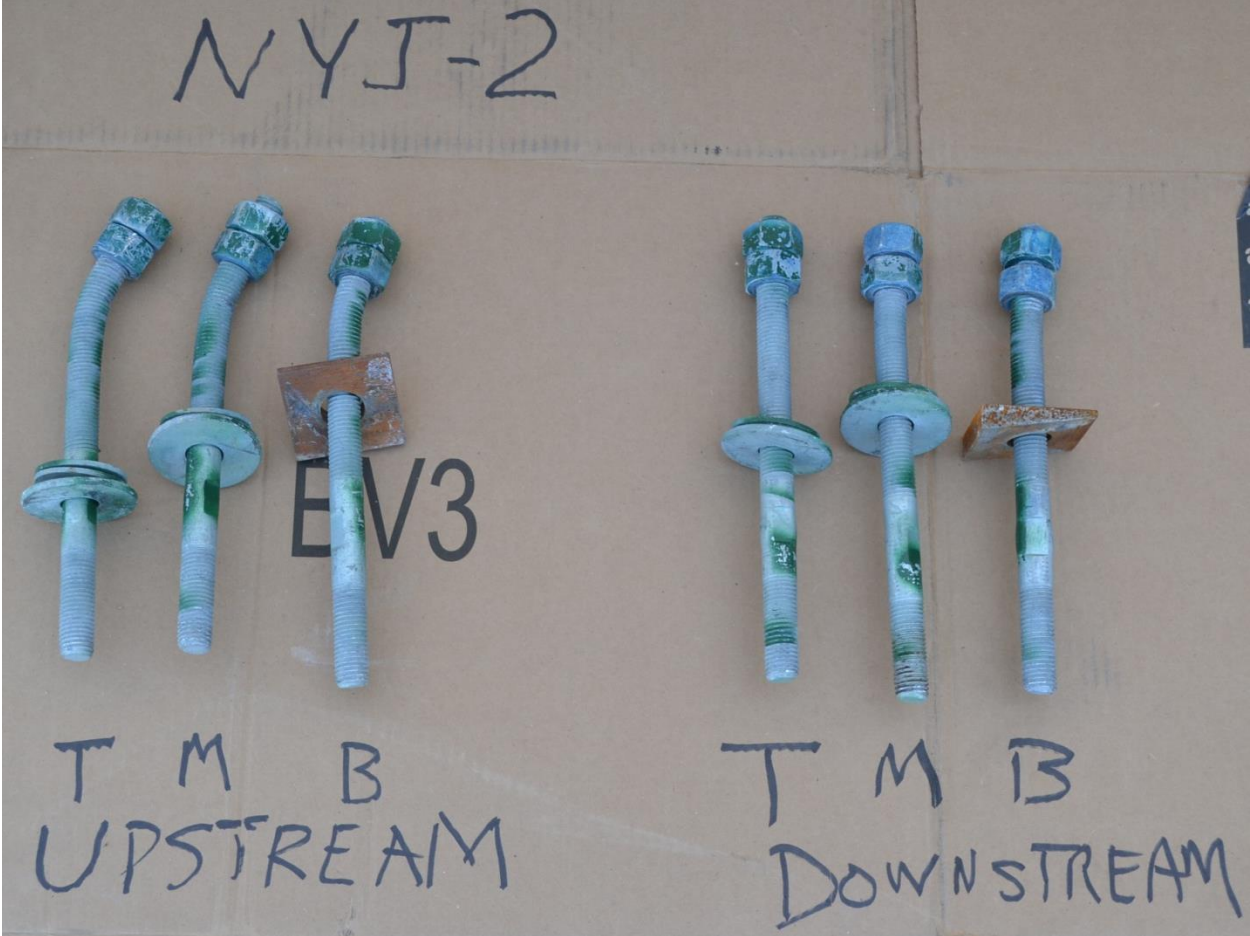
Figure 88. Top, Middle, and Bottom Cable Barrier Termination Threaded Rods for Upstream and Downstream Anchors

Significantly more anchor rod deformation occurred at the upstream anchor than the downstream anchor, as shown in Figure 88.

Several threaded end termination rods fractured due to the cable ends being constrained by the threaded J-hooks in the concrete anchor block. It was believed that if the height of the J-hooks in the end anchorage were reduced, and if the hanger post had not bent toward impact, the cable ends may not have fractured. The cable threaded ends may have been constrained against rotation during test nos. NYJ-1 and NYJ-2 as well. Recall, 4 of 6 anchor rods were bent in test no. NYJ-2. Cable tensions never reached maximum levels during test no. NYJ-1 due to failure of the end fittings and splices.

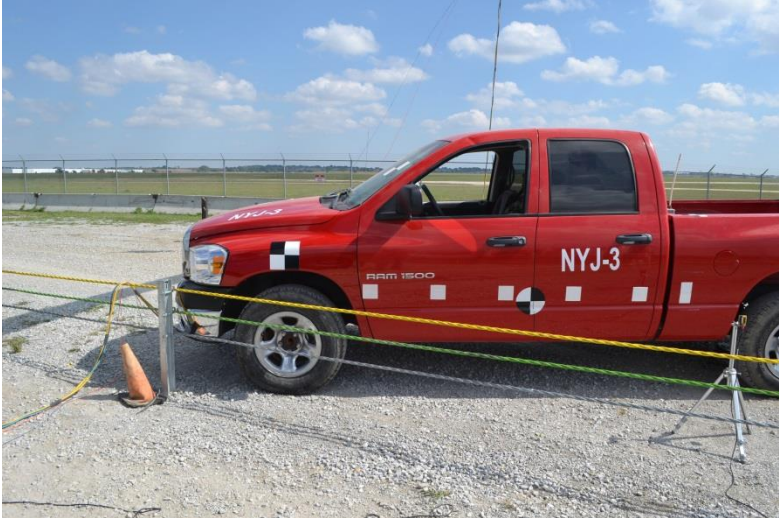
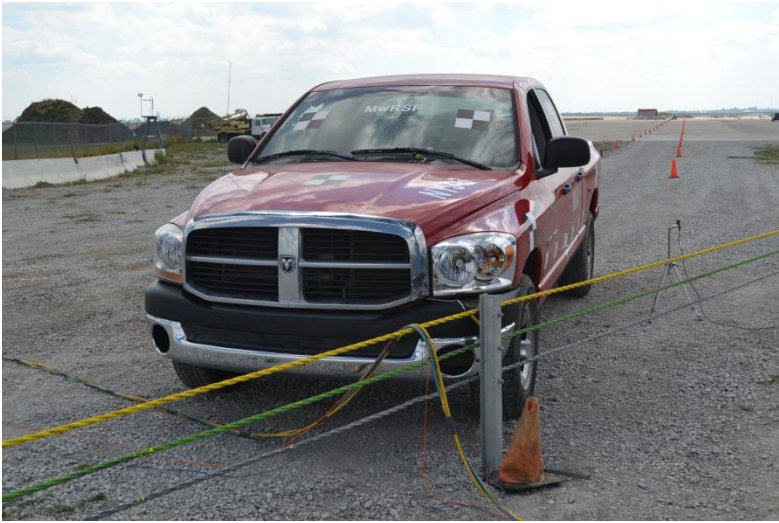
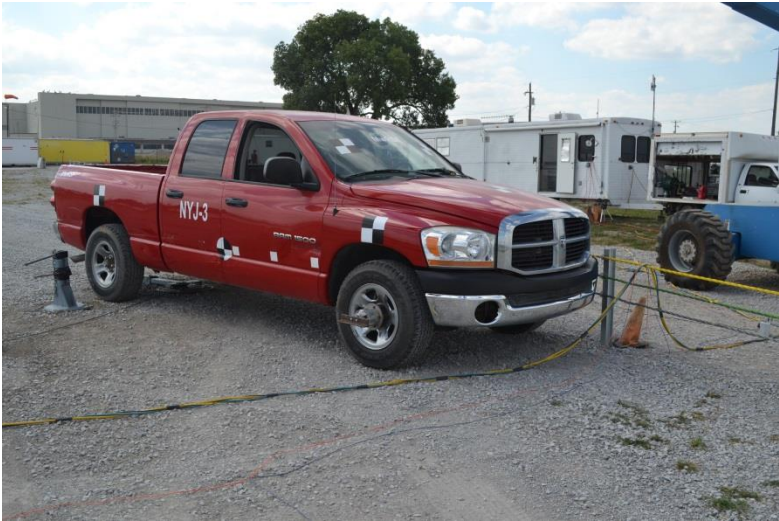
Figure 92. Impact Location, Test No. NYJ-3

Initial vehicle impact was to occur 12 in. (305 mm) upstream from post no. 17, as shown in Figure 92, which was selected based on MASH recommendations. The actual point of impact was at the targeted impact point. A sequential description of the impact events is contained in Table 17. The vehicle came to rest 142 ft – 1 in. (43.3 m) downstream from impact and 40 ft – 1 in. (12.2 m) laterally behind the system. The vehicle trajectory and final position are shown in Figures 89 and 93.

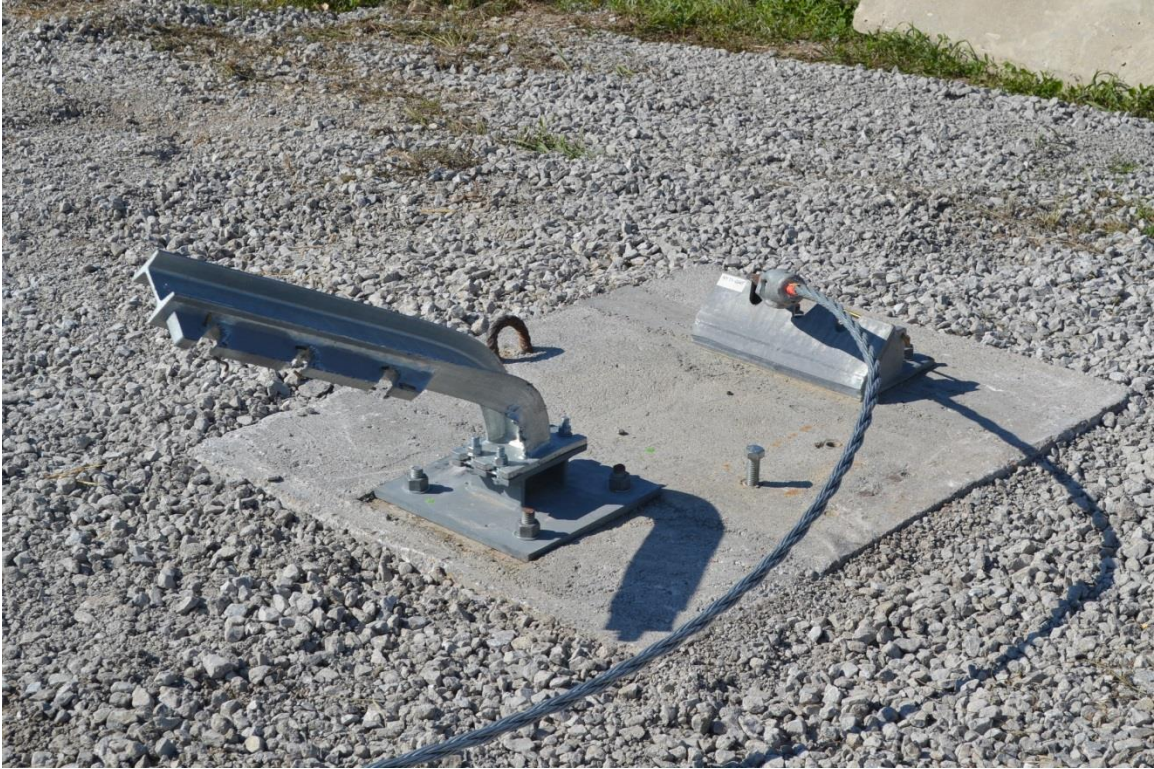
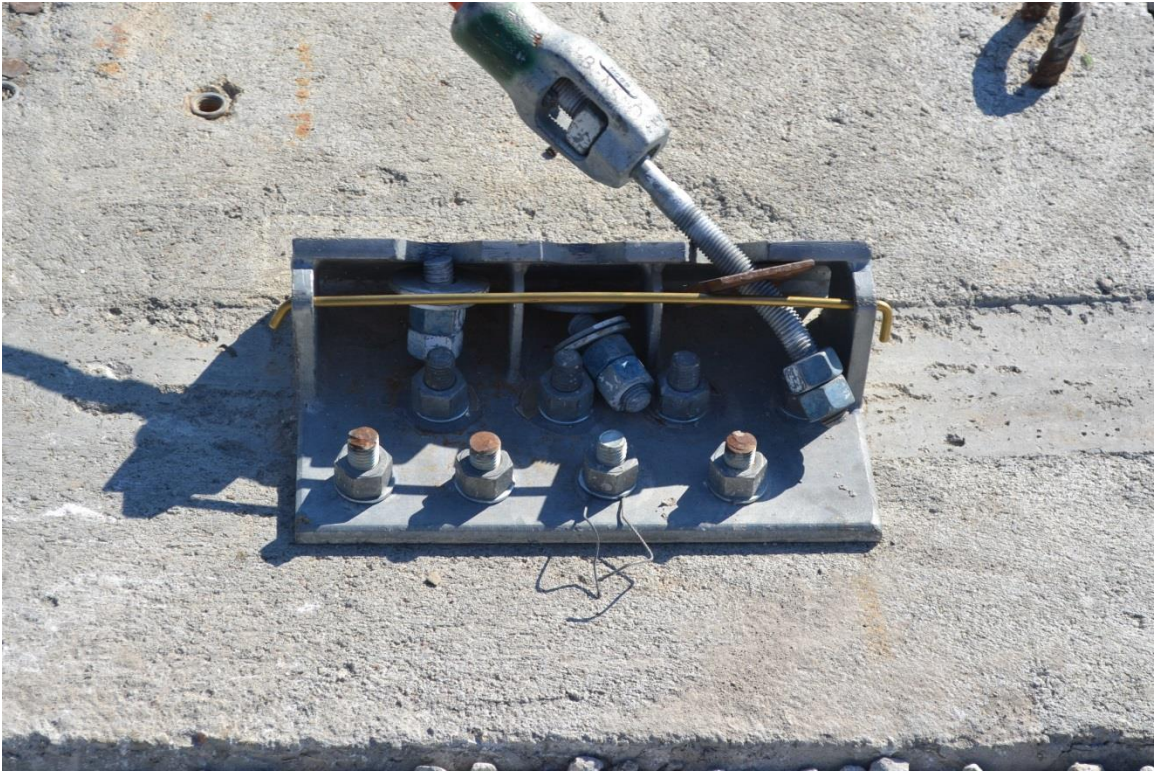
Figure 95. Downstream Anchor Damage, Test No. NYJ-3

Damage to the barrier was severe, as shown in Figures 94 through 97. Barrier damage consisted of fractured J-bolts, deformed posts, and disengaged cables. The permanent set, dynamic deflection, and working width were not recorded due to failure of the cable guardrail system. The permanent displacement of the upstream anchors was 0.15 in. (4 mm).

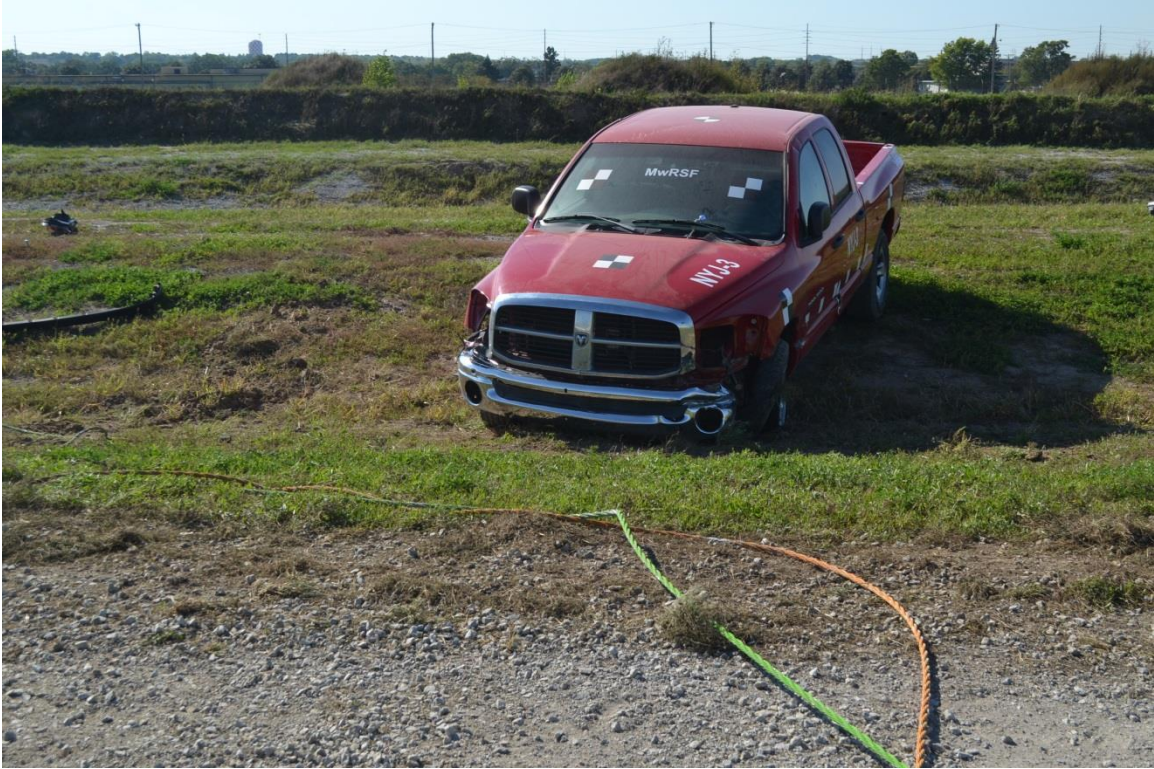
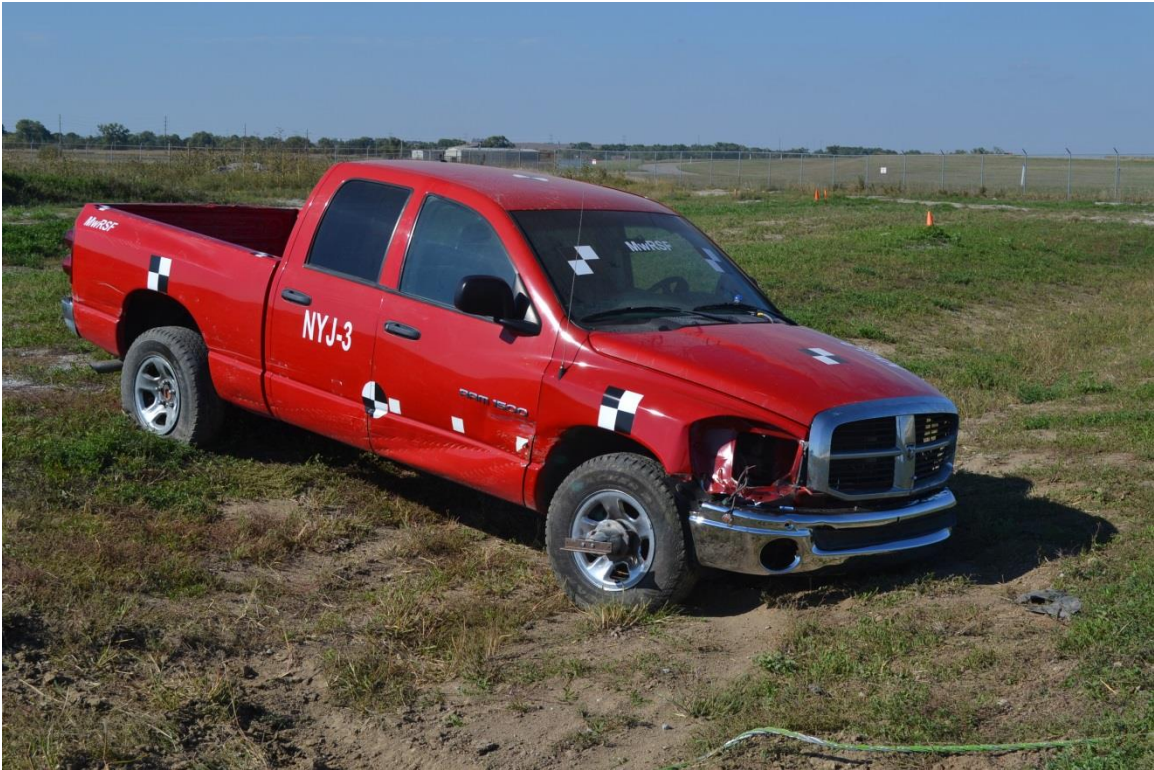
Figure 98. Vehicle Damage, Test No. NYJ-3

The damage to the vehicle was minimal, as shown in Figures 98 and 99. The maximum occupant compartment deformations are listed in Table 18 along with the deformation limits established in MASH for various areas of the occupant compartment. Note that none of the maximum deformation values exceeded MASH established deformation limits. Complete occupant compartment and vehicle deformations and the corresponding locations are provided in Appendix E.
