# **CABLE GUARDRAIL WITH STRONG J-BOLTS**

## **MIDWEST ROADSIDE SAFETY FACILITY**

## **NEW YORK STATE DEPARTMENT OF TRANSPORTATION**

MwRSF Research Report No. TRP-03-299-14

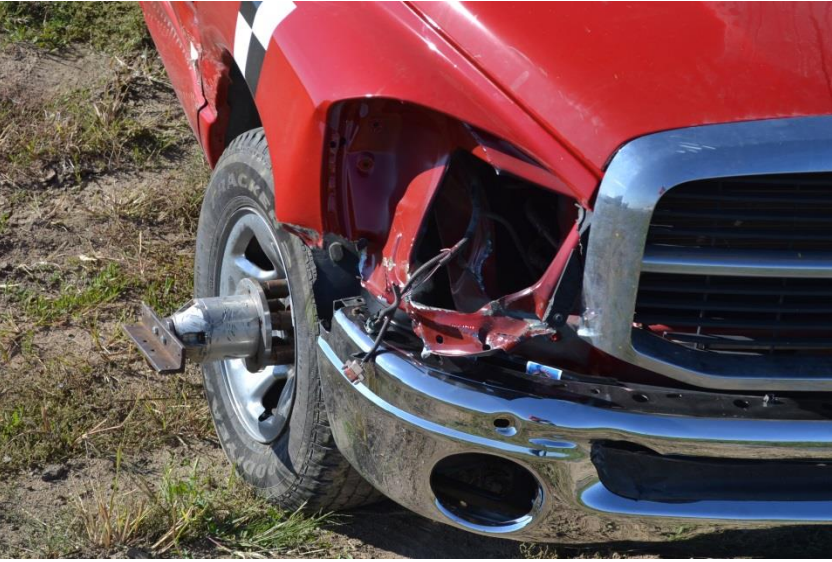
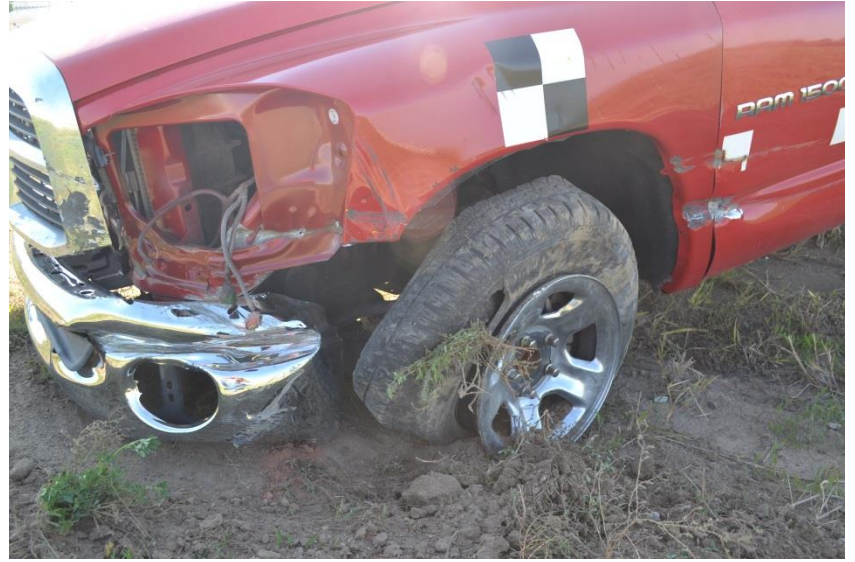
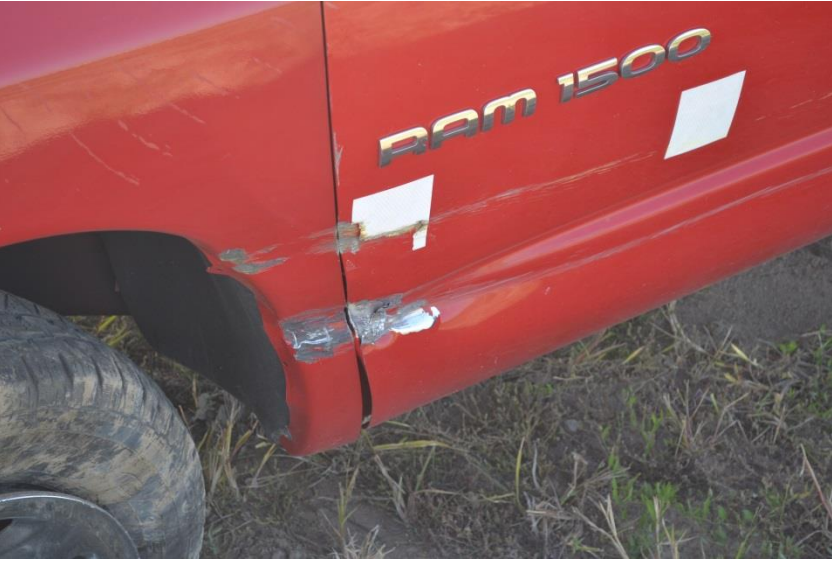
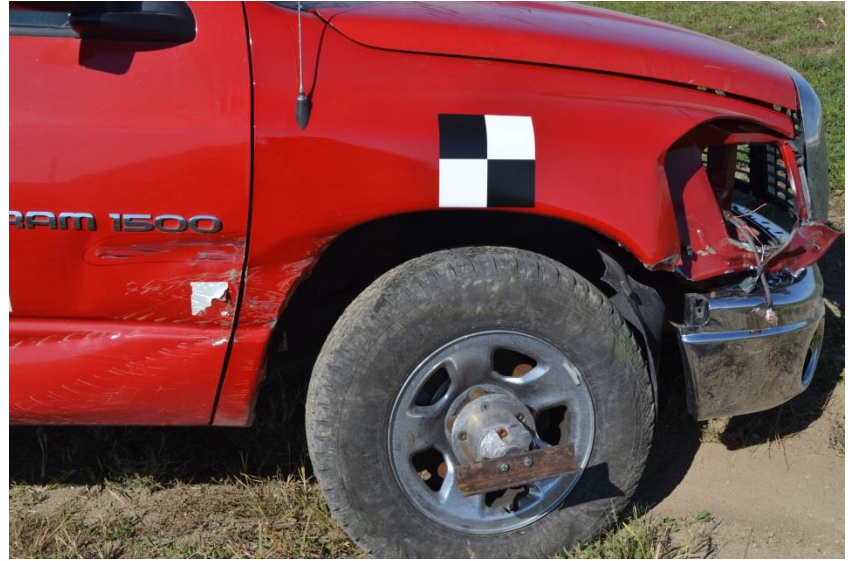
Figure 99. Vehicle Damage, Test No. NYJ-3

The damage to the vehicle was minimal, as shown in Figures 98 and 99. The maximum occupant compartment deformations are listed in Table 18 along with the deformation limits established in MASH for various areas of the occupant compartment. Note that none of the maximum deformation values exceeded MASH established deformation limits. Complete occupant compartment and vehicle deformations and the corresponding locations are provided in Appendix E.

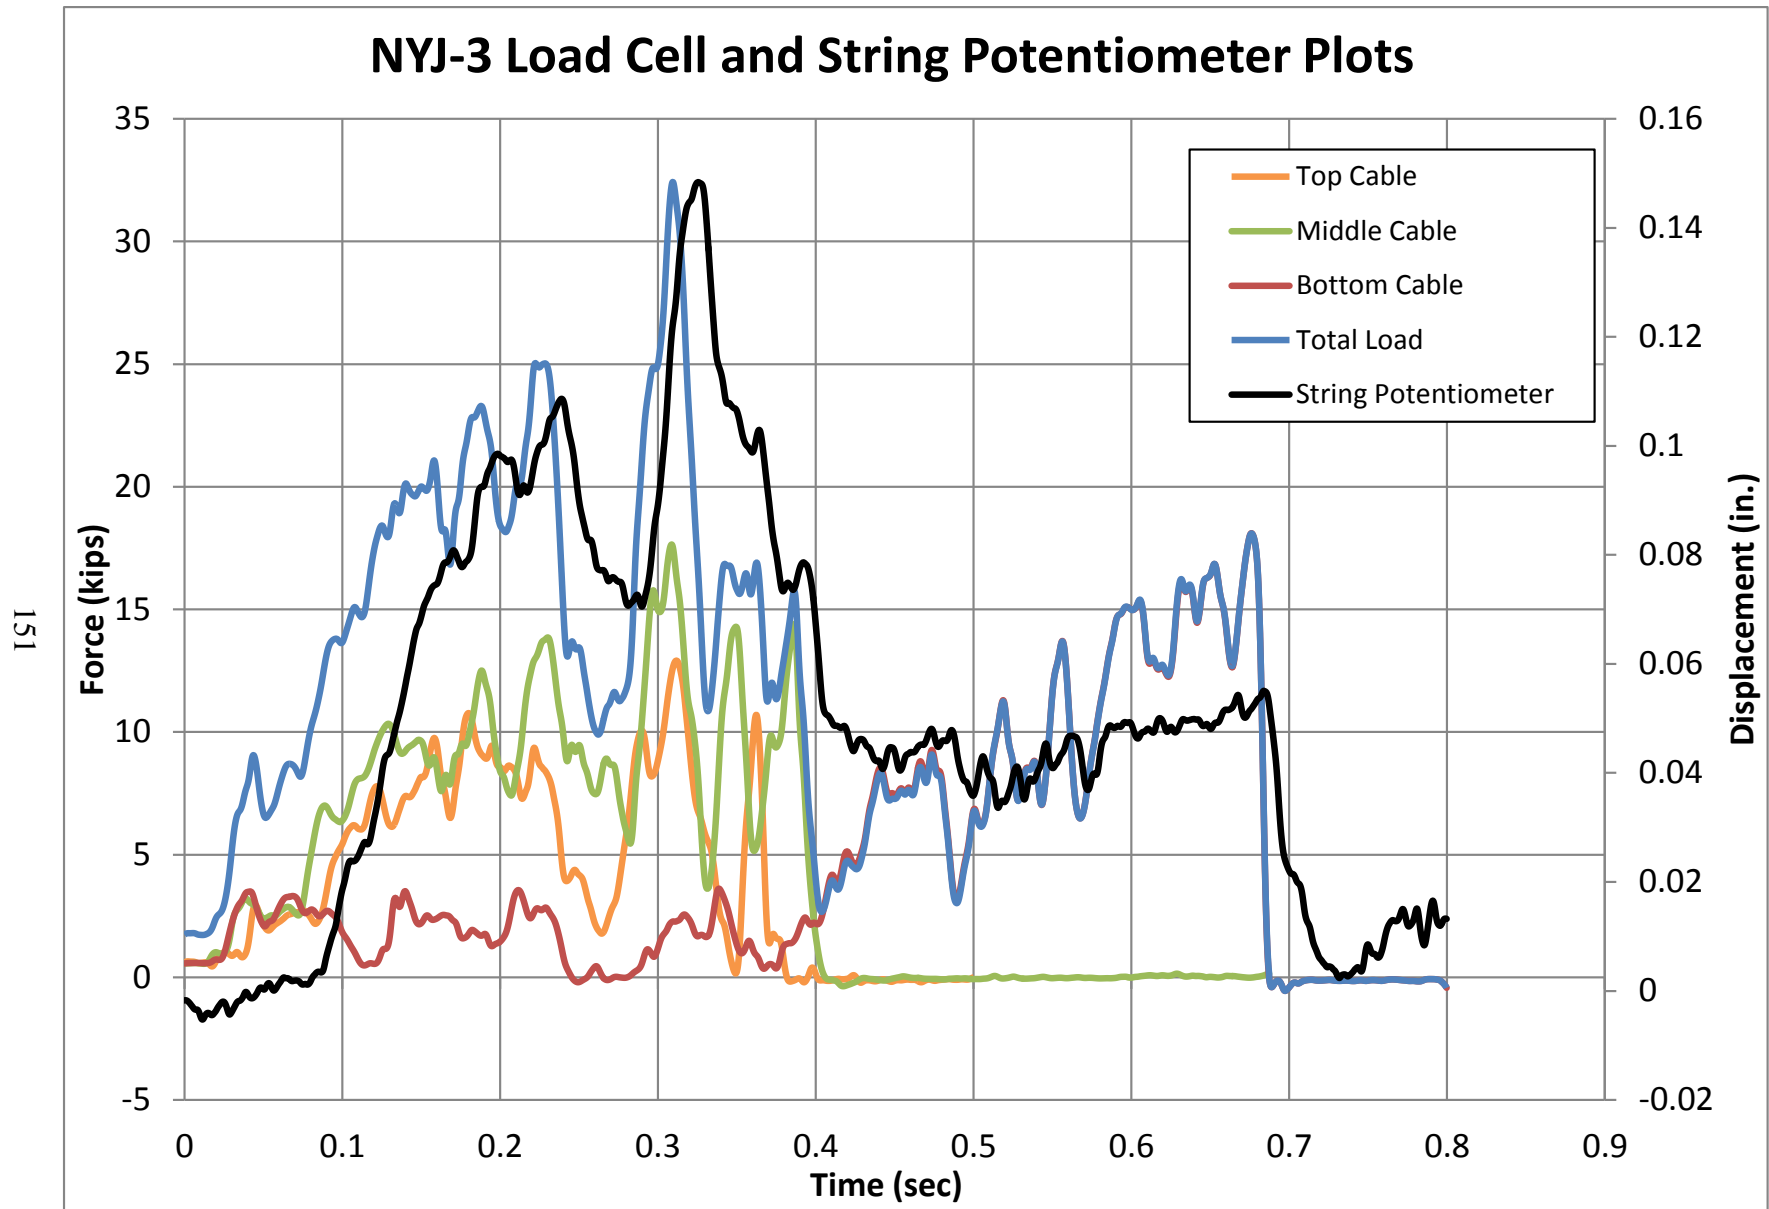
Figure 100. Load Cell and String Pot Plots, Test No. NYJ-3

the transducers are summarized in Table 20. The individual cable loads, along with the total combined cable load imparted to the upstream end anchor, are shown graphically in Figure 100.

Upstream anchor displacement was also tracked using a string potentiometer. The displacement-time history of the upstream anchor is also shown in Figure 100. The anchor on the upstream end had a maximum displacement of 0.15 in. (4 mm).
