MASH TEST NOS. 3-11 AND 3-10 ON A NON-PROPRIETARY CABLE MEDIAN BARRIER

MIDWEST ROADSIDE SAFETY FACILITY

MwRSF Research Report No. TRP-03-327-16

May 17, 2016

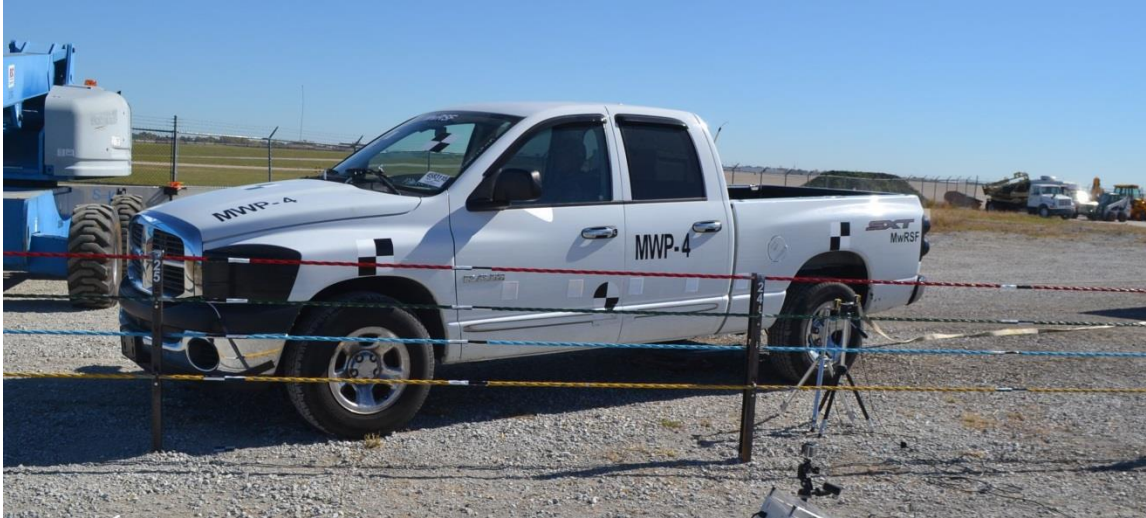
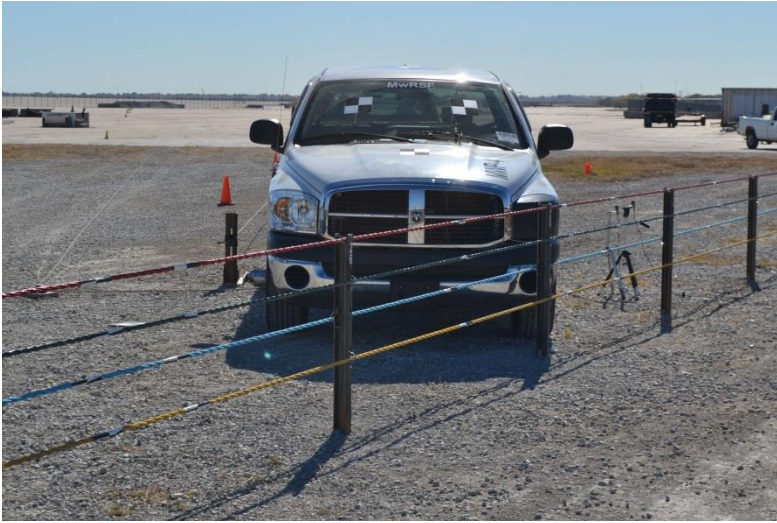
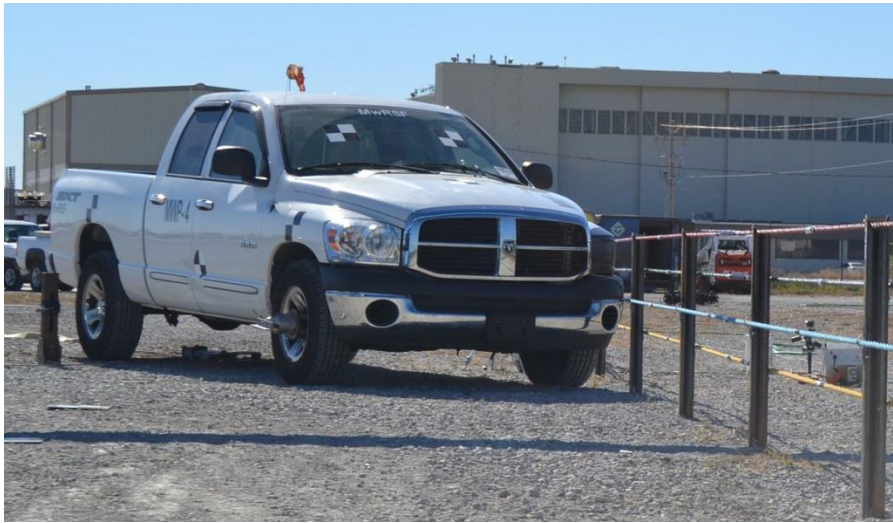
Figure 48. Vehicle Final Position and Trajectory, Test No. MWP-4

Initial vehicle impact was to occur 1 ft (0.3 m) upstream from post no. 25, as shown in Figure 47, which was selected according to proposed MASH updates. The actual point of impact was approximately 1.9 in. (48 mm) upstream from the target impact point. A sequential description of the impact events is contained in Table 5. The vehicle came to rest 144 ft - 10 in. (44.1 m) downstream from the point of impact, between post nos. 38 and 39. The vehicle trajectory and final position are shown in Figures 42 and 48.

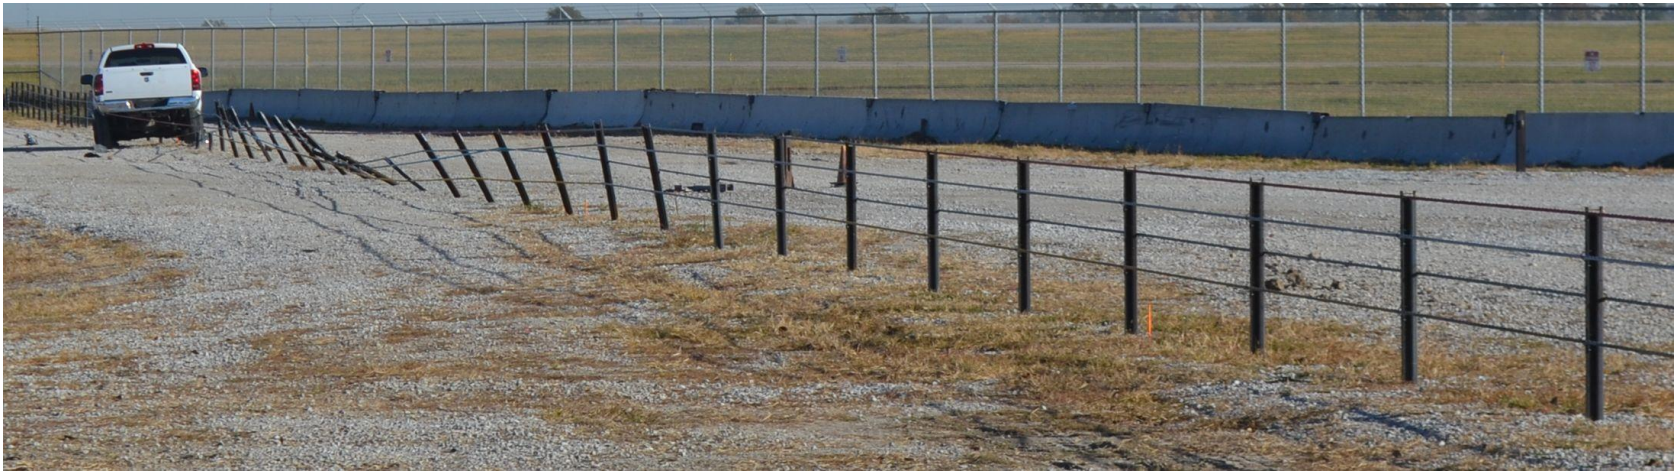
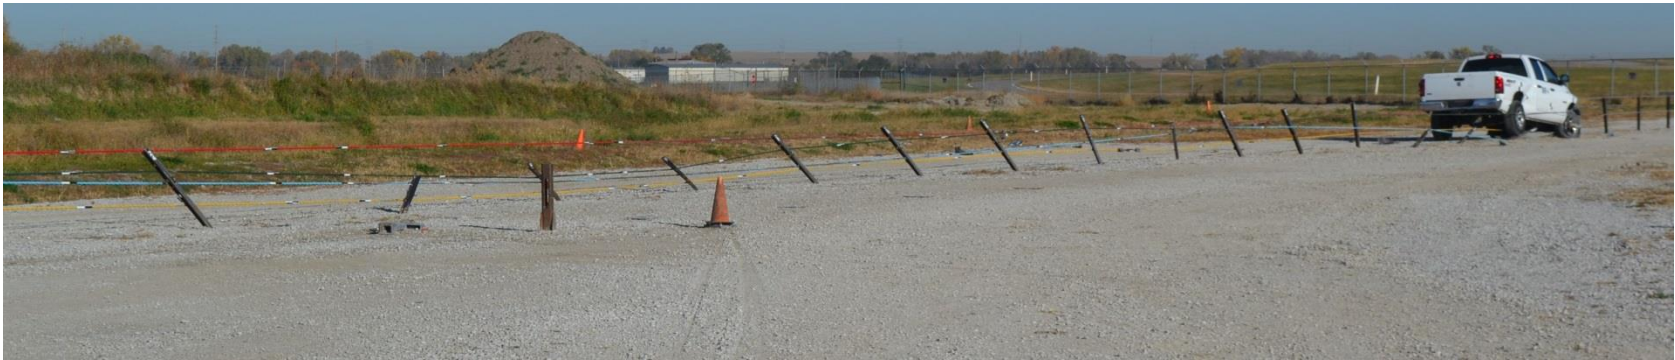
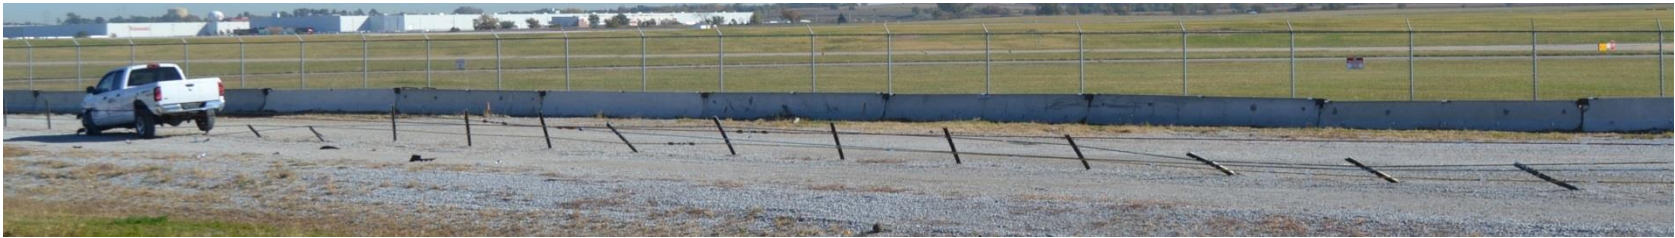
Figure 49. System Damage, Test No. MWP-4

Damage to the barrier was moderate, as shown in Figures 49 through 59. Barrier damage consisted of bent posts, disengaged cables, and deformed brackets. At its final resting position, the vehicle was still in contact with the cables. Cable nos. 1 and 2 were beneath the vehicle, cable no. 4 was on the impact side of the vehicle, and cable no. 3 was on the non-impact side of the vehicle.

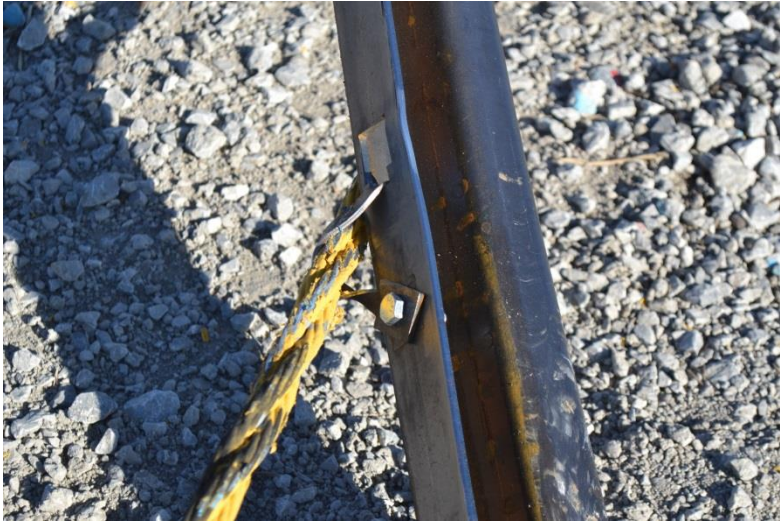
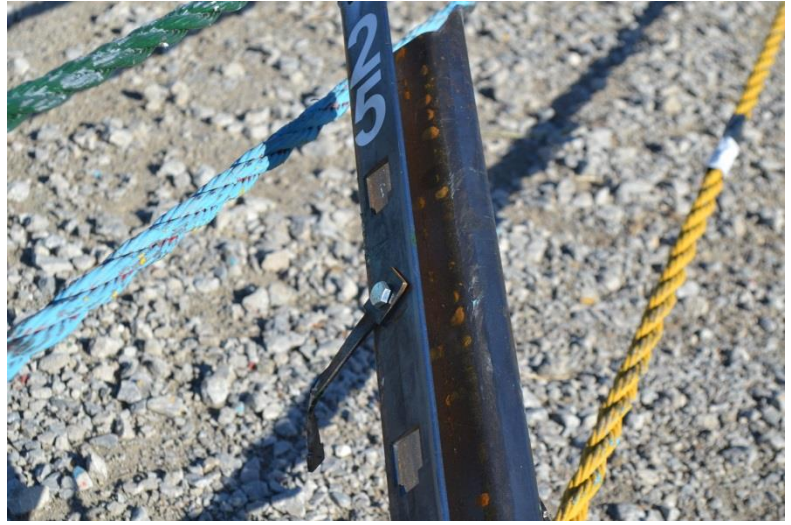
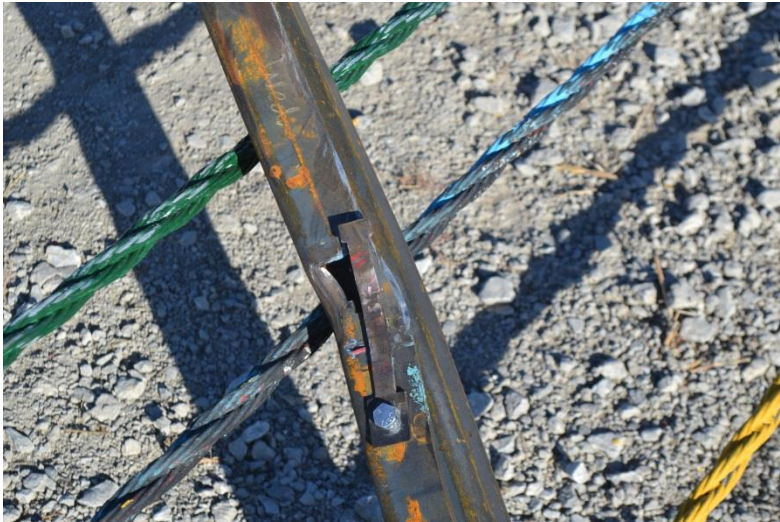
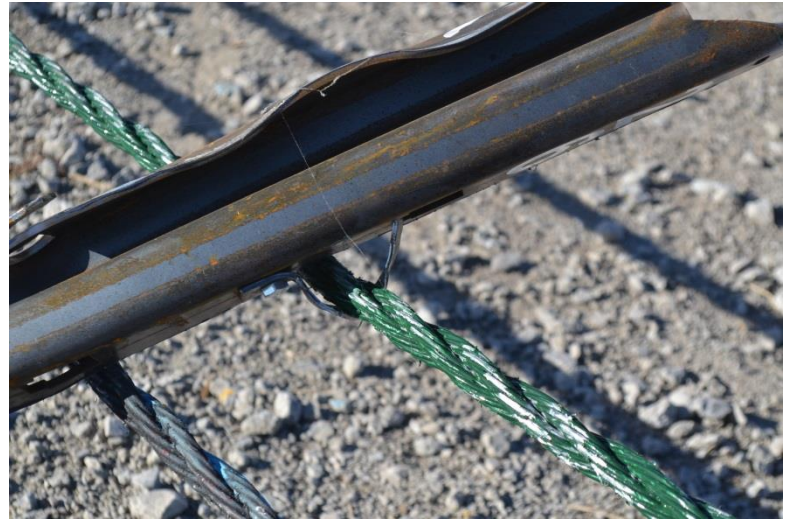
Figure 51. System Damage, Cable Brackets, Test No. MWP-4

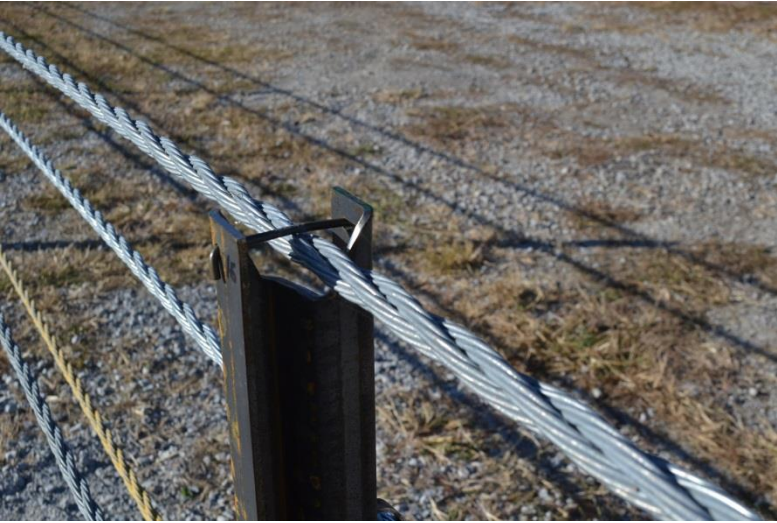
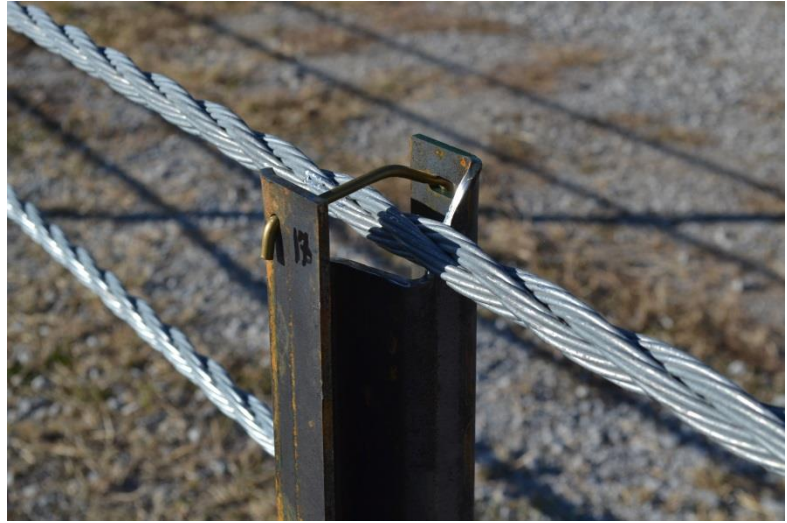
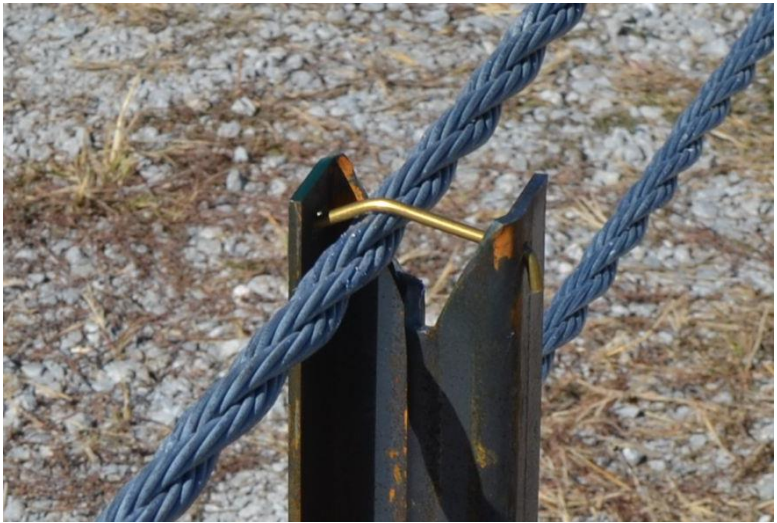
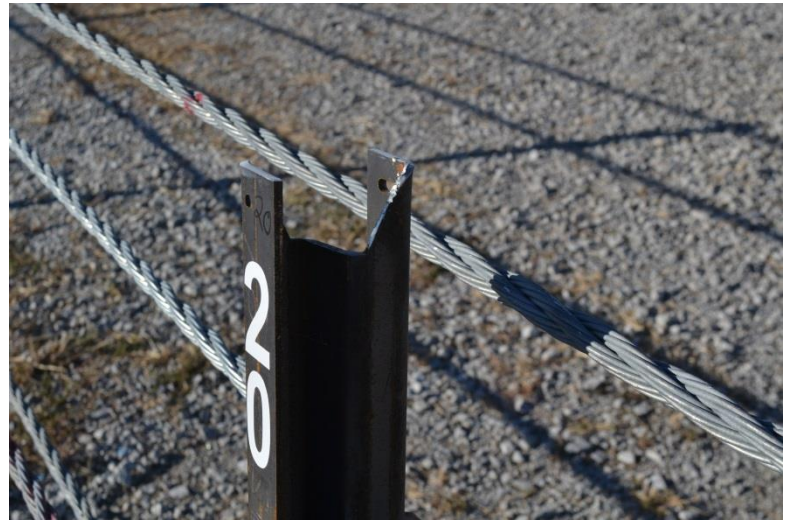
Figure 52. System Damage, Cable Brackets, Test No. MWP-4

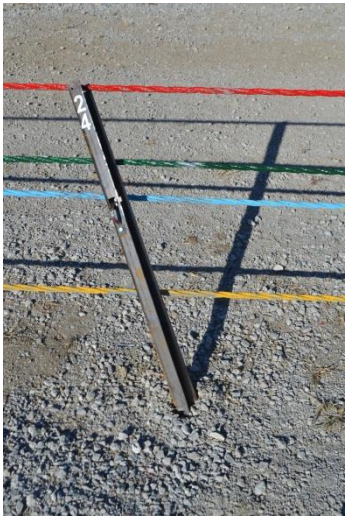
Post No. 24

Figure 54. System Damage, Post Nos. 24 through 26, Test No. MWP-4

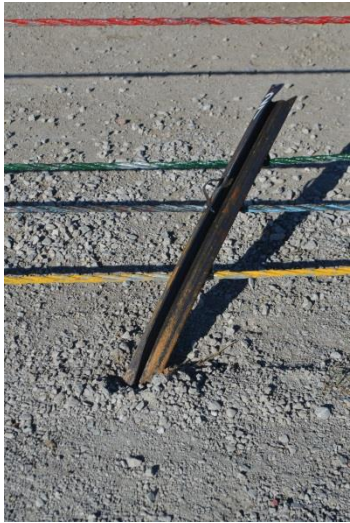
Post No. 27

Figure 55. System Damage, Post Nos. 27 through 29, Test No. MWP-4

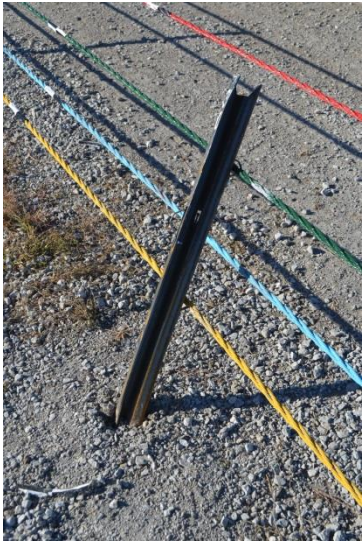
Post No. 30

Figure 56. System Damage, Post Nos. 30 through 32, Test No. MWP-4

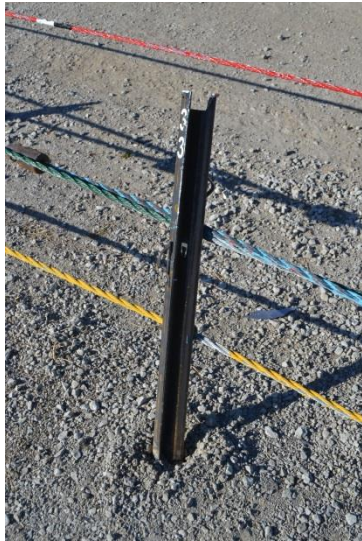
Post No. 33

Figure 57. System Damage, Post Nos. 33 through 35, Test No. MWP-4

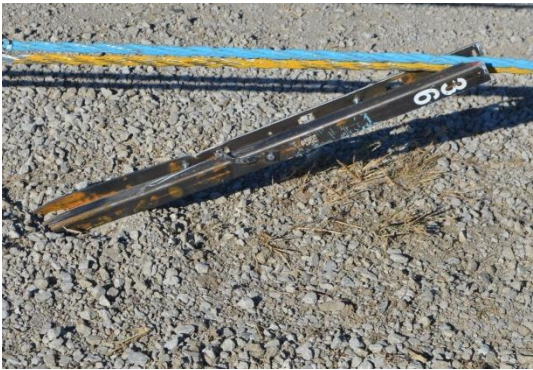
Post No. 36

Figure 58. System Damage, Post Nos. 36 through 38, Test No. MWP-4

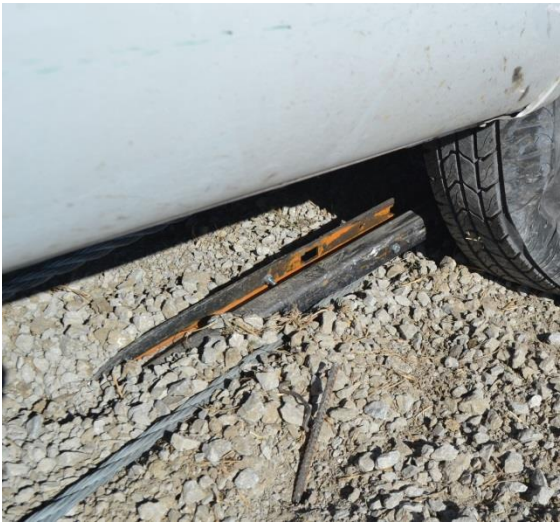
Post No. 39

Figure 59. System Damage, Post Nos. 39 through 41, Test No. MWP-4

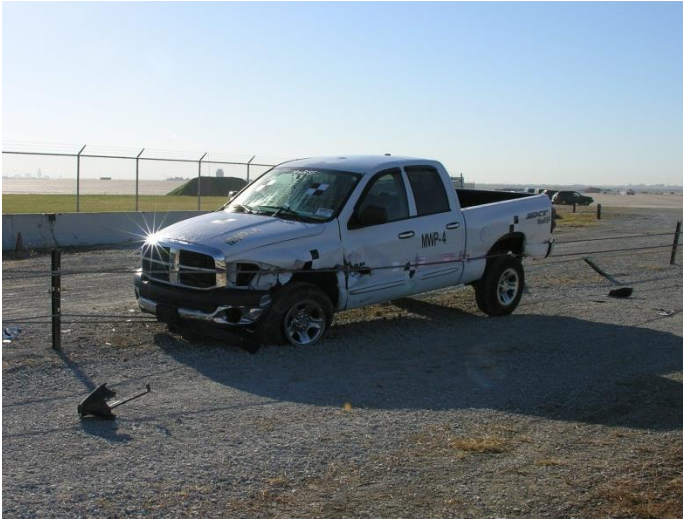
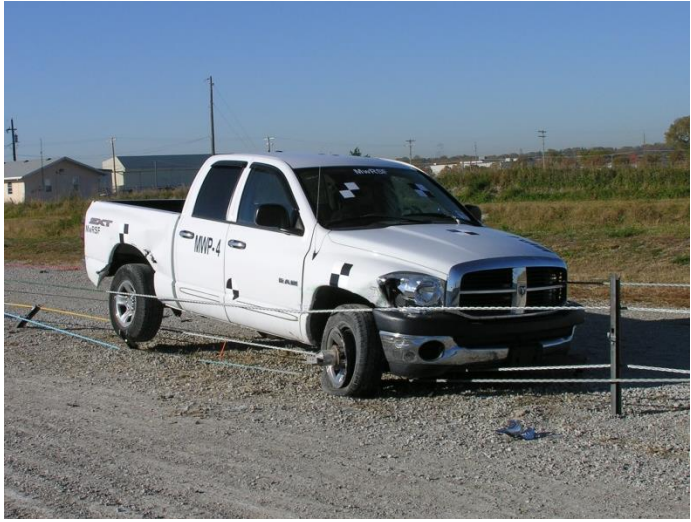
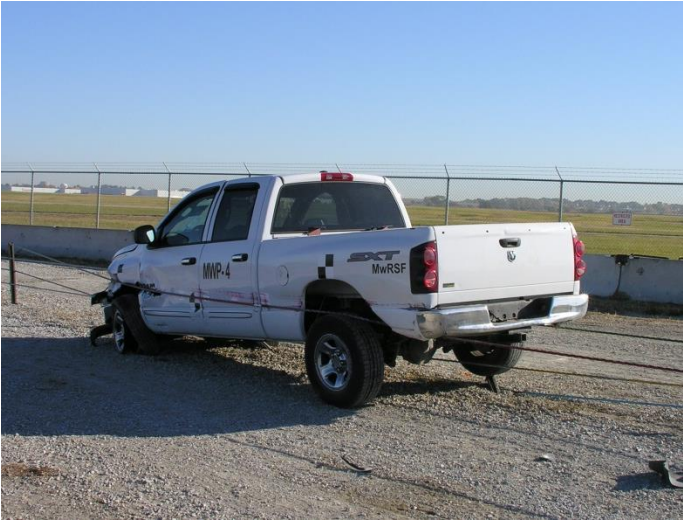
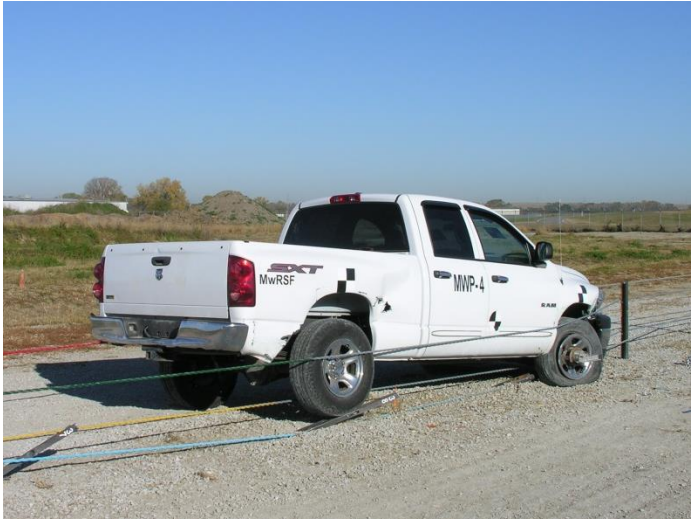
The damage to the vehicle was moderate, as shown in Figures 60 and 61. The maximum occupant compartment deformations are listed in Table 6 along with the deformation limits established in MASH for various areas of the occupant compartment. Note that none of the MASH-established deformation limits were violated. Complete occupant compartment and vehicle deformations as well as the corresponding locations are provided in Appendix D.

- Vehicle Damage..... Moderate
 - VDS [8] 11-LFQ-4
 - CDC [9] 11-LYEN-3
 - Maximum Interior Deformation 1 in. (25 mm)

Figure 60. Vehicle Damage, Test No. MWP-4

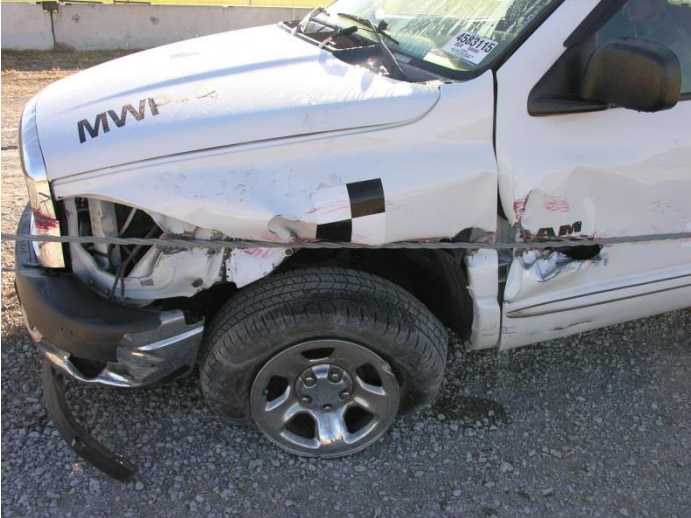
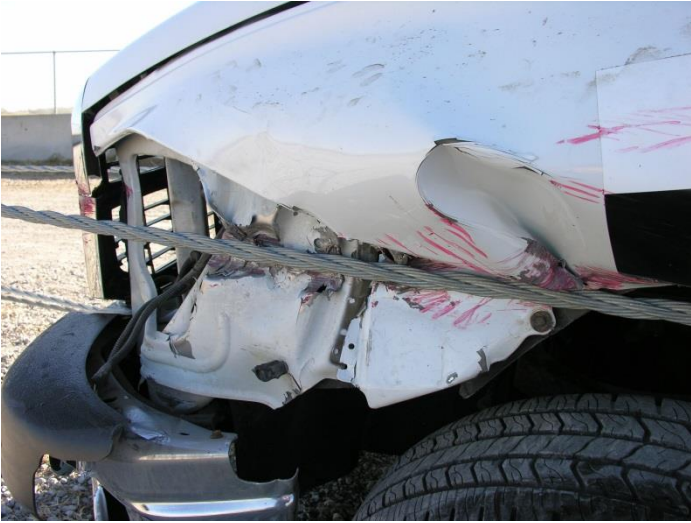
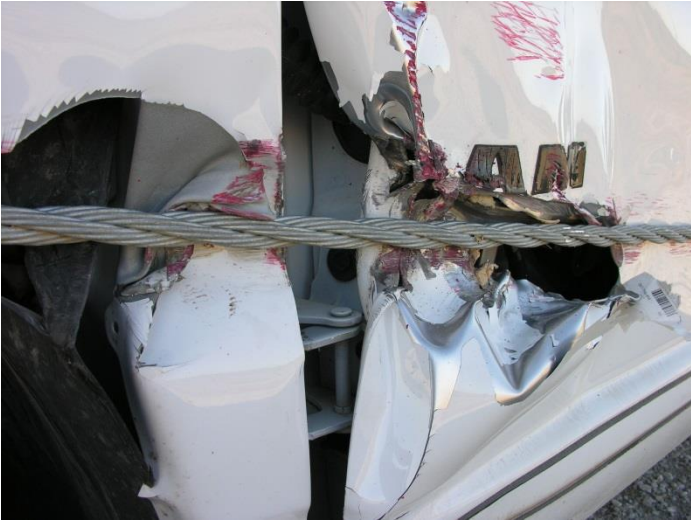
Figure 61. Vehicle Damage, Test No. MWP-4

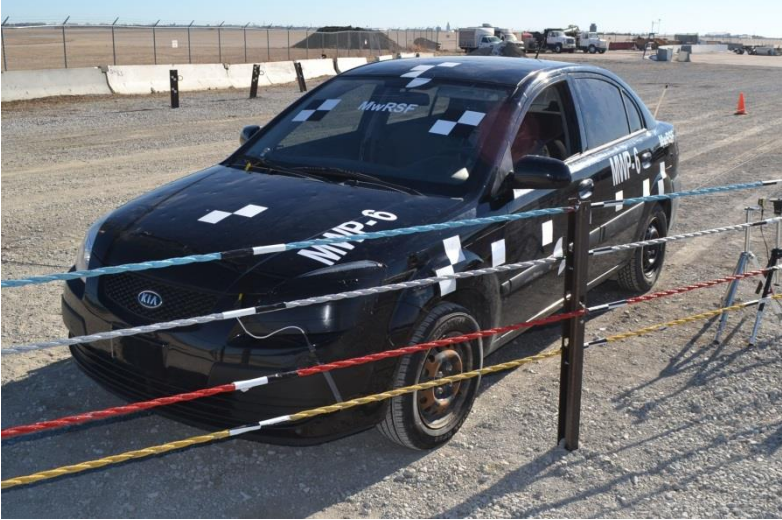
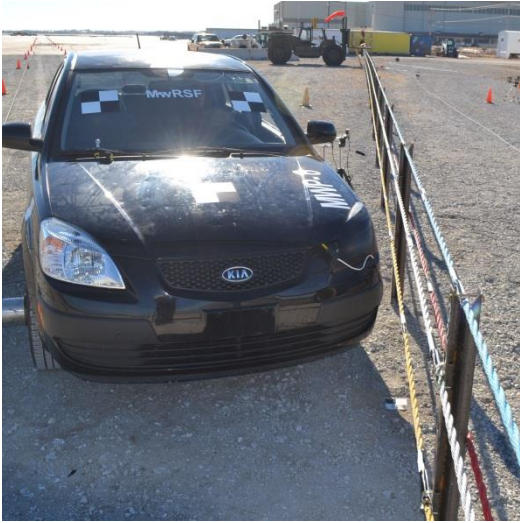
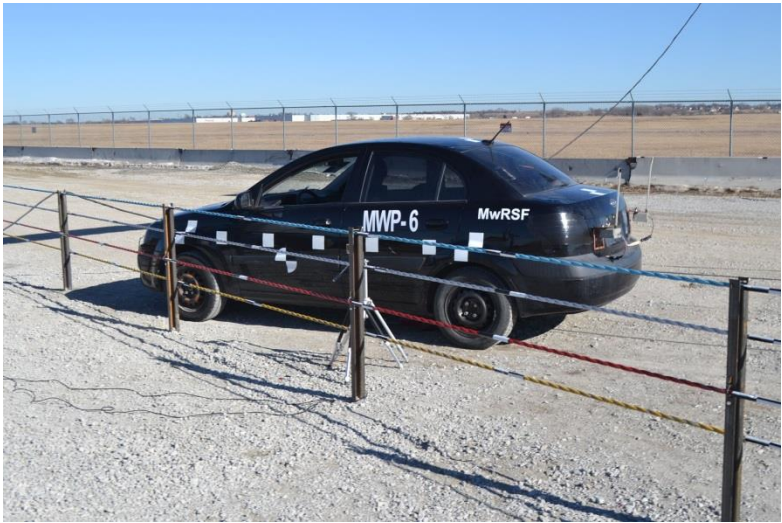
Figure 93. Documentary Photographs, Test No. MWP-6

The 2,572-lb (1,167-kg) small car impacted the high-tension, four-cable median barrier at a speed of 63.5 mph (102.2 km/h) and at an angle of 24.9 degrees. A summary of the test results and sequential photographs are shown in Figure 90. Additional sequential photographs are shown in Figures 91 and 92. Documentary photographs of the crash test are shown in Figure 93.

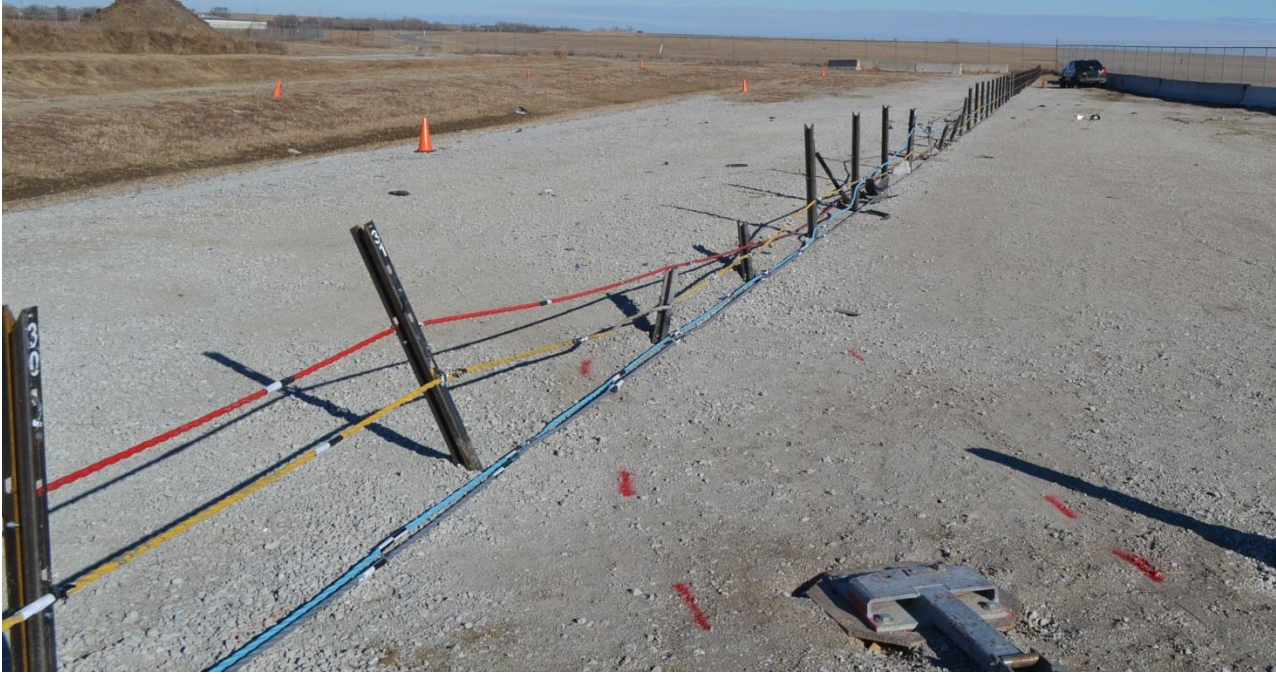
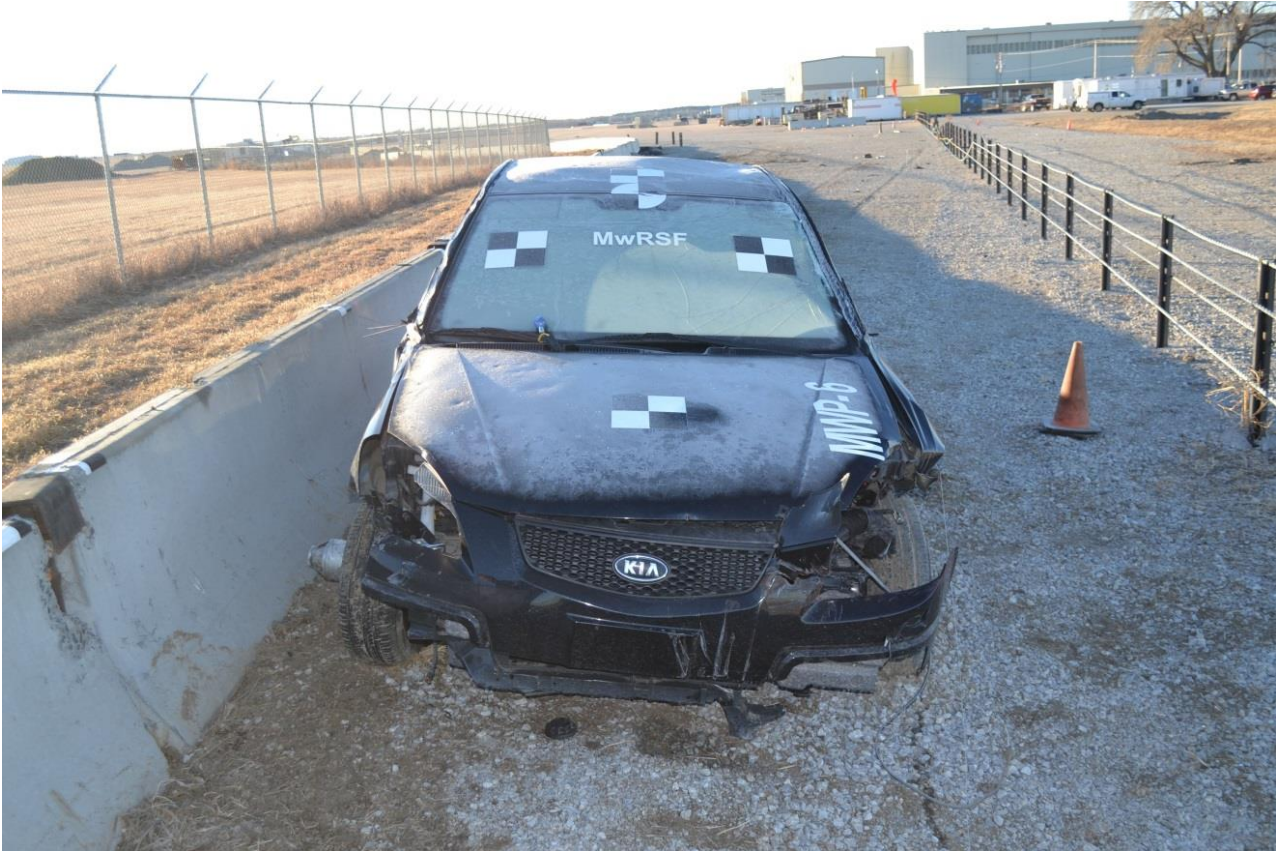
Figure 94. Impact Location, Test No. MWP-6

Initial vehicle impact was to occur at a midspan location, or 4 ft (1.2 m) upstream from post no. 32, as shown in Figure 94, which was selected according to MASH guidelines. The actual point of impact was approximately 4.5 in. (114 mm) upstream from the target impact point. A sequential description of the impact events is contained in Table 10. The vehicle came to rest 234 ft - 6 in. (71.5 m) downstream from the point of impact. The vehicle trajectory and final position are shown in Figures 90 and 95.

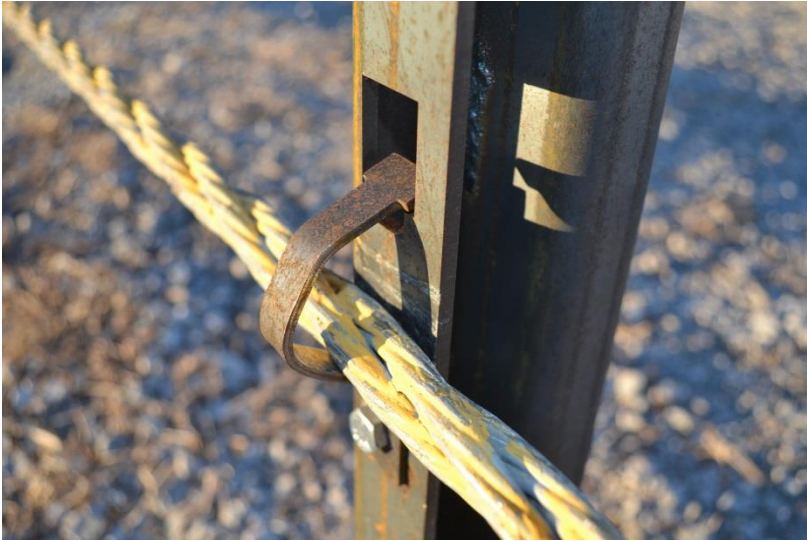
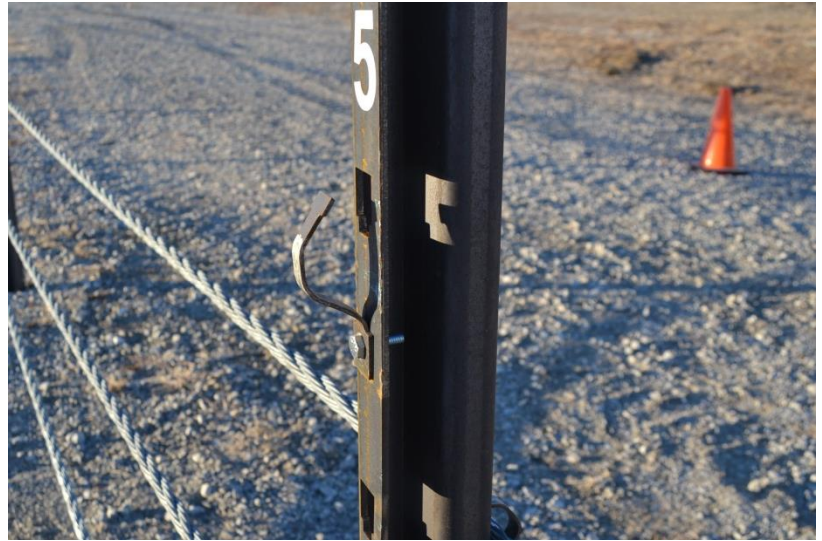
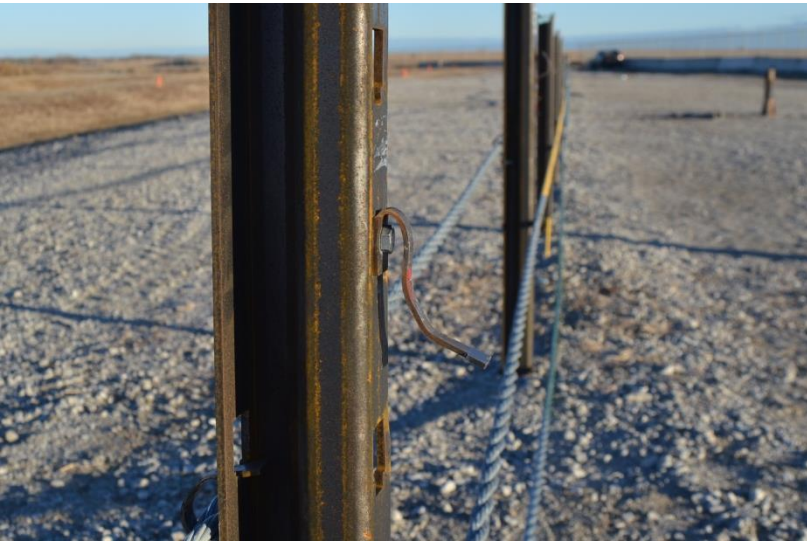
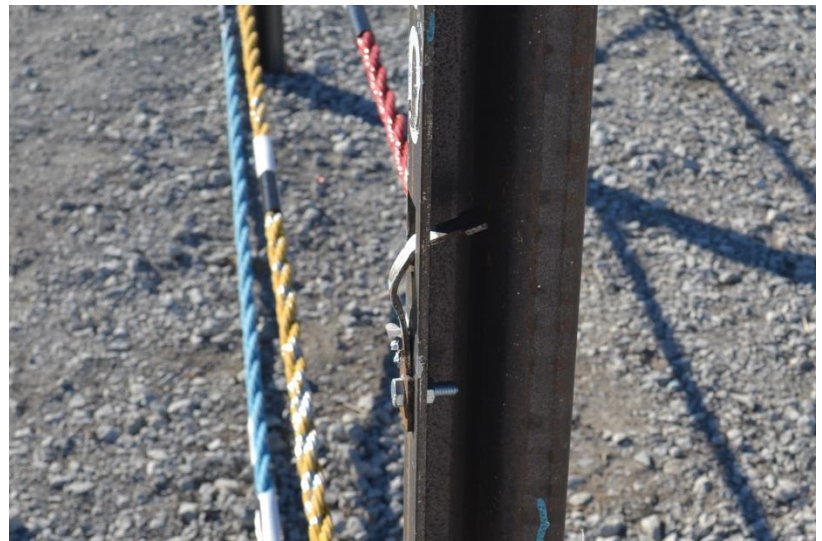
Figure 98. System Damage, Cable Brackets, Test No. MWP-6

Damage to the barrier was moderate, as shown in Figures 96 through 104. Barrier damage consisted of bent posts, disengaged cables, and bent and fractured brackets. At its final resting position, the vehicle was no longer in contact with the system.

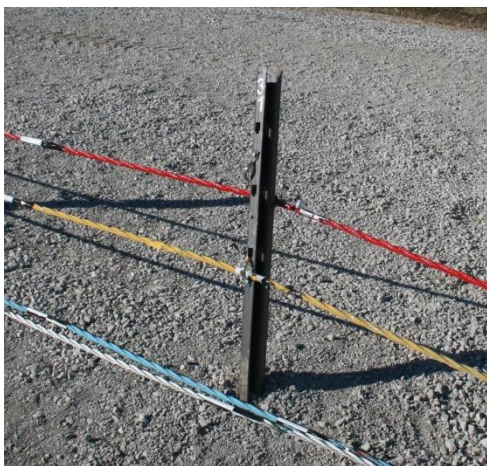
Post No. 31

Figure 100. System Damage, Post Nos. 31 through 33, Test No. MWP-6

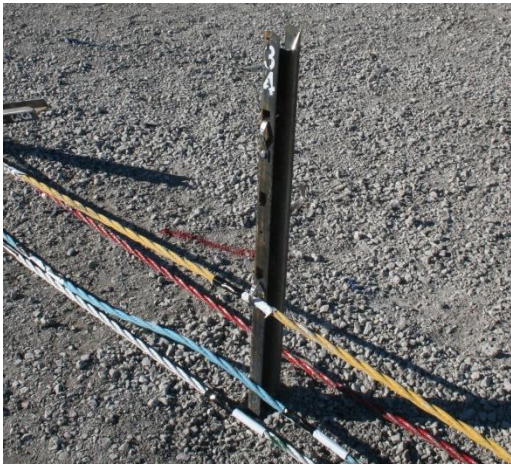
Post No. 34

Figure 101. System Damage, Post Nos. 34 through 36, Test No. MWP-6

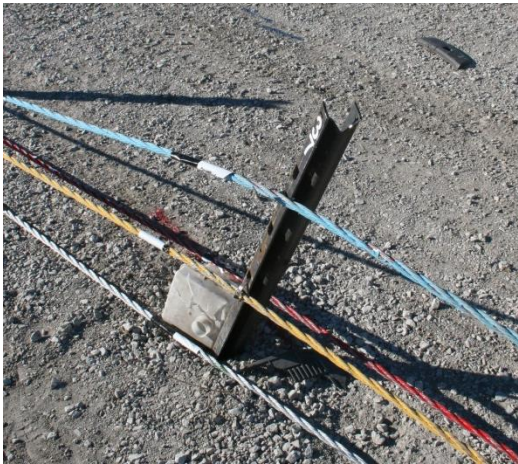
Post No. 37

Figure 102. System Damage, Post Nos. 37 through 39, Test No. MWP-6

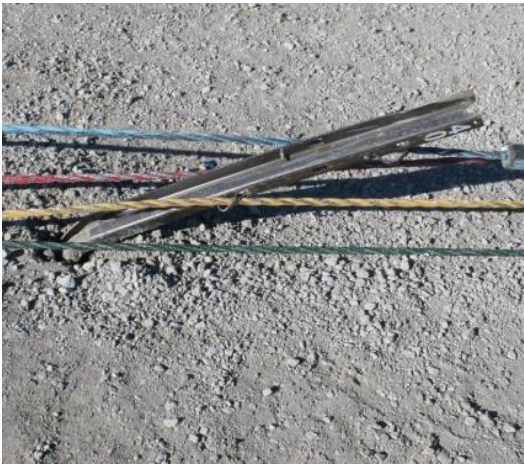
Post No. 40

Figure 103. System Damage, Post Nos. 40 through 42, Test No. MWP-6

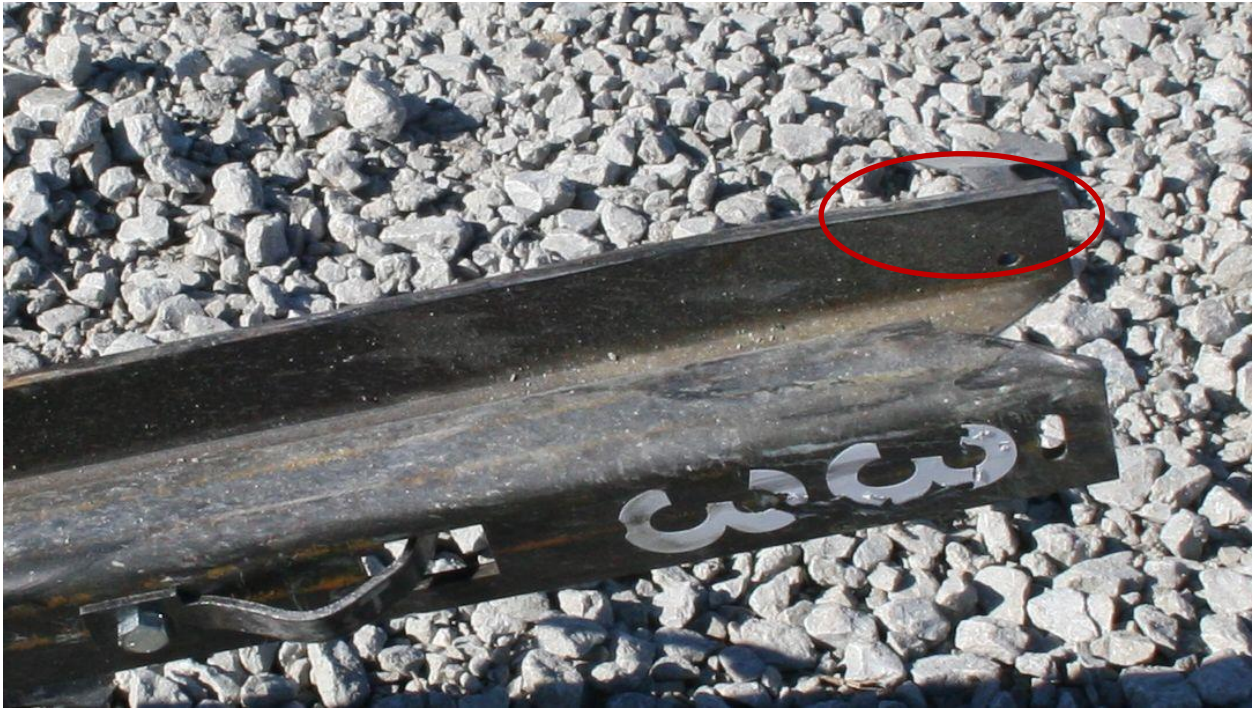
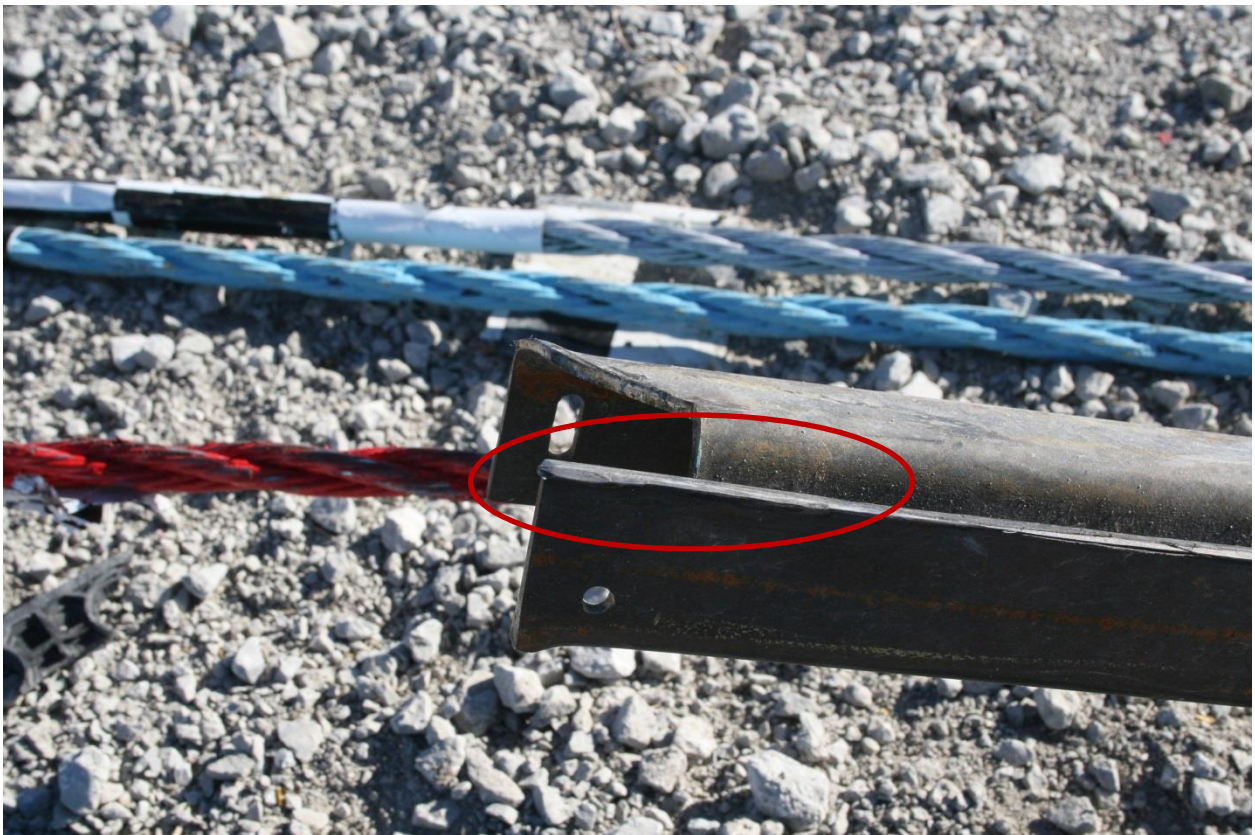
Figure 104. Post Contact Marks, Test No. MWP-6

Following the unsuccessful system performance in test no. MWP-6, the researchers brainstormed several potential design changes to mitigate floorpan penetrations. Analysis of the vehicle undercarriage and contact marks on both the system posts and the vehicle suggested that the floorpan tears were created as the post was overridden by the vehicle and the edges of the post scraped along the bottom of the vehicle. Contact marks from both the left and right flanges when bending about the weak axis of the post were visible in the deformed floorpan. A review of these contact marks indicated that the tearing was primarily caused by the free edges of the post, as shown in Figures 104 and 108.

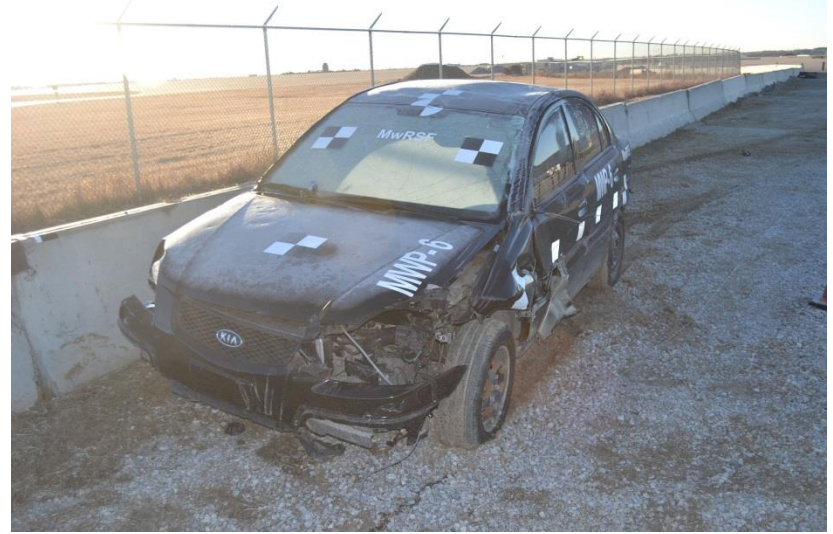
Figure 105. Vehicle Damage, Test No. MWP-6

The damage to the vehicle was moderate, as shown in Figures 105 through 110. The maximum occupant compartment deformations are listed in Table 11 along with the deformation limits established in MASH for various areas of the occupant compartment. Note that none of the MASH-established deformation limits were violated. Complete occupant compartment and vehicle deformations as well as the corresponding locations are provided in Appendix D.

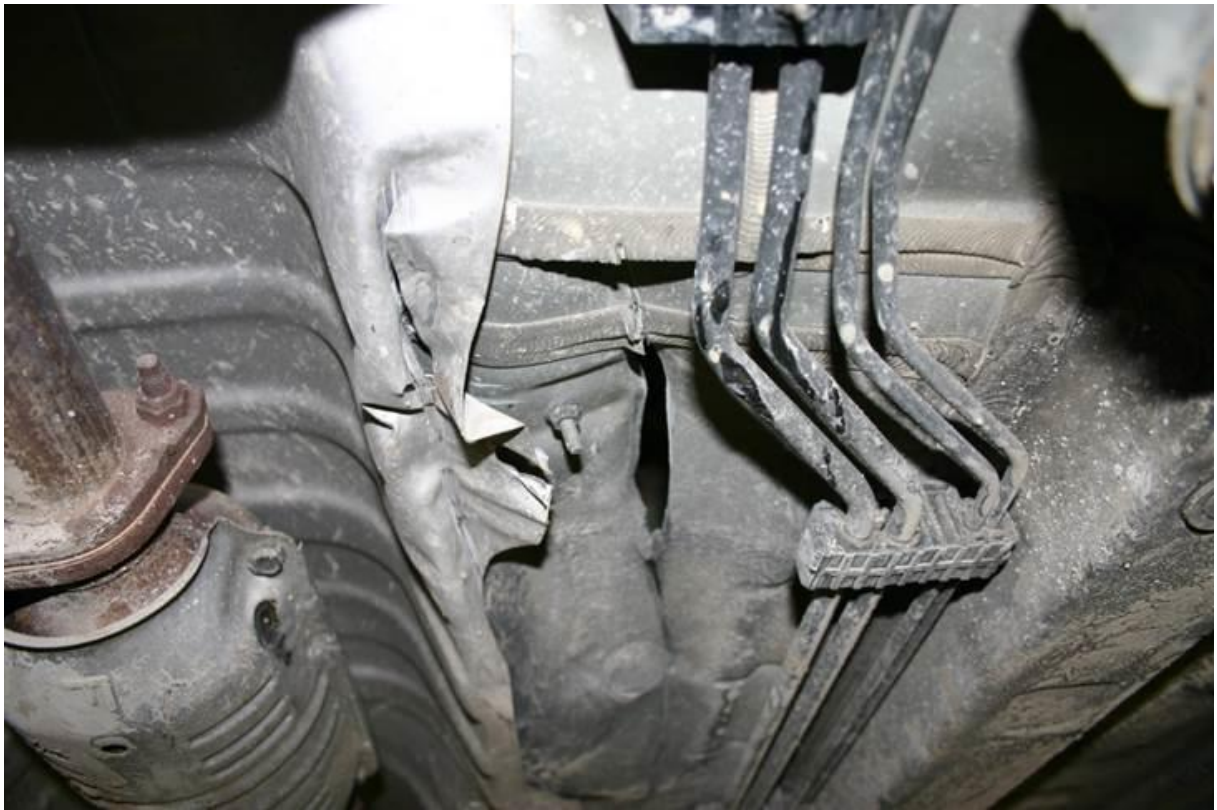
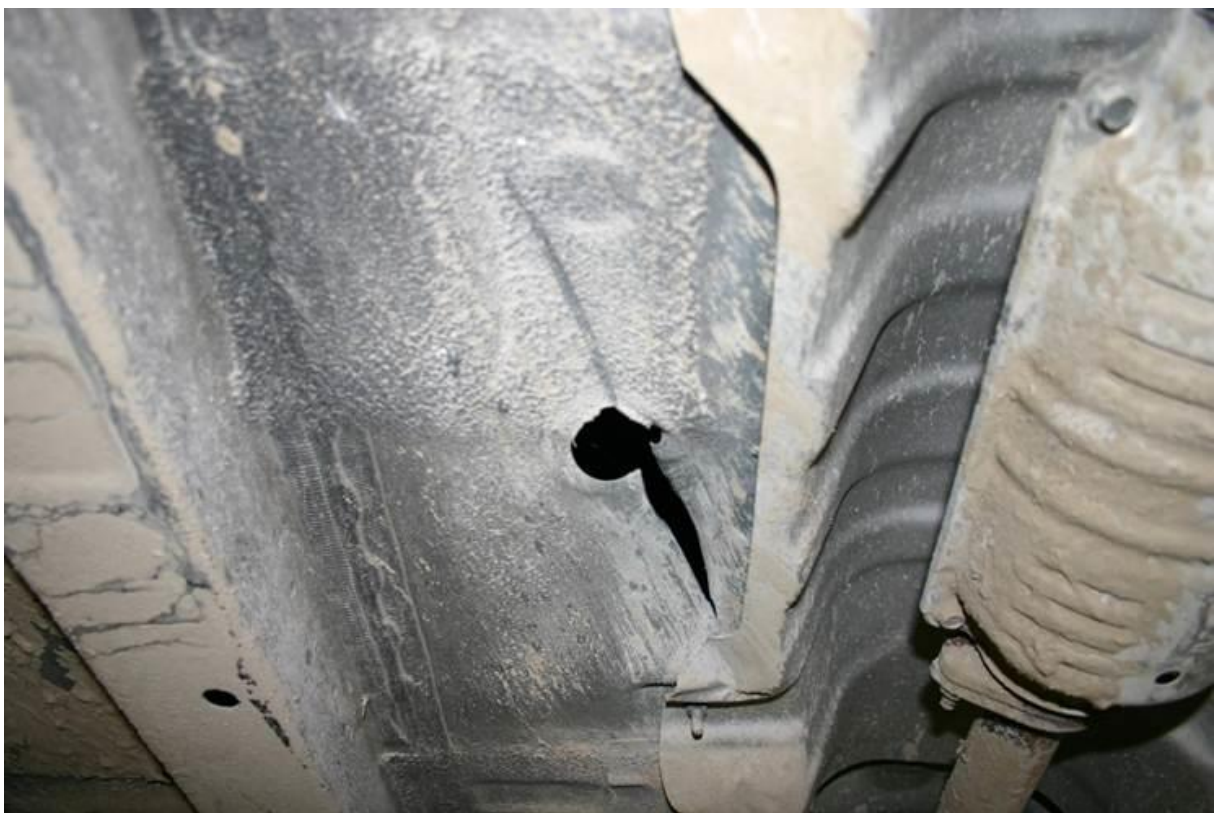
Figure 108. Occupant Compartment Penetration, Test No. MWP-6

The floorpan was torn in several locations. A 7.5-in. (191-mm) long floorpan tear was located on the left side of the transmission hump, and a 4-in. (102-mm) long tear was on the right side of the transmission hump extending backward from a hole in the floorpan. These tears can be seen on the interior of the vehicle in Figure 107 and from the undercarriage in Figure 108. Although the occupant compartment deformations were within the bounds set by MASH, the occupant compartment penetrations via floorpan tears were unacceptable. The spare tire area of the trunk also had a 4-in. (102-mm) long tear, as shown in Figure 109. While not part of the
