MASH TEST NOS. 3-11 AND 3-10 ON A NON-PROPRIETARY CABLE MEDIAN BARRIER

MIDWEST ROADSIDE SAFETY FACILITY

MwRSF Research Report No. TRP-03-327-16

May 17, 2016

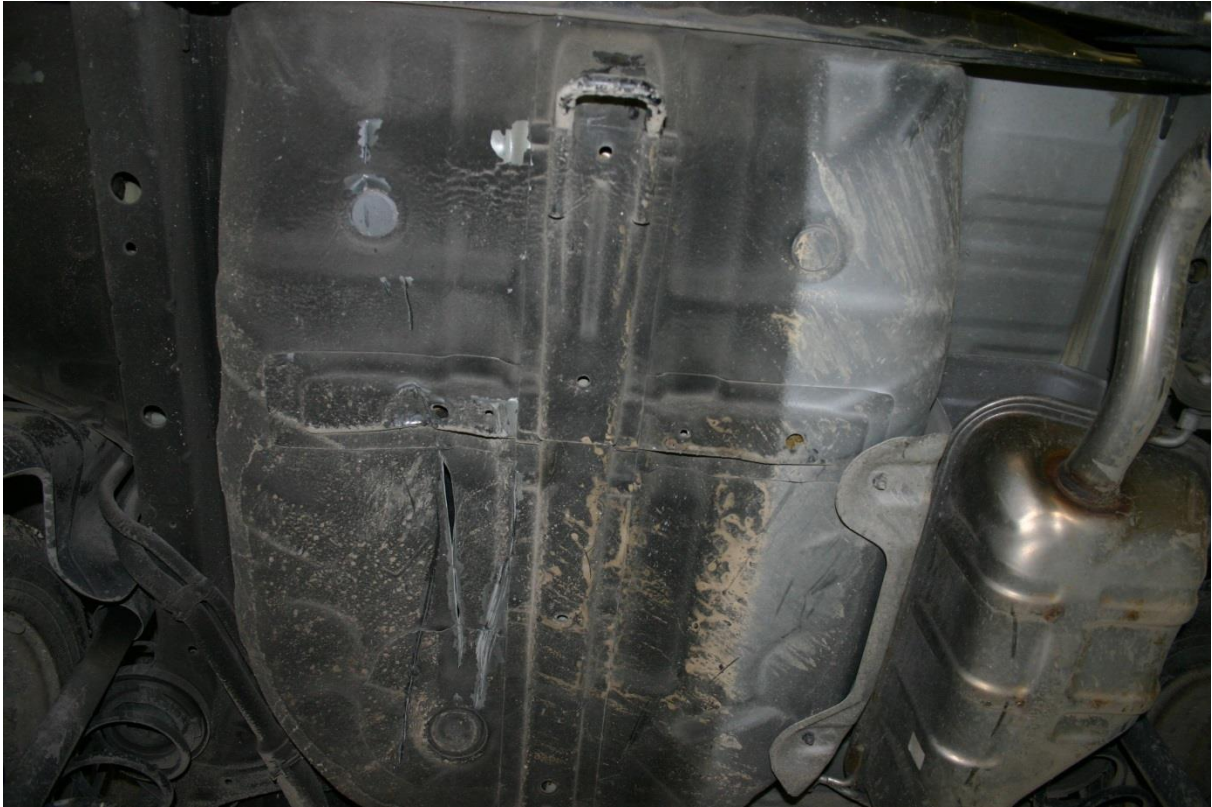
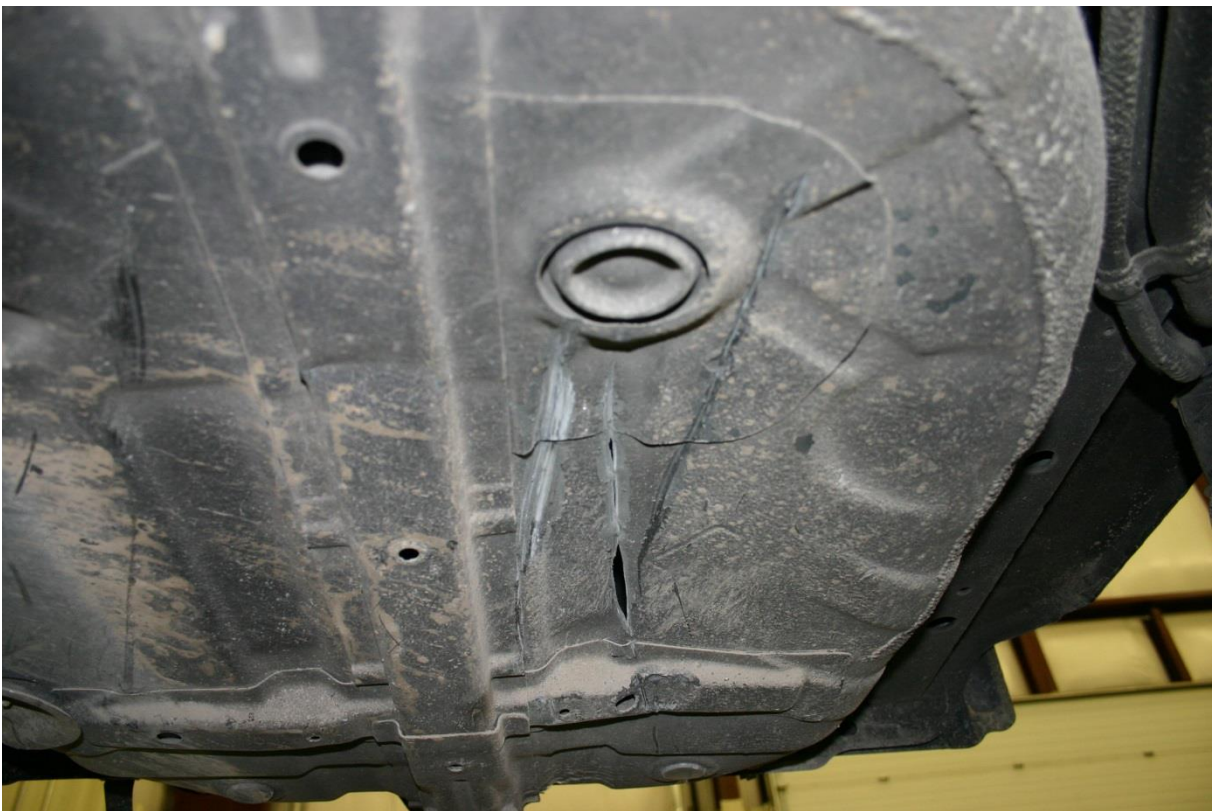
Figure 109. Spare Tire Compartment Penetration, Test No. MWP-6

The floorpan was torn in several locations. A 7.5-in. (191-mm) long floorpan tear was located on the left side of the transmission hump, and a 4-in. (102-mm) long tear was on the right side of the transmission hump extending backward from a hole in the floorpan. These tears can be seen on the interior of the vehicle in Figure 107 and from the undercarriage in Figure 108. Although the occupant compartment deformations were within the bounds set by MASH, the occupant compartment penetrations via floorpan tears were unacceptable. The spare tire area of the trunk also had a 4-in. (102-mm) long tear, as shown in Figure 109. While not part of the

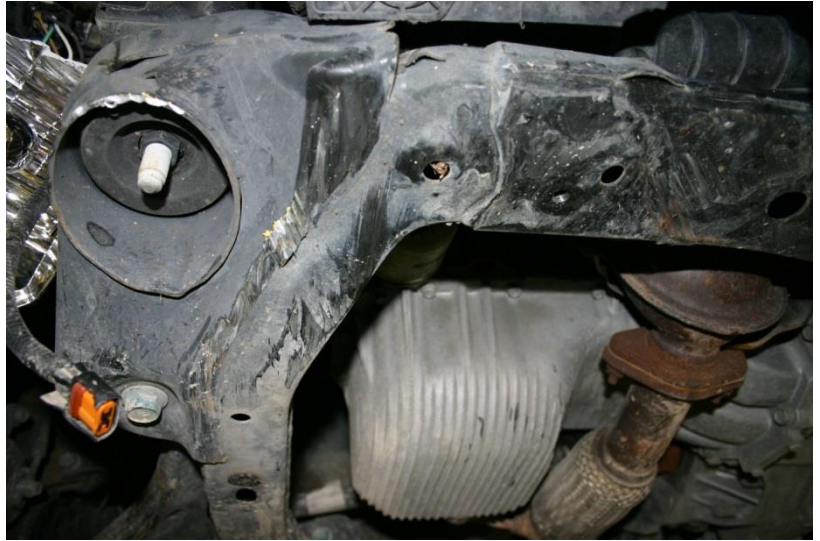
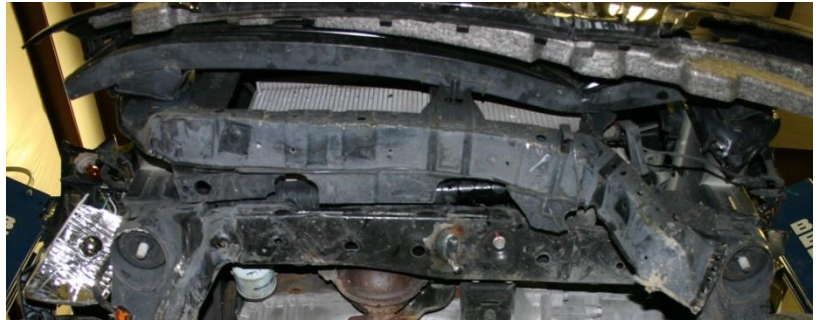
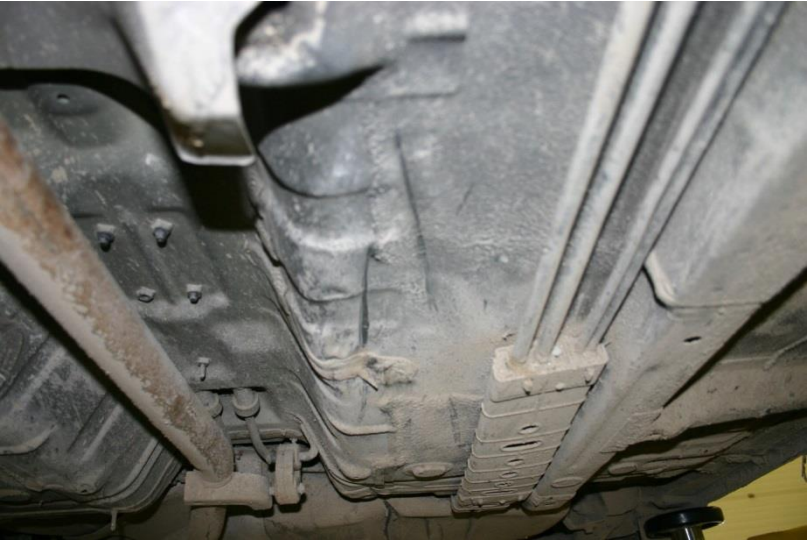
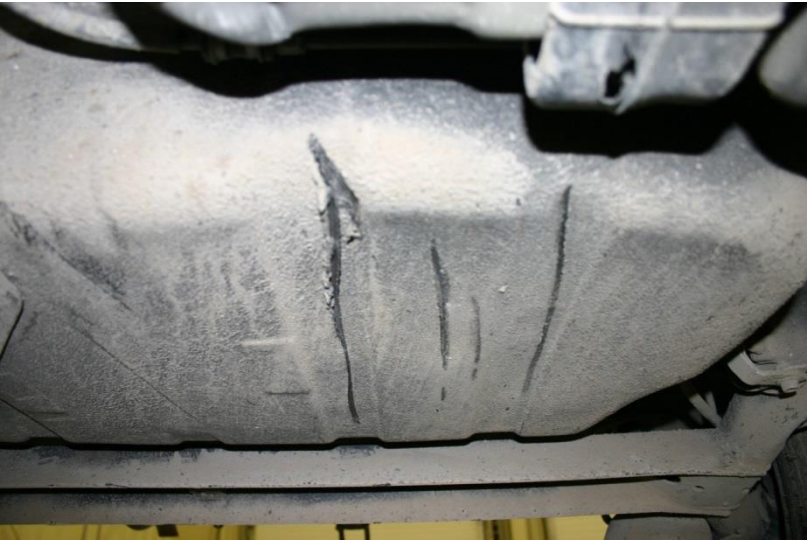
Figure 110. Additional Undercarriage Damage, Test No. MWP-6

occupant compartment, this trunk damage still raises concern. Additional scrapes and gouges were found on the floorpan and vehicle undercarriage, as shown in Figure 110.

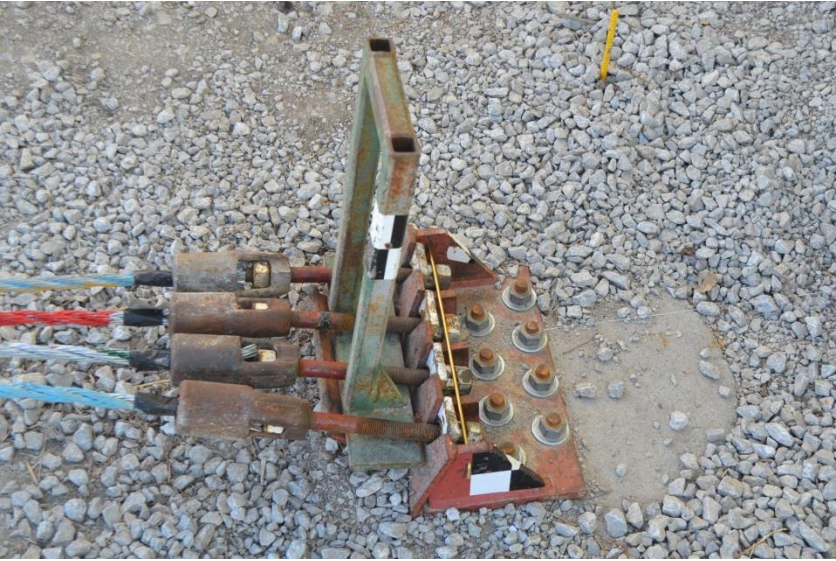
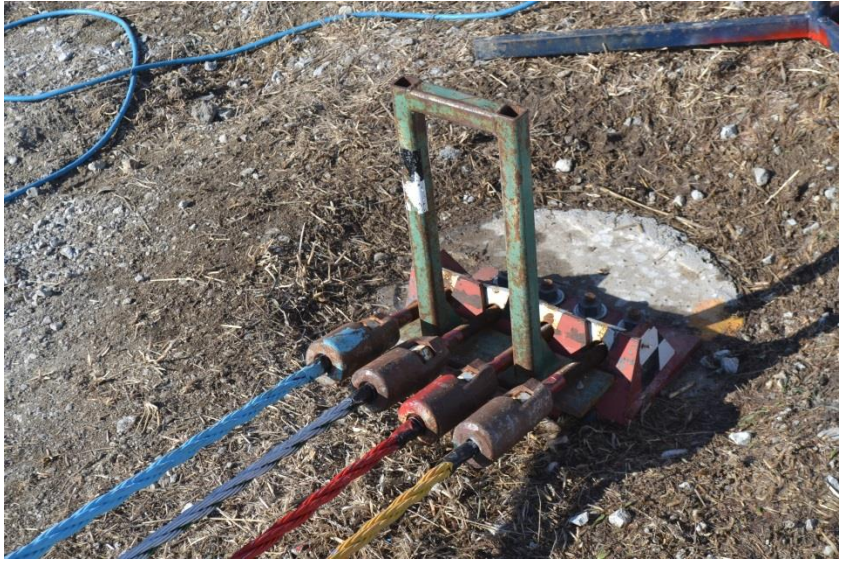
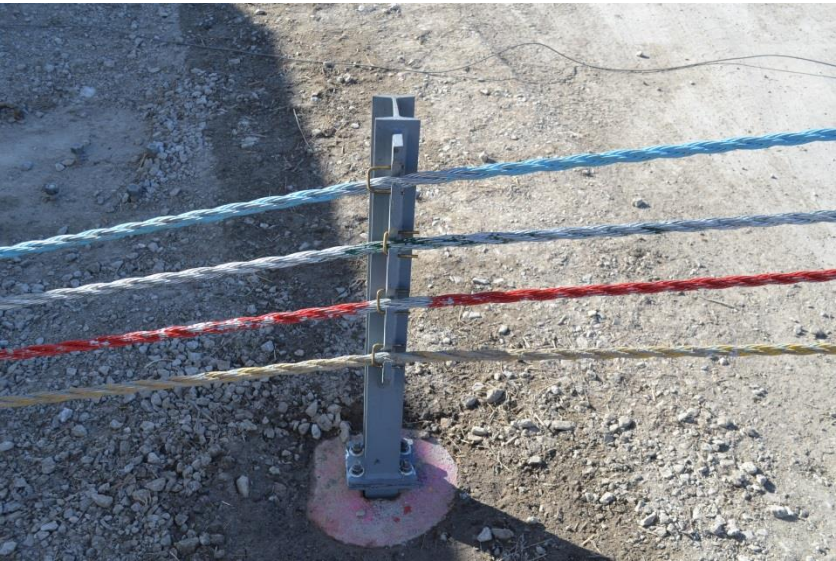
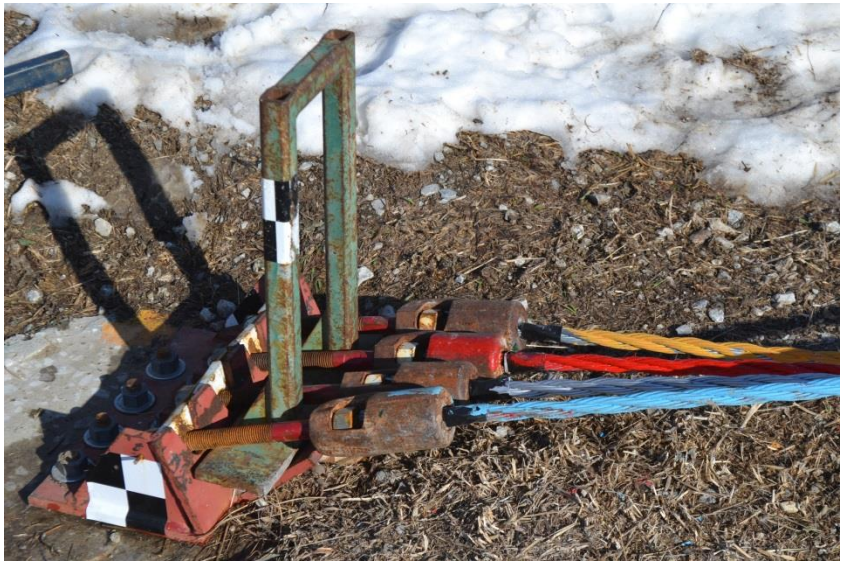
Figure 148. System Damage, Test No. MWP-7

Damage to the barrier was moderate, as shown in Figures 148 through 158. Barrier damage consisted of bent posts, disengaged cables, and bent and fractured brackets. At its final resting position, the vehicle was still in contact with the cables. Cable no. 3 was beneath the vehicle, cable no. 2 was on the impact side of the vehicle, and cable nos. 1 and 4 were on the non-impacting side of the vehicle.

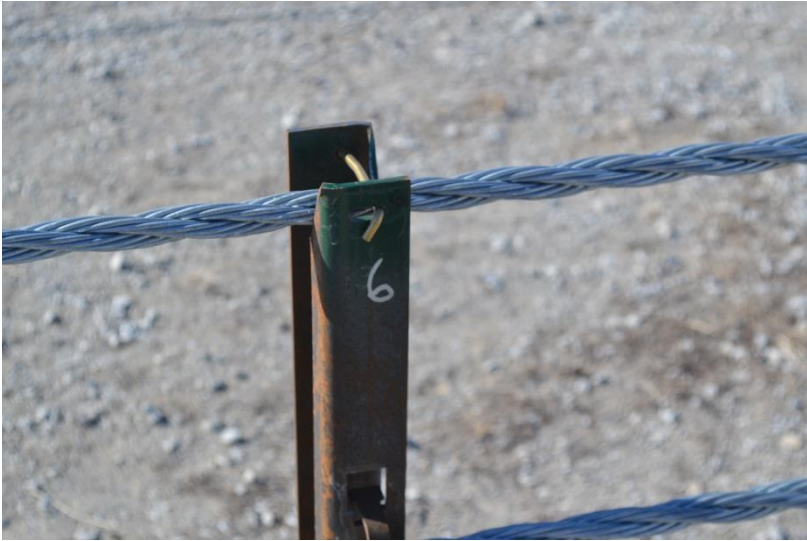
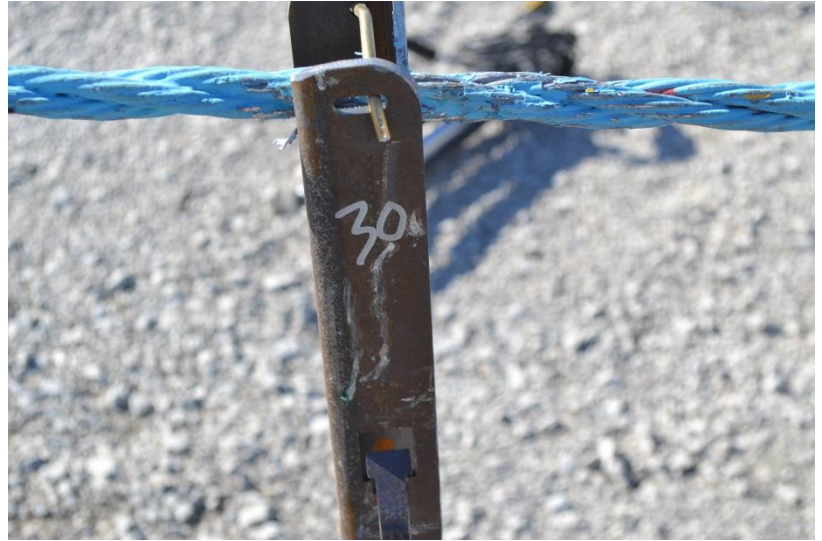
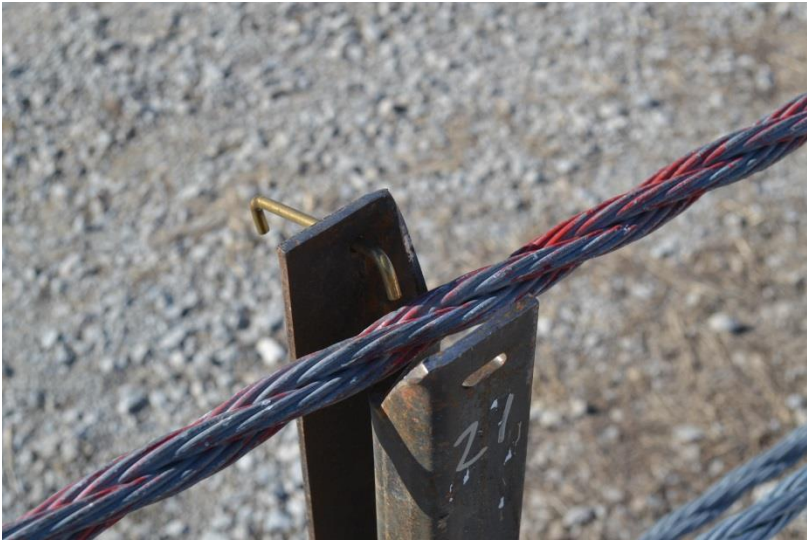
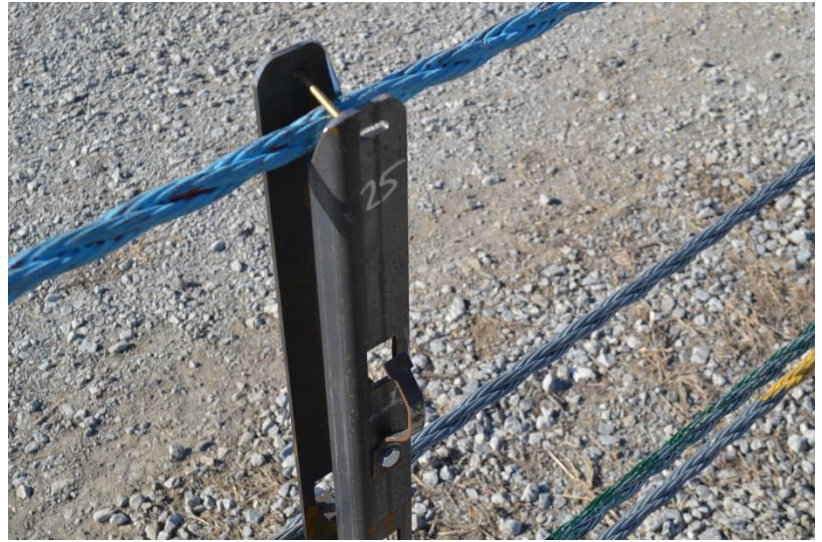
Figure 150. System Damage, Cable Brackets, Test No. MWP-7

Cable no. 4 disengaged from post nos. 31 through 46 due to fracturing of the brass keeper rods. Cable no. 3 disengaged from post nos. 23 through 45. Cable no. 2 disengaged from post nos. 31 through 43. Cable no. 1 disengaged from post nos. 32, 33, as well as from post nos. 36 through 44. Seven of these cable brackets fractured at the neck, and two fractured at the tabs. The remainder of the brackets released the cables due to rotation of the bracket tab through the keyway. Negligible cable slip occurred at splice locations.

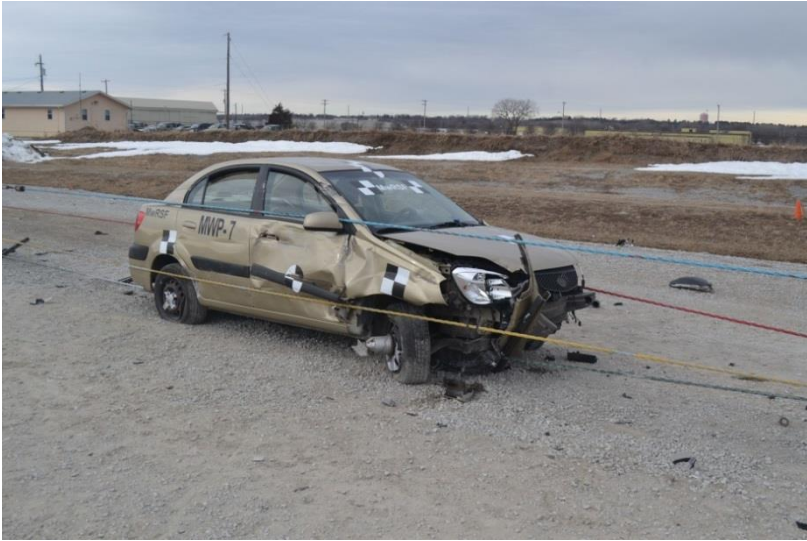
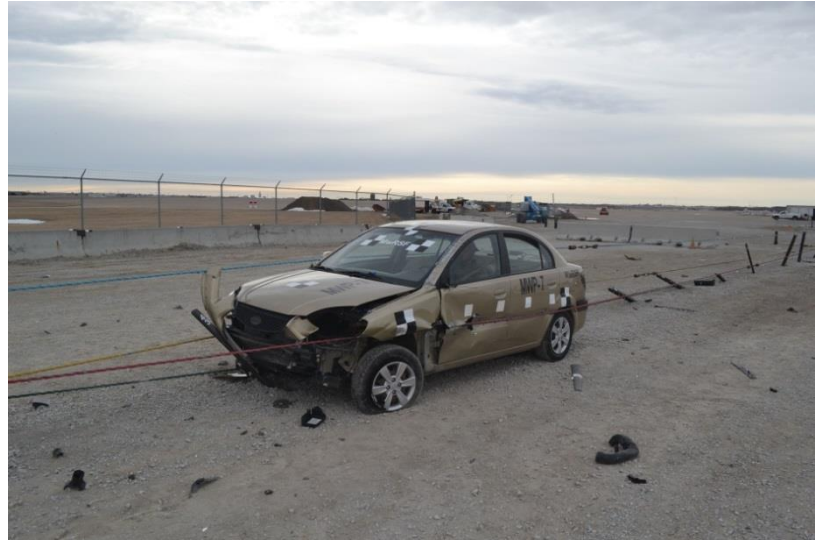
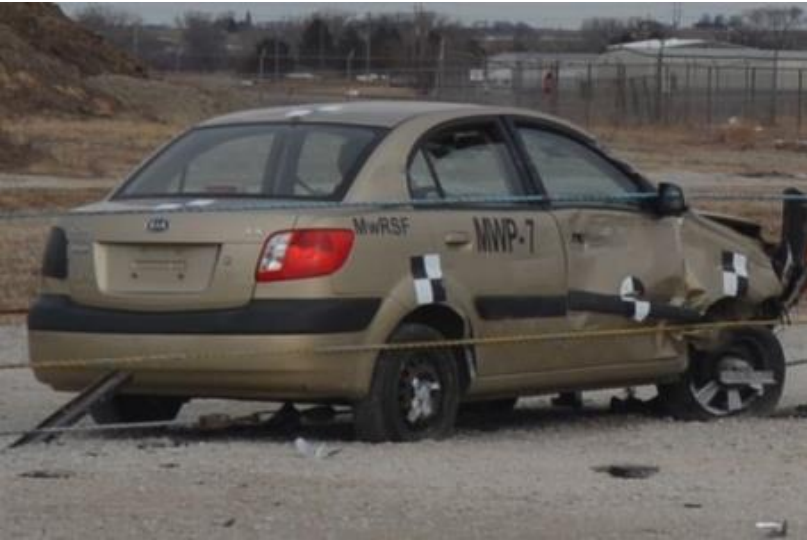
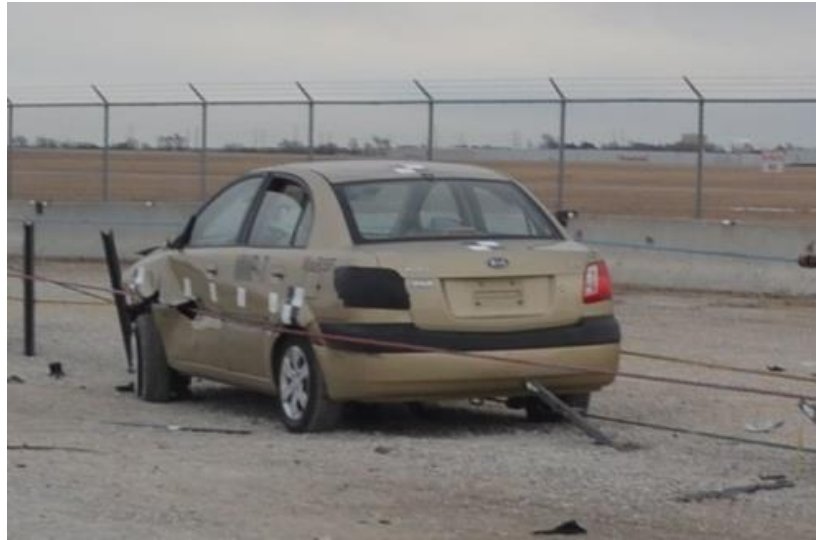
Figure 159. Vehicle Damage, Test No. MWP-7

The damage to the vehicle was moderate, as shown in Figures 159 through 162. The maximum occupant compartment deformations are listed in Table 16 along with the deformation limits established in MASH for various areas of the occupant compartment. Note that none of the MASH-established deformation limits were violated. Complete occupant compartment and vehicle deformations and the corresponding locations are provided in Appendix D.

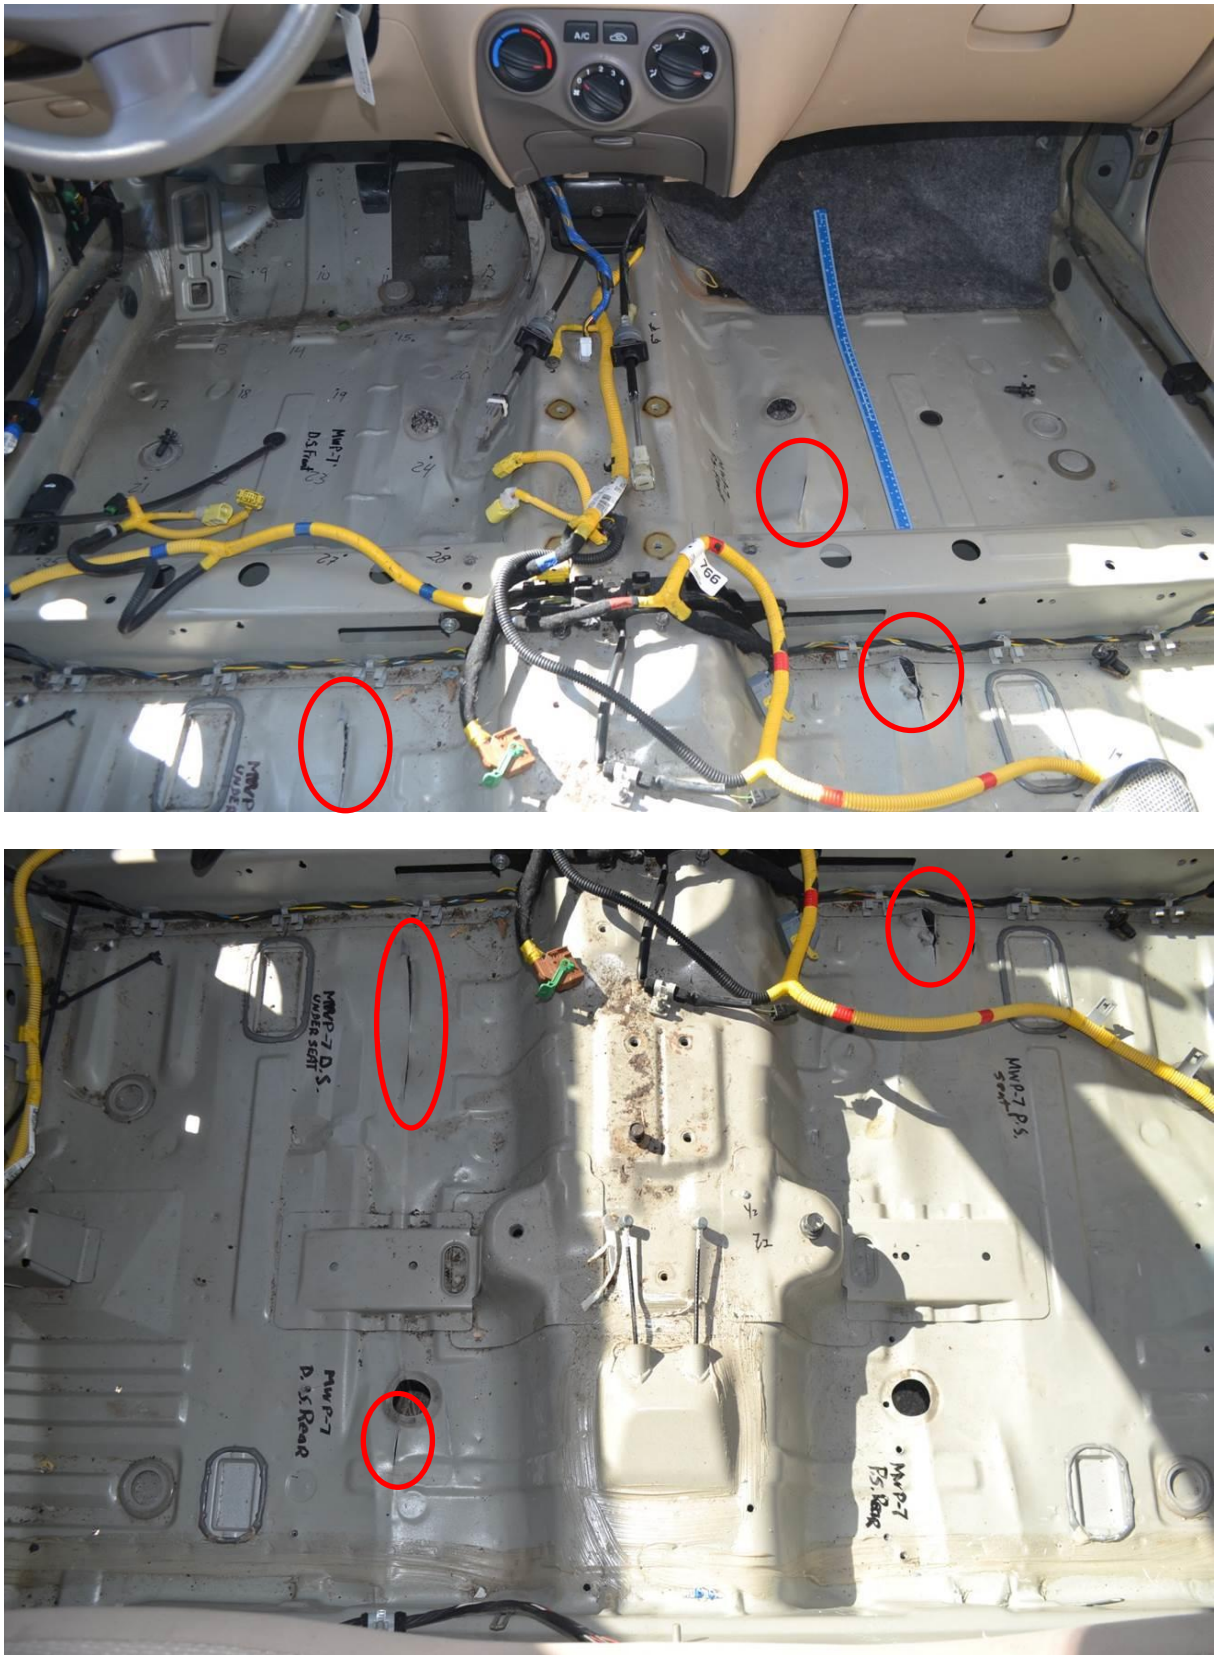
Figure 161. Occupant Compartment Damage, Test No. MWP-7
208

There were four tears in the floor pan of the vehicle. There was a 2¾-in. (70-mm) long tear in the right-front floor pan, an 8-in. (203-mm) long tear behind the left-front seat, a 3½-in. (89-mm) long tear behind the right-front seat, and a 1-in. (25-mm) long tear in the left-rear of the floor pan. This damage can be seen in Figures 161 and 162.

As a result of the unsuccessful 1100C crash tests, the prototype high-tension, four-cable, median barrier system will need to be further redesigned to prevent penetration of the occupant compartment observed in test nos. MWP-6 and MWP-7. Possible design changes may include, but are not limited to, alternative post spacings, reduction of weak-axis post strength at the ground line, further treatment of the post edges, and changes to post geometry. After the cable barrier system has been redesigned, it will need to be reevaluated according to MASH test designation no. 3-10 criteria before proceeding with remaining tests listed within the recommended testing matrix for cable barriers installed within median V-ditches. Depending on the nature of the design changes, it may be necessary to evaluate whether prior successful crash tests need to be rerun. The potential test designation nos. may be nos. 3-17 and 3-11 at a wide post spacings, and test no. 3-11 with a narrow post spacing.
