*Midwest States Pooled Fund Research Program  
Fiscal Years 2013 (Years 23)  
Research Project Number TPF-5(193) Supplement #56  
NDOR Sponsoring Agency Code RFPF-13-MGS-3*

# **INCREASED SPAN LENGTH FOR THE MGS LONG-SPAN GUARDRAIL SYSTEM PART III: FAILURE ANALYSIS**

MwRSF Research Report No. TRP-03-362-17

September 29, 2017

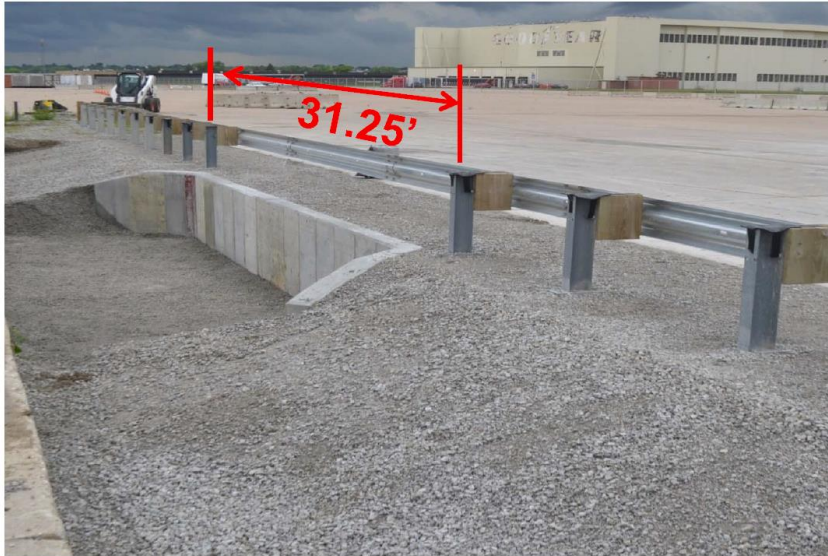
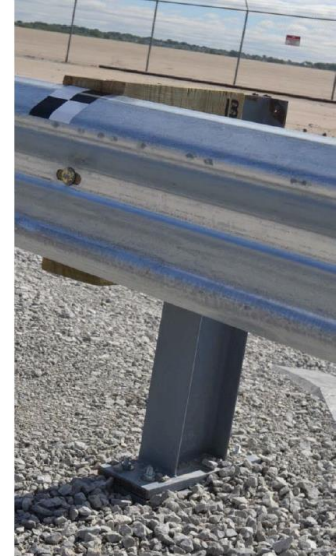
Figure 1. MGS Long-Span Guardrail, 31.25-ft (9.5-m) Unsupported Span

Test Installation

UBSP Post

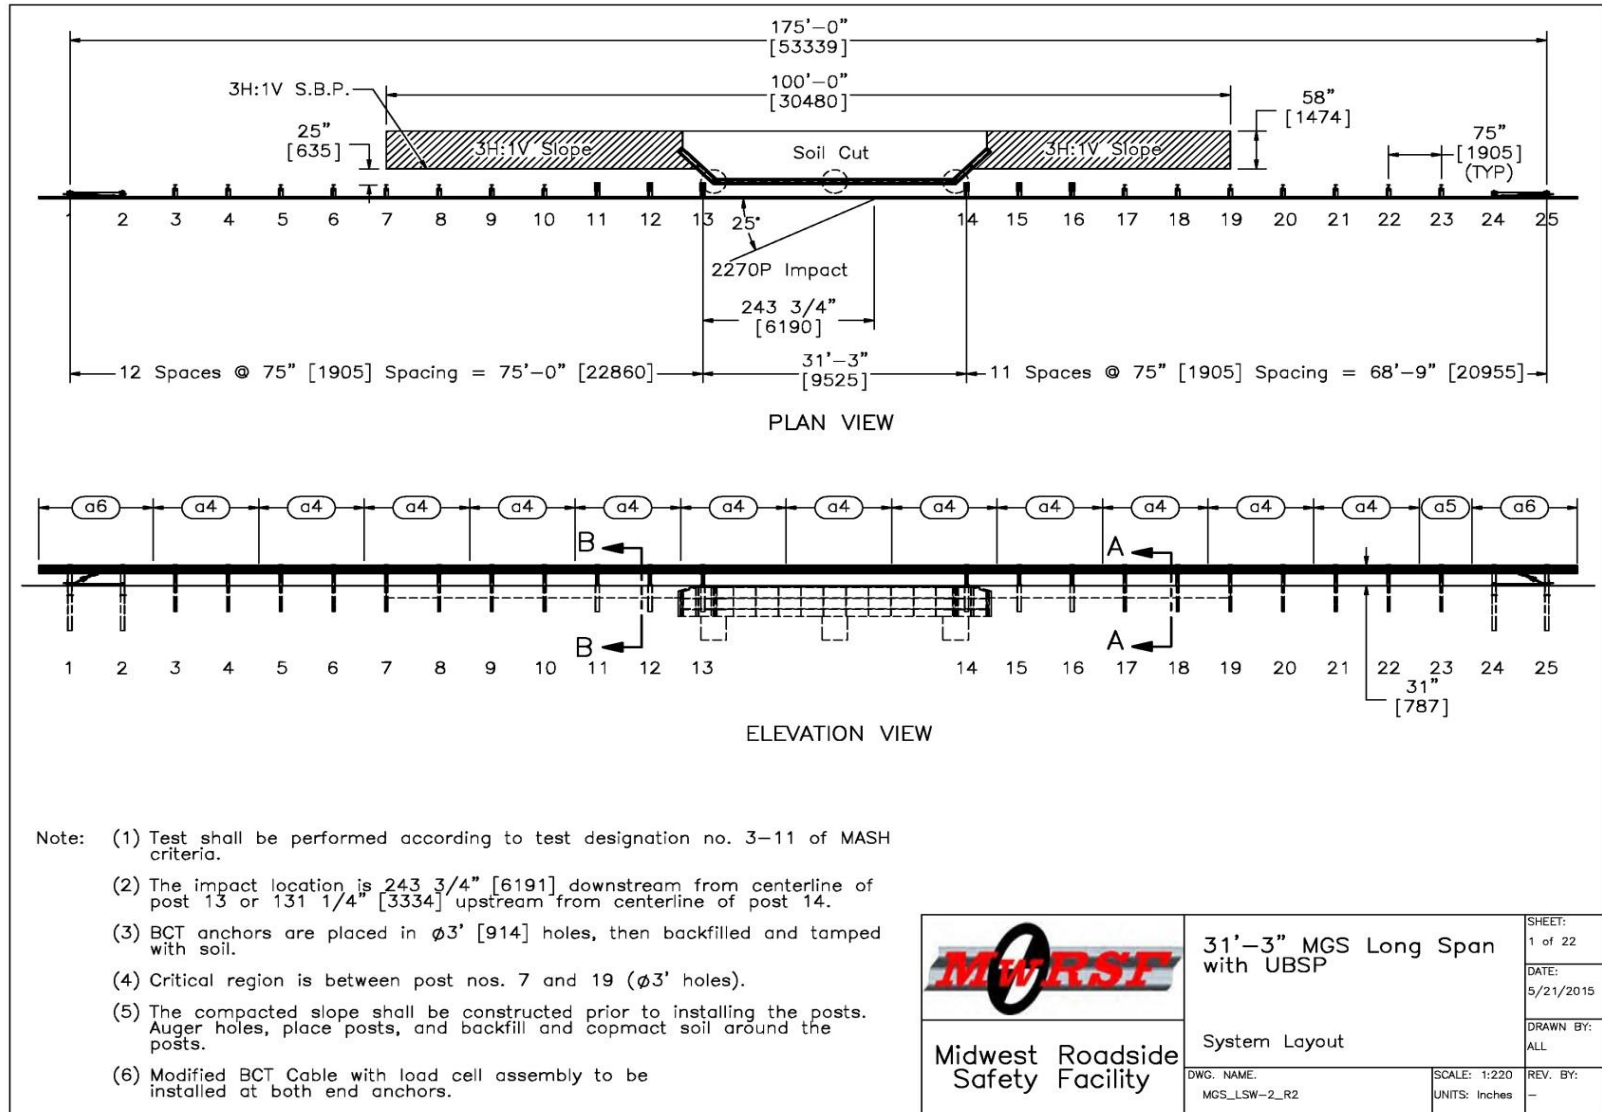
Figure 2. Test Installation Layout, Test No. MGSL-2

The MGS BCT posts were installed in steel soil foundation tubes, which were embedded to a depth of 70 in. (1778 mm). A BCT cable assembly was attached to the post by inserting a swaged end of the cable into the BCT hole and through a bearing plate, and attached to the guardrail using a cable anchor bracket. The guardrail was attached to the BCT posts with a top mounting height of 31 in. (787 mm). A bent plate, C-shape, ground line strut was used to connect the two soil foundation tubes [20]. For test no. MGSLS-2, anchor cable on each end of the system was spliced with a 50-kip load cell assembly. The load cell had been spliced into the anchor cable in a variety of past guardrail tests with no adverse effect on anchor capacity, and the incorporation of the load cell provided valuable anchor load data.

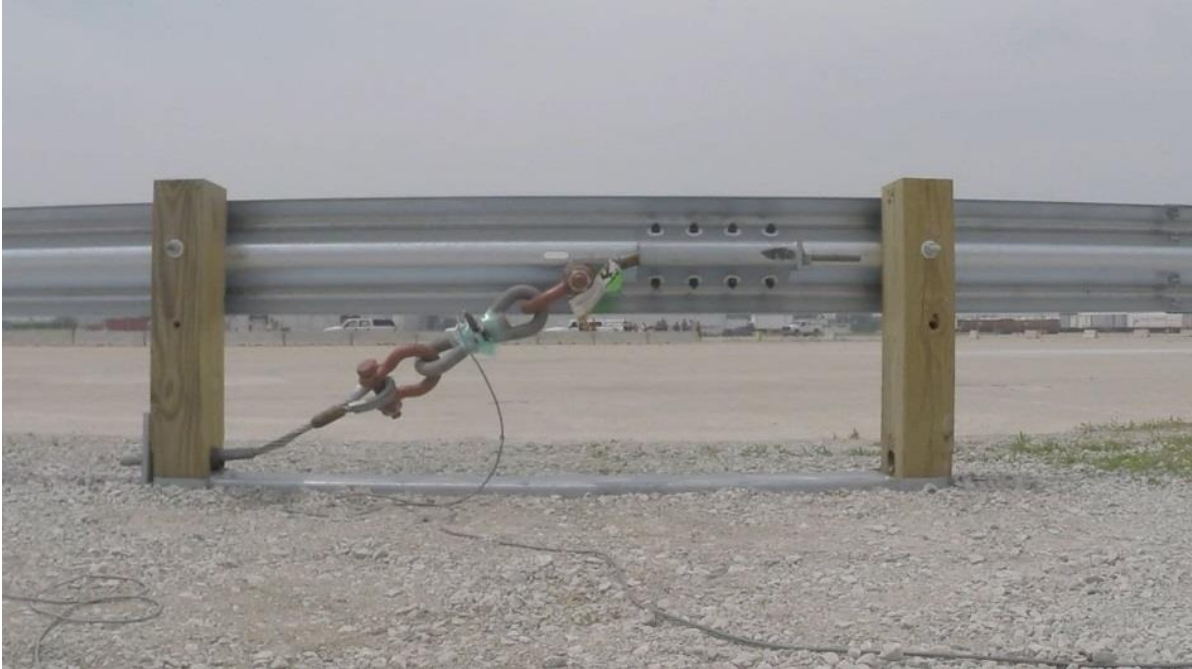
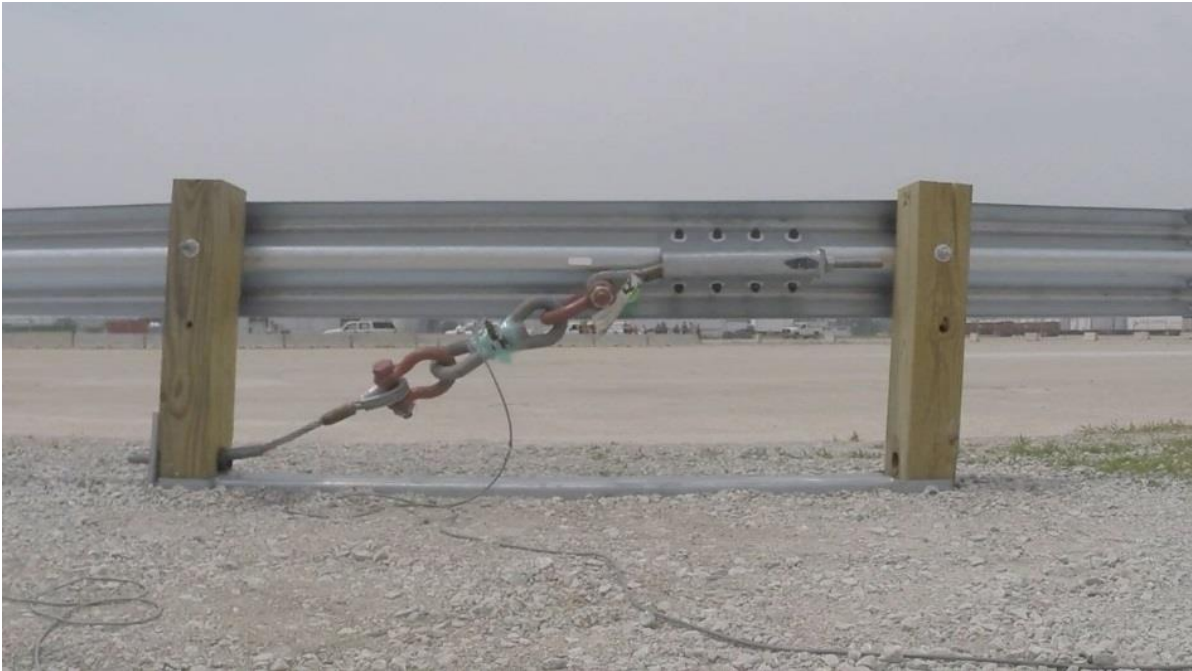
Figure 6. Sequential Photographs of Downstream End Anchorage, Test No. MGSLs-2

As the vehicle was redirected, the BCT posts at the downstream end anchorage, post nos. 24 and 25, were deflected longitudinally upstream due to tensile loads in the guardrail and the cable anchorage. Vertical cracking in post no. 24 was initiated at approximately 0.095 sec due to longitudinal loading of the post through the post bolt connecting the post to the guardrail, as shown in Figure 6 and Figure 7. As loading of the downstream anchorage continued, a diagonal crack initiated near the top of the BCT cable anchor plate on the downstream face of post no. 25. This crack propagated down to the hole in the base of the BCT post and caused complete fracture and release of post no. 25 at approximately 0.140 sec after impact. Following the release of the cable anchorage at post no. 25, post no. 24 fractured and released as well. Release of the downstream end anchorage caused the guardrail to lose tensile on the downstream end of the system and allowed the 2270P vehicle to penetrate into the barrier system in an uncontrolled manner.

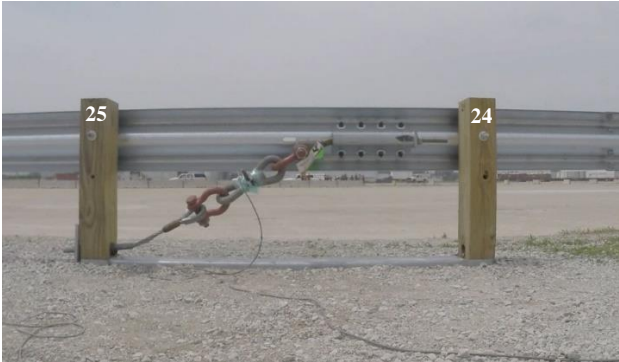
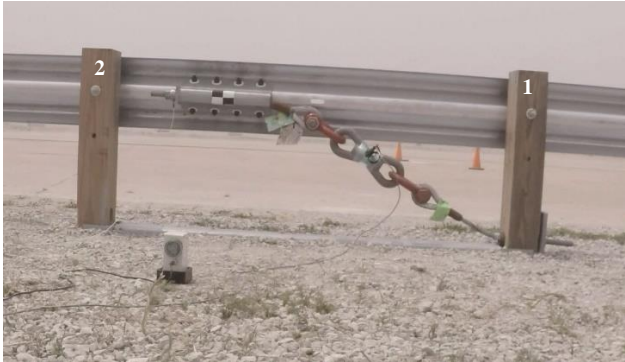
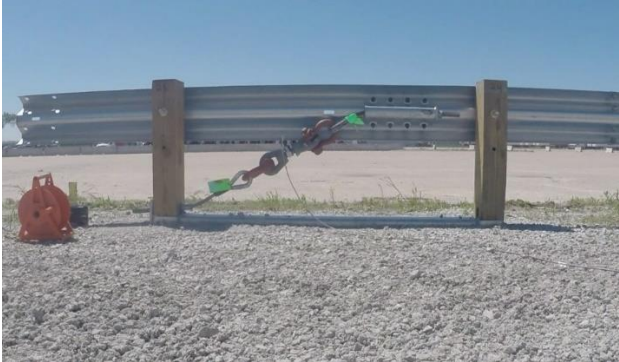
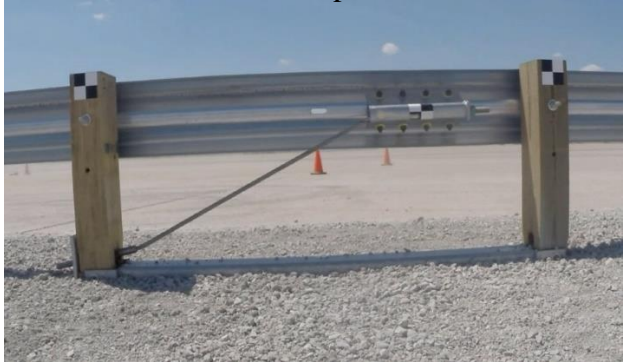
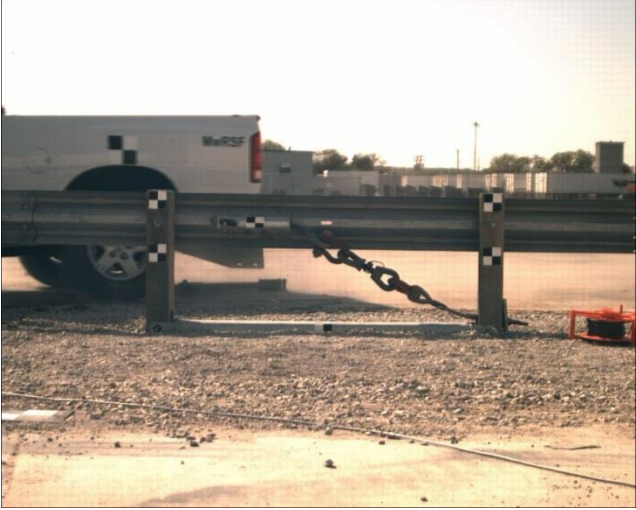
Figure 10. End Anchorage Sequential View Comparison of MGS Tests

Analysis of the anchor failure began with a comparison the load and deflection of the downstream end anchorage in test no. MGSLS-2 with other available data from tests of similar end anchorages. Figures 11 through 18 show a sequential comparison between the loading and deflection of the downstream end anchorage in test no. MGSLS-2 and other similar anchorages under full-scale testing impacts with 2270P vehicles, including the upstream end anchorages from test nos. MGSLS-2, MGSMP-1, and MGSMIN-1 and the downstream end anchorage from MGSLS-1. Review of the sequential images found that all of the anchorages displayed similar deflection behavior in terms of deflection downstream due to the tensile loading of the W-beam rail. The vertical splitting of post no. 24 in test no. MGSLS-2 was not a singular event as test nos. MGSLS-2 and MGSMP-1 demonstrated similar behavior on the upstream anchors, but did not fail. Motion of the cable end plate was also reviewed for all of the tests and no abnormal deflection or rotation of the cable end plate was noted in test no. MGSLS-2 prior to the anchorage failure as compared to the other tests.

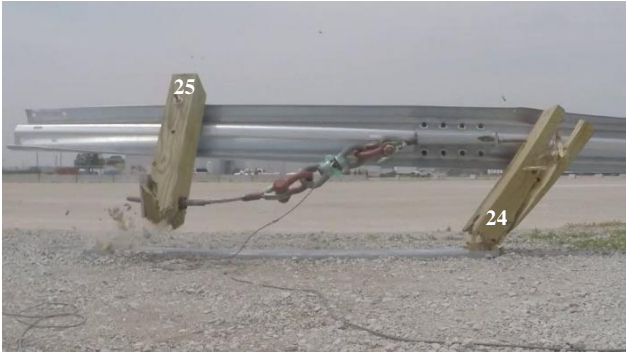
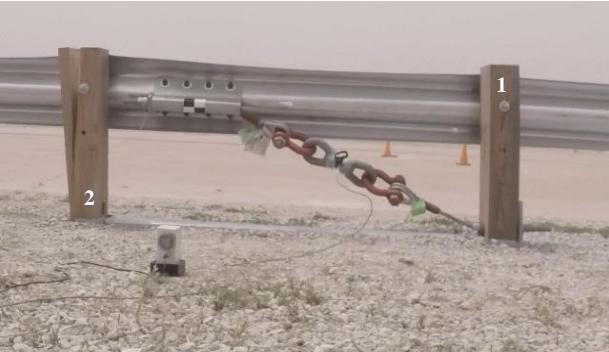
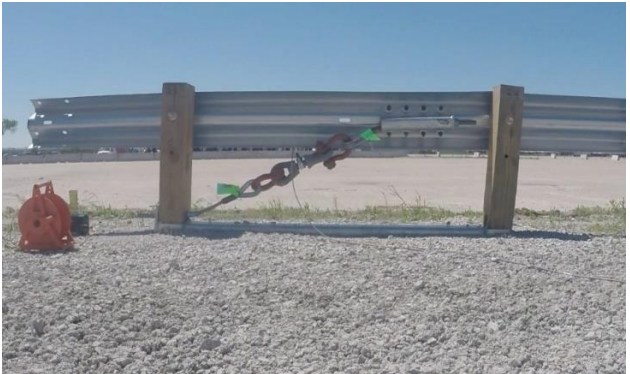
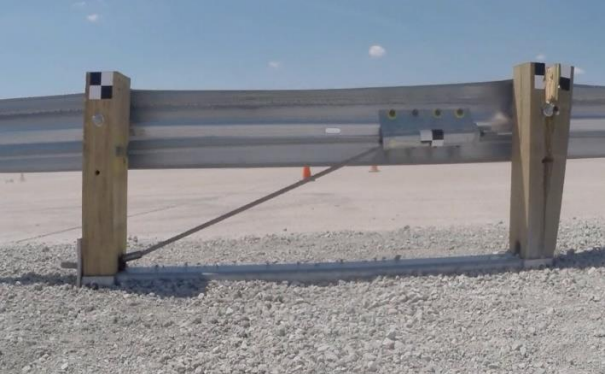
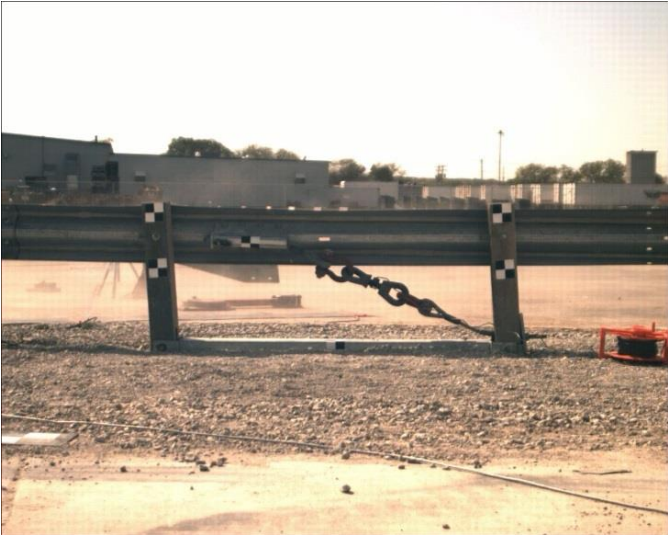
Figure 17. End Anchorage Sequential View Comparison of MGS Tests

Failure of an instrumented end anchorage assembly had not been observed in any full-scale crash tests prior to test no. MGSL-2. However, dynamic component testing of end anchorages was conducted as part of the development of trailing end anchor requirements for the MGS [19]. As part of this research, the same end anchorage used in test no. MGSL-2 was subjected to a dynamic pull test using the MwRSF heavy bogie vehicle, as shown in Figure 22. In test no. DSAP-2, the end anchorage was loaded until the final BCT post fractured at the base and released the anchor cable, as shown in Figure 23. This was a very similar failure mode to that observed in test no. MGSL-2. Anchor cable load versus deflection of the foundation tube is shown in Figure 24. The end anchorage in test no. DSAP-2 developed a peak load of 34.6 kips (153.9 kN) at approximately 0.9 in. (23 mm) of deflection prior to failure the final BCT post and release of the anchor cable. The loads observed in test no. DSAP-2 were 25.8% higher than those observed in test no. MGSL-2 and indicated that the end anchorage that failed during test no. MGSL-2 had the potential to develop significantly higher end anchor loads prior to failure.

Analysis and comparison of the end anchorage load and deflection from test no. MGSL-2 and other comparable tests did not identify a potential source of the end anchorage failure observed in test no. MGSL-2. The peak load recorded in the failed anchorage did not appear to be excessive when compared with similar full-scale crash tests and did not exceed previous dynamic load testing of similar anchorages. The deflection and stiffness of the failed end anchorage did not suggest any significant departure from previous anchor testing. Finally, no behaviors were noted during loading of the end anchorage that were different from those observed in other end anchorages.

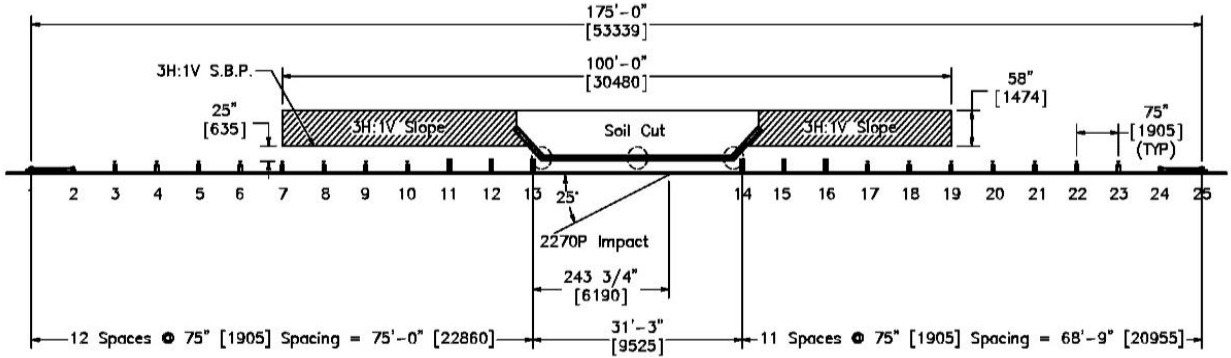
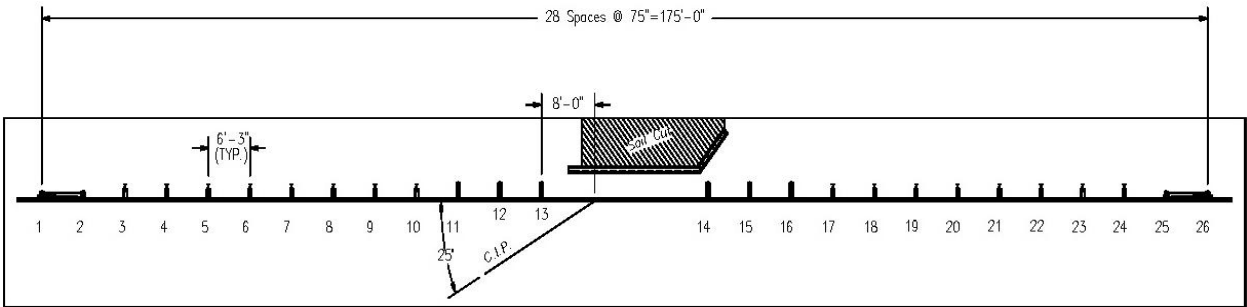
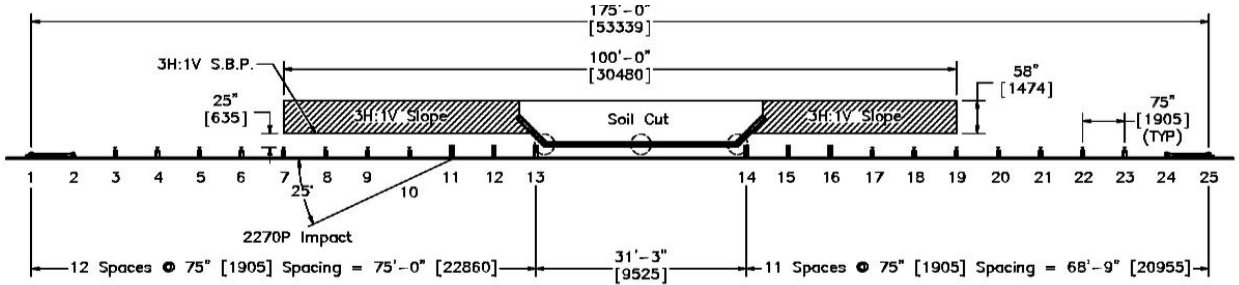
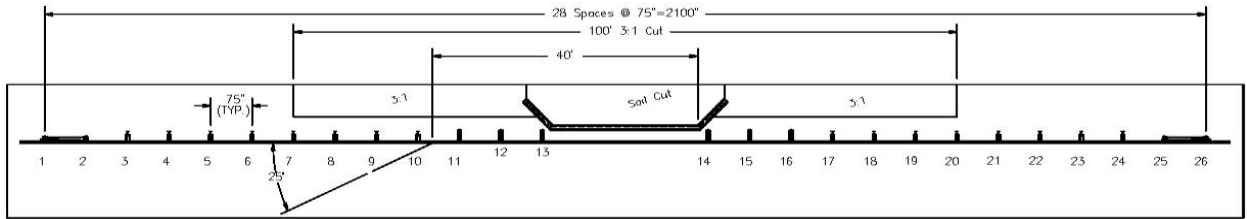
Figure 27. Impact Point for Test Nos. MGSL-2, LSC-1, MGSL-1, and LSC-2

Differences between the vehicle impact point of test no. MGSL-2 and other comparable tests were reviewed to determine if the vehicle impact point may have contributed to the failure of the downstream end anchorage. The impact point for test no. MGSL-2 was compared with other similar tests with respect to its proximity to the first post downstream of impact, its proximity to the first rail splice downstream of impact, and the distance to the downstream end anchorage. It was believed that the position of the vehicle impact relative to these critical points may have affected the barrier performance and altered the loading of the end anchorage. Impact points for test no. MGSL-2 and several comparable tests are shown in Figure 27 and Figure 28. The impact points relative to the first post downstream of impact and the first splice downstream of impact to for test no. MGSL-2 and comparable tests are shown in Figure 29 and Figure 30, respectively. Finally, the position of the impact points for each test relative to the location of the downstream end anchorage is shown in Figure 31.

Review of the data found that the impact point for test no. MGSL-2 fell into the mid-range with respect to distance to the first post downstream of impact, which suggested that the impact point with respect to the first impacted post likely had little effect on loading of the end anchorage. However, rail pocketing caused by the impact location relative to a post may have increased anchor loads, as noted previously. Similarly, the distance from the impact point to the first splice downstream for test no. MGSL-2 fell into the mid-range of the comparable systems. It was noted that in test no. MGSL-2 the impact was closer to the downstream end anchorage than in previous long span guardrail tests and was closer to the end of the guardrail system than all comparable tests except test nos. WIDA-1 and MGSMIN-1. Test no. LSC-1 was impacted farther from the first post downstream of the unsupported span than test no. MGSL-2, but no concerns with anchor failure were associated with the former test. Test no. WIDA-1 evaluated an impact near the end of the redirective length of the MGS with a trailing end terminal. In this test, the end anchor failed, but it did not release until the 2270P vehicle had nearly reached the end of the barrier system, and high lateral and longitudinal loads were imparted on the trailing end anchorage. Thus, the failure mode was not similar to the failure under longitudinal loading observed in test no. MGSL-2. Test no. MGSMIN-1 evaluated a 75-ft (22.9-m) long MGS and impacted 56 ft-3 in. (17.1 m) from the end anchorage. However, the 2270P vehicle was safely redirected and no failure of the end anchorage occurred as a result of the impact closer to the downstream end anchorage. Thus, while the impact point for test no. MGSL-2 was different as compared to previous tests of the MGS and MGS long span, no evidence was found that suggested the impact point directly contributed to the anchor failure.

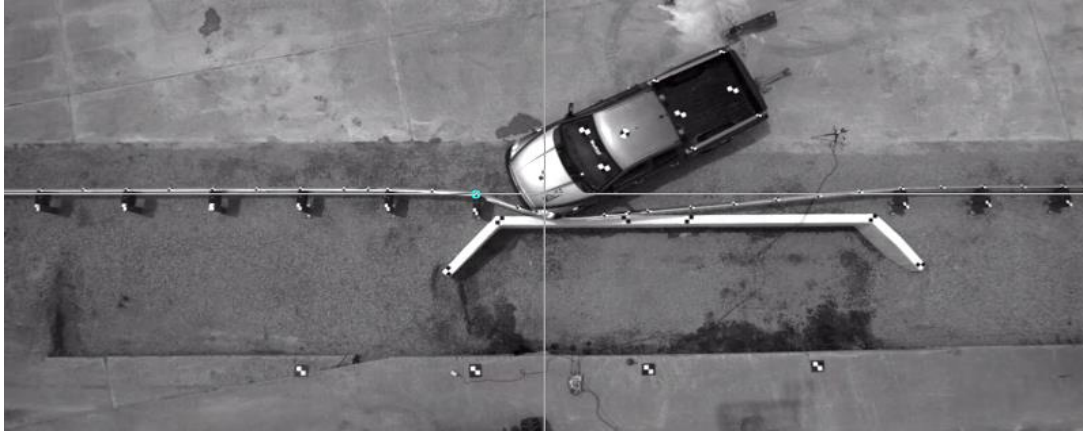
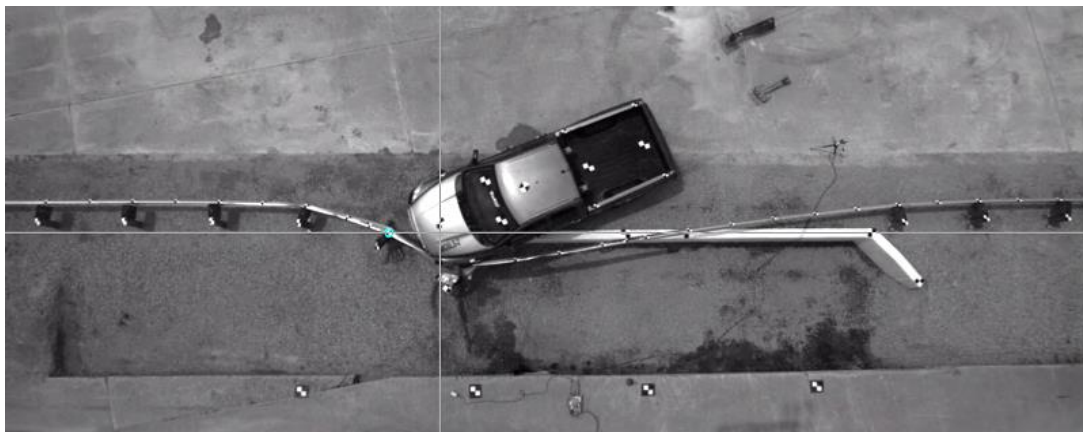
Figure 32. Longitudinal Distance of Fractured Post Relative to 2270P Bumper Corner, Test no. MGSLs-2

The comparison of post fracture and disengagement in test nos. MGSL-2 vs LSC-1 is shown in Table 2. Review of the data found that the UBSPs in test no. MGSL-2 broke away when the truck was significantly closer to the post as compared to test no. LSC-1. Comparison of post breakaway was most relevant for the first breakaway post downstream of the unsupported span in each test, as anchor failure occurred in test no. MGSL-2 prior to breakaway of the second and third posts downstream of the unsupported span. The first breakaway post downstream of the unsupported span in test no. MGSL-2 disengaged when the truck was 18.7 in. (475 mm) closer as compared to the disengagement of the same post in test no. LSC-1. This may indicate that the UBSP provided additional support to the guardrail prior to fracture and may have led to increased barrier stiffness and rail pocketing. Another factor in the delayed disengagement of the UBSP post

may have been that some of the CRT posts in test no. LSC-1 fractured at the second weakening hole in the CRT post below grade, as well as splitting vertically. The UBSP only has a fracture mechanism at ground line and is made of steel. Thus, it cannot replicate a failure of the post below grade or the vertical splitting observed in test no. LSC-1.

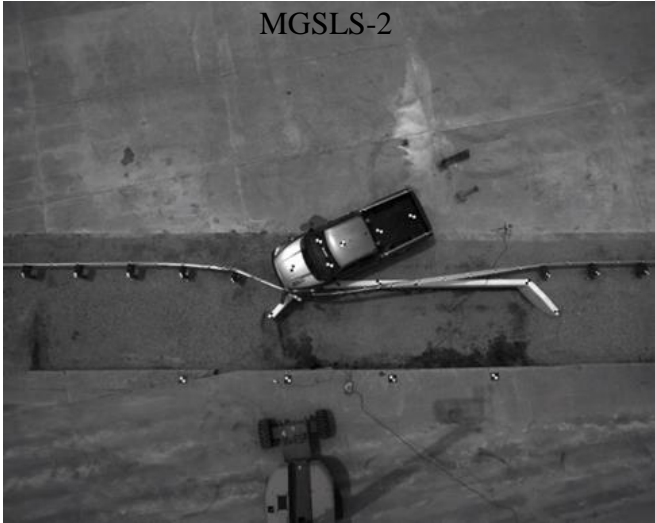
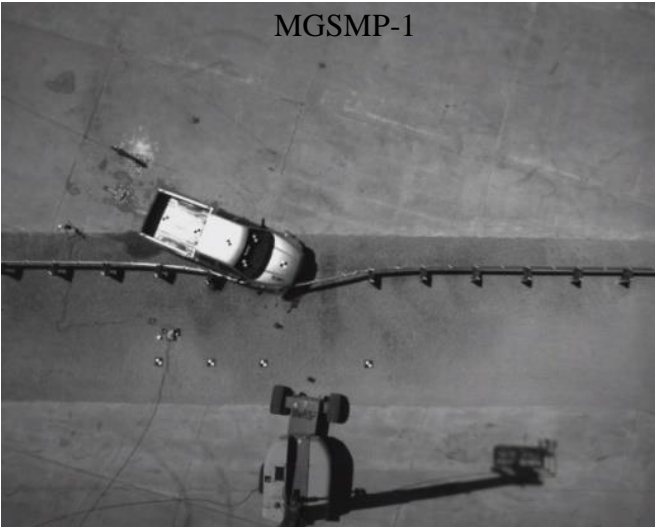
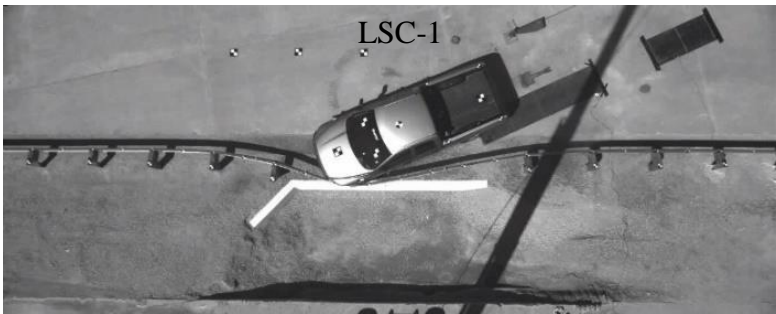
Figure 36. Overhead View at Time = 0.120 sec, Test Nos. MGSLS-2, MGSMP-1, and LSC-1

The maximum pocketing angle for test no. MGSLS-2, as well as comparable test nos. MGSLS-1 and MGSMP-1, were calculated from analysis of overhead video. Sequential images of the overhead video from 0.000 sec to 0.140 sec for test nos. MGSLS-2, LSC-1, and MGSMP-1 are shown in Figures 34 through 37, and the calculated pocketing angles are shown in Figure 38. Note that the calculated pocketing angles shown for test no. MGSLS-2 are only relevant up to the point of the downstream end anchor failure at approximately 140 msec after impact. Review of the data found that test no. MGSLS-2 initially had slightly higher pocketing angles than test nos. LSC-1 and MGSMP-1. By 0.040 sec after impact, test no. MGSMP-1 showed a sharp increase in pocketing angle due to the vehicle approaching the first standard line post downstream of the unsupported span created by the omission of a single post. Test no. MGSLS-2 showed a similar increase in pocketing angle as the vehicle approached the first UBSP downstream of the unsupported span. The pocketing angle for test no. MGSLS-2 continued to increase until anchor failure at approximately 0.140 sec after impact. Test no. MGSLS-2 displayed pocketing angles

that were generally greater than those of test no. LSC-1. This was consistent with the earlier disengagement of the CRT posts in test no. LSC-1 noted previously, and may potentially indicate that rail loading was affected by use of the UBSPs. However, anchor load data was not available from test no. LSC-1. The pocketing angles observed for all three tests were less than or very near

the threshold of 23 degrees that has previously been deemed acceptable. Additionally, the maximum pocketing angles for test nos. MGSLS-2 and MGSMP-1 were very similar prior to anchor failure, but the end anchor in test no. MGSMP-1 did not fail. The pocketing analysis also noted that some kinking of the rail was observed at the first post downstream of the unsupported span in test no. MGSLS-2 which was not observed in test nos. MGSMP-1 and LSC-1. This may indicate that the UBSP provided additional stiffness prior to fracture and potentially affected rail loading as compared the other tested systems. However, the kinking observed was not sufficient to believe to be a direct cause of the failure of the end anchorage.

Thus, the analysis indicated that the rail pocketing observed in test no. MGSLS-2 was more than observed in previous testing of the MGS long-span guardrail and may have affected rail loading, but the magnitude did not appear to be large enough to indicate a serious concern that would lead the researchers to suspect it as the cause of the downstream end anchorage failure. Additionally, while pocketing of the guardrail was similar to previous testing rail loading may have been affected based on the kinking of the rail prior to anchor failure.

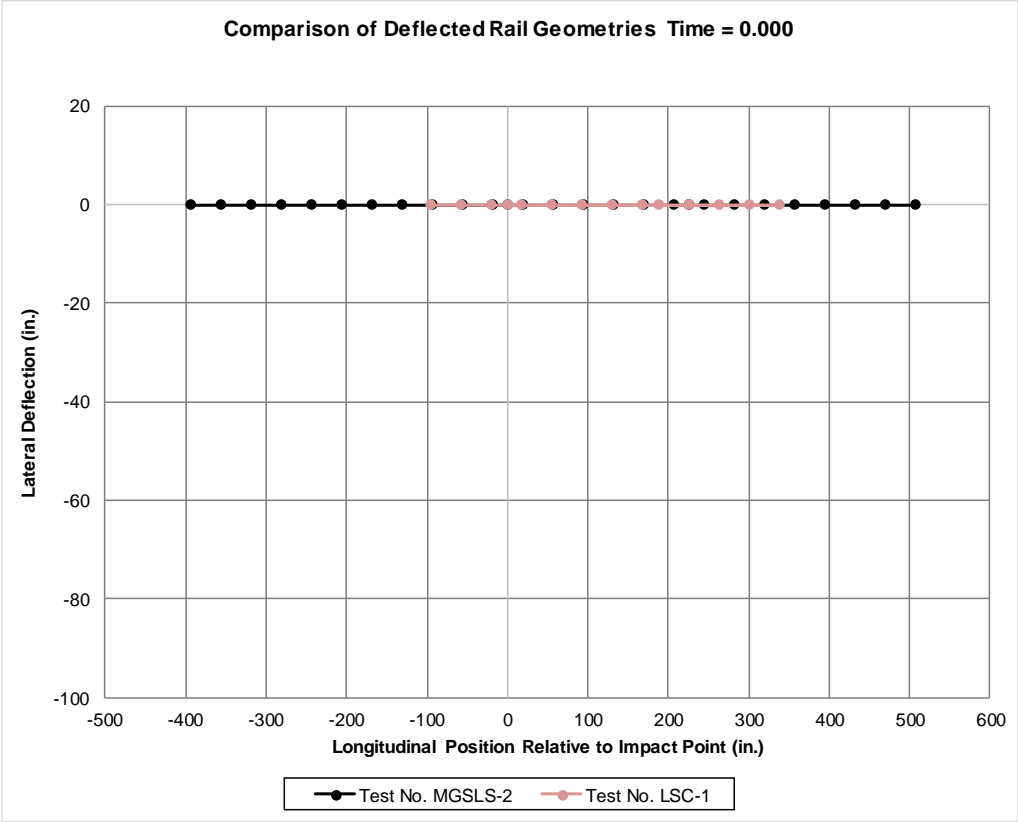
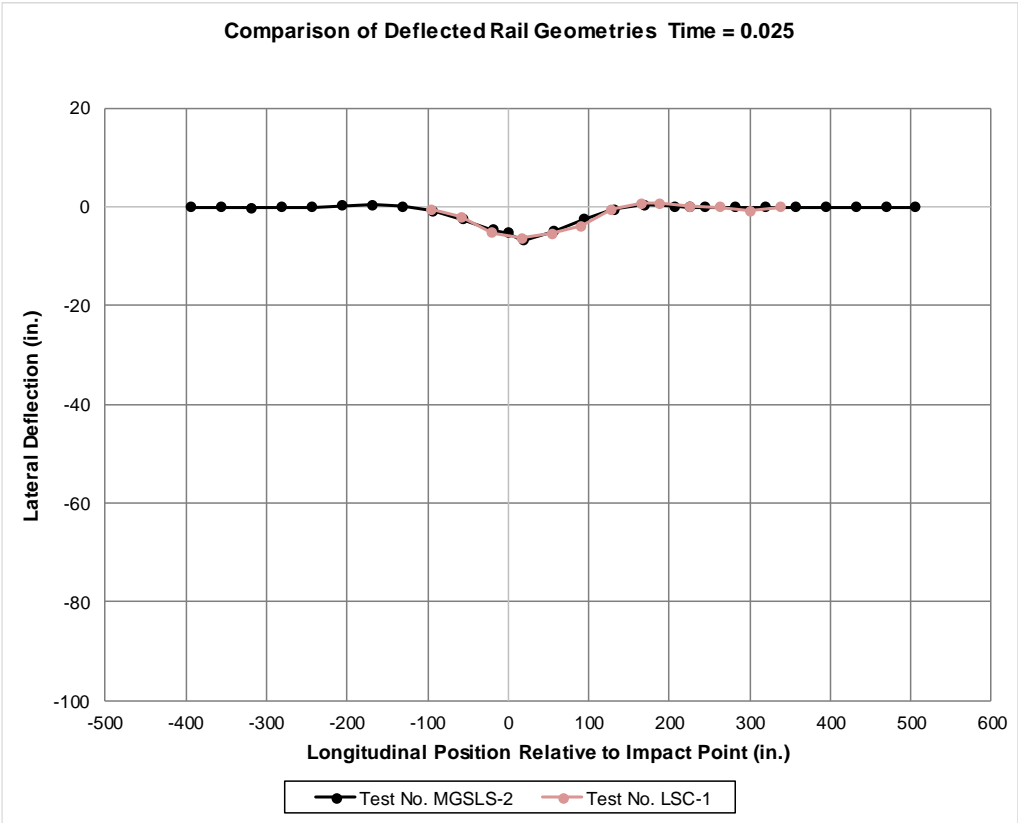
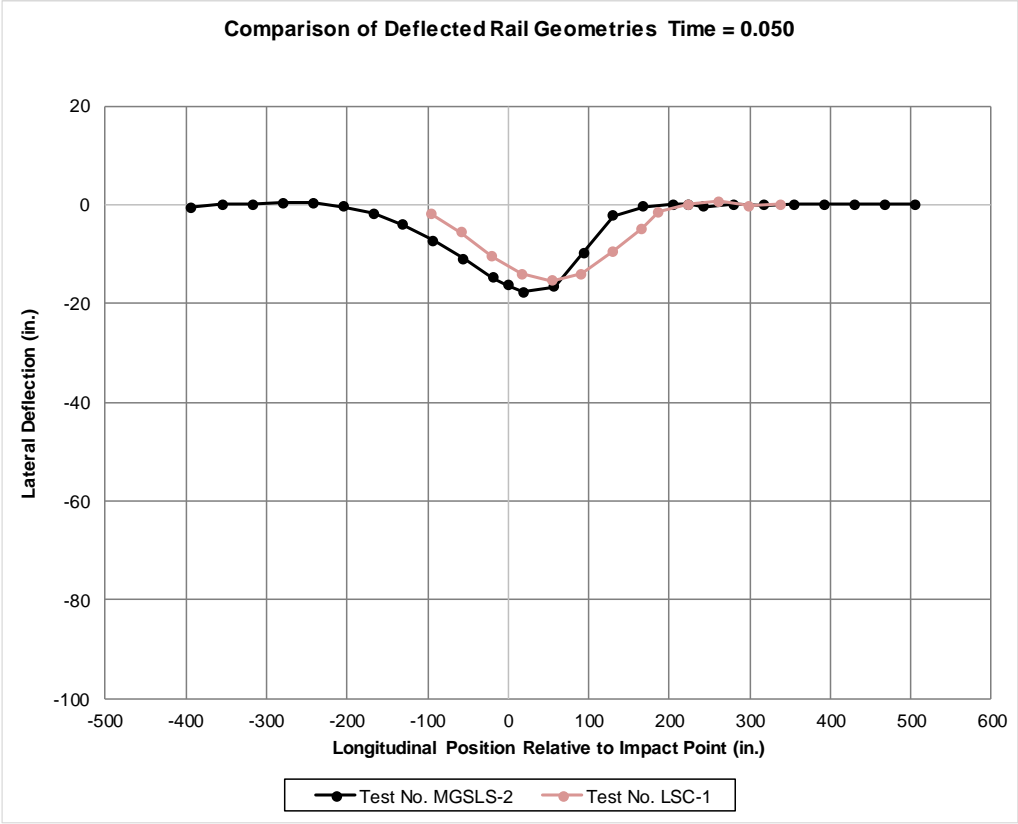
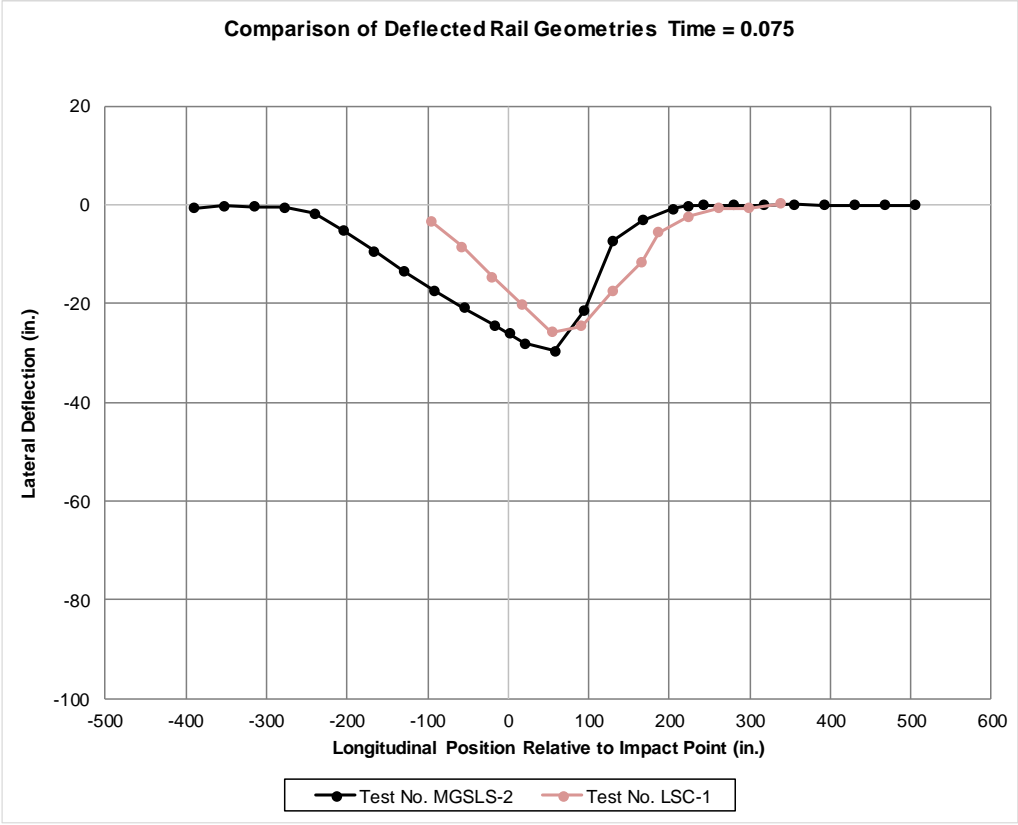
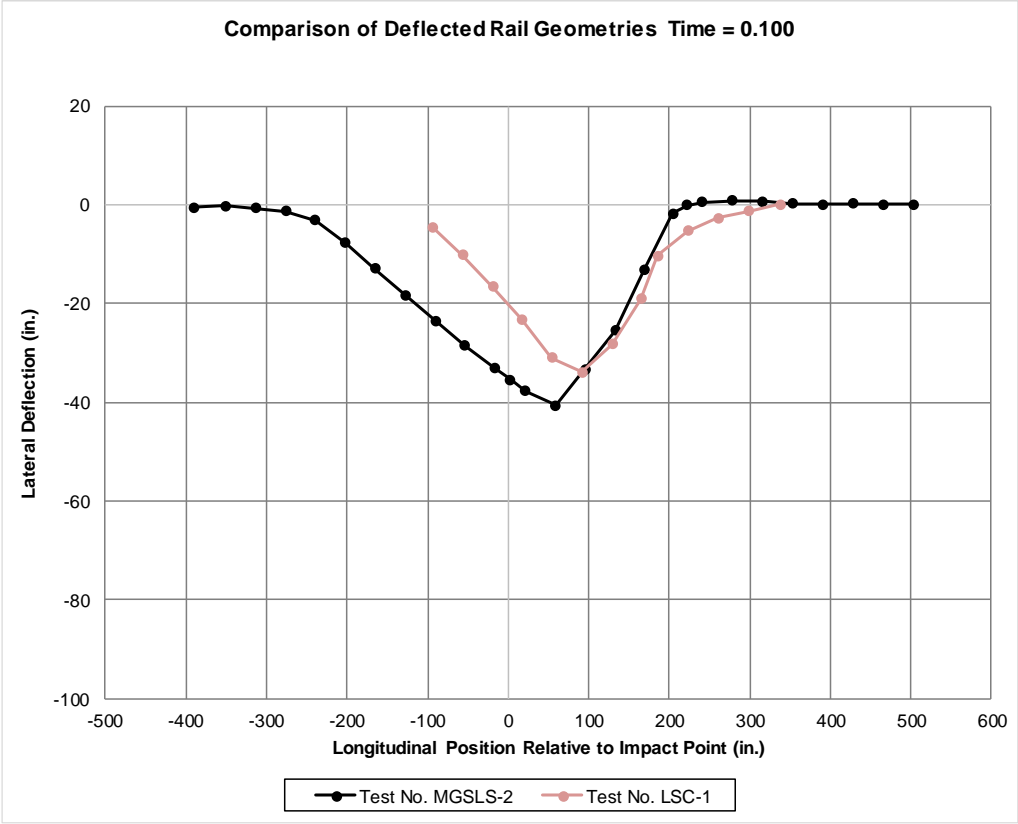
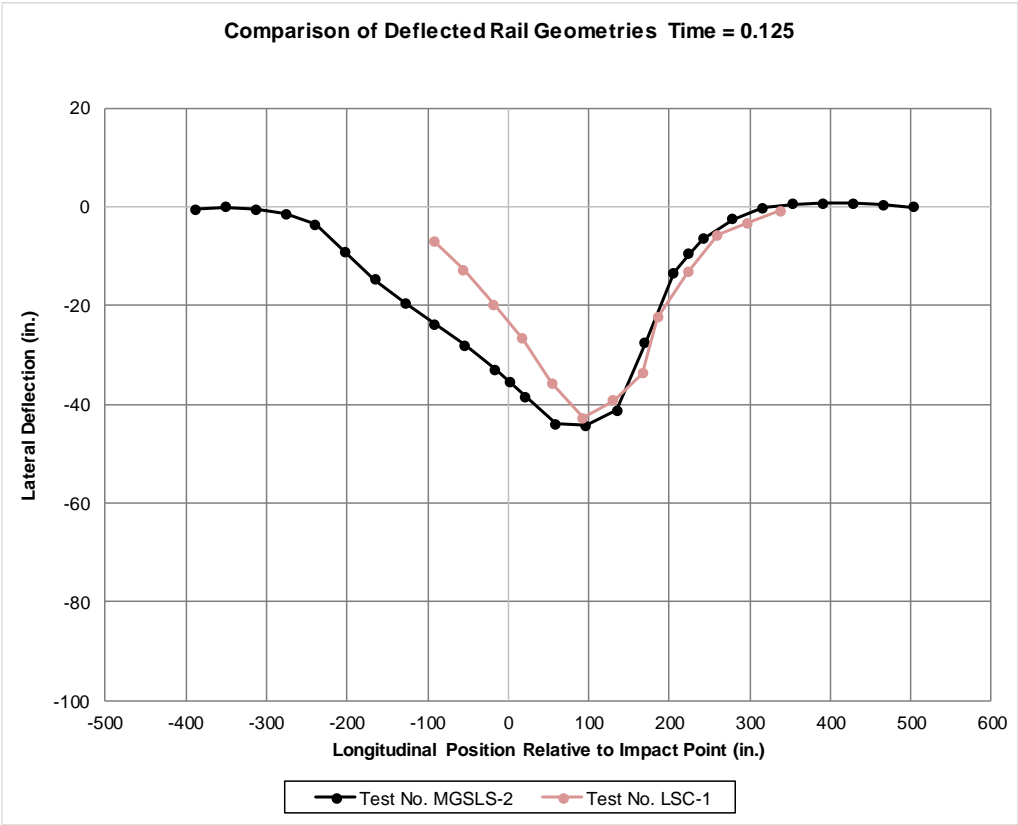
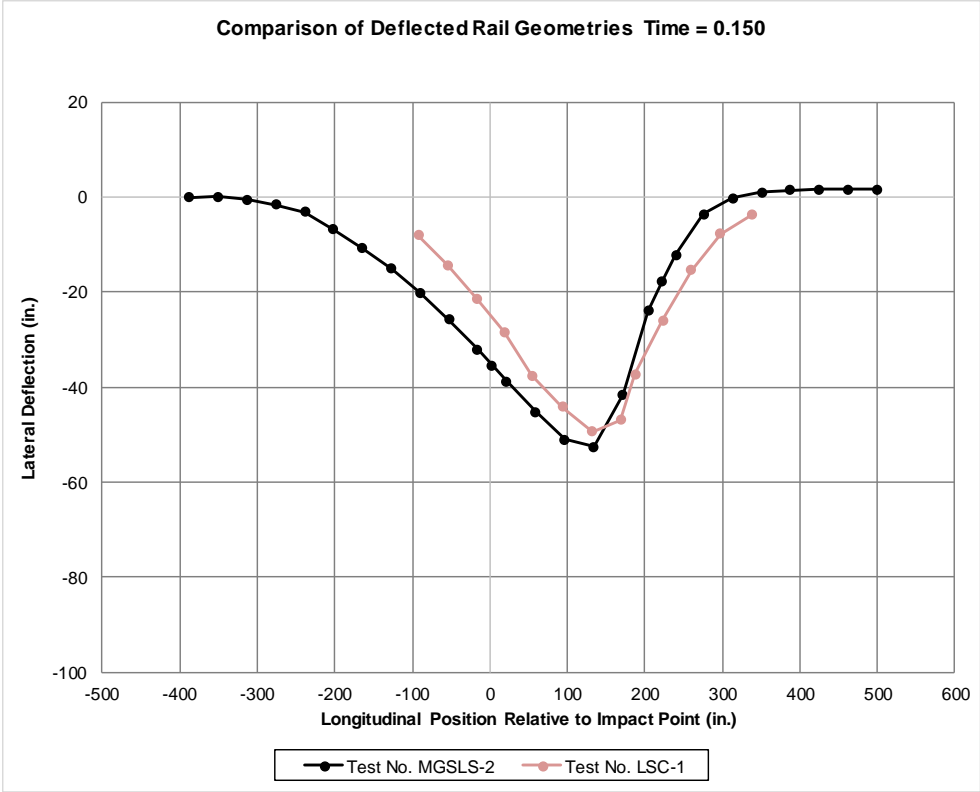
with the original unsupported span length. The dynamic rail deflection at various time intervals for test nos. MGSLs-2 and LSC-1 is shown in Figures 39 through 42. Test no. MGSLs-2 displayed higher rail deflections at each time interval as compared to test no. LSC-1. The increased deflection was consistent with the effect of the increased unsupported span length in test no. MGSLs-2 and correlated well with the increased pocketing angles noted previously for test no. MGSLs-2. When combined with increased rail pocketing, the increased rail deflection observed would suggest that the loading of the downstream end anchorage in test no. MGSLs-2 may have been affected by modifications to the barrier as compared to the long-span guardrail evaluated in test no. LSC-1. However, the increased rail deflection and pocketing were not believed to be sufficient to precipitate the failure of the downstream anchorage.

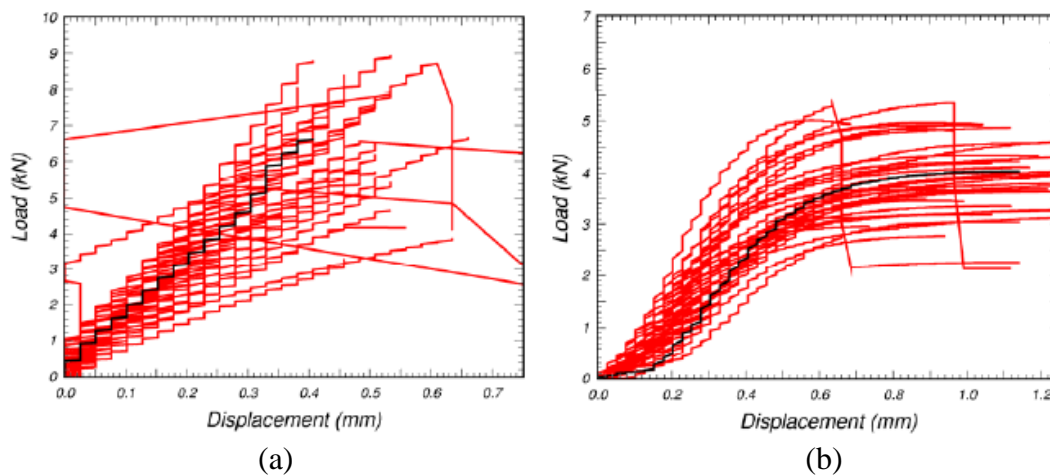
Figure 44. Southern Yellow Pine (a) Tension Parallel and (b) Compression Perpendicular

Another potential factor that could have affected the failure of the downstream end anchorage in test no. MGSLs-2 was the inherent variability of the southern yellow pine (SYP) BCT posts used in the anchorage. The strength of SYP can vary for several reasons, including natural variations in density, the presence of latewood and earlywood growth rings, and defects such as knots, checks, and shakes. Moisture content and other factors may play a role as well. Figure 44 shows the variability in tension and compression of SYP clear wood at 12% moisture content. The plots show that even clear wood has strengths that vary 50% or more from the median.

In order to minimize the effect of wood variability observed in test no. MWTSP-1, MwRSF specified that the BCT posts used in full-scale crash tests be Grade No. 1 or better SYP with no knots 18 in. (457 mm) above or below the hole at ground line. In test no. MGSLs-2, similar criteria were used, and review of the fractured posts in the downstream end anchorage found no flaws in critical region of BCT posts. Additionally, the post geometry and system details were consistent with the CAD details and previously tested anchorages. While examination of the fractured posts did not indicate any issues that would have affected the strength and capacity of the end anchorage, the variability of wood strength still may have affected the capacity of the end anchorage.

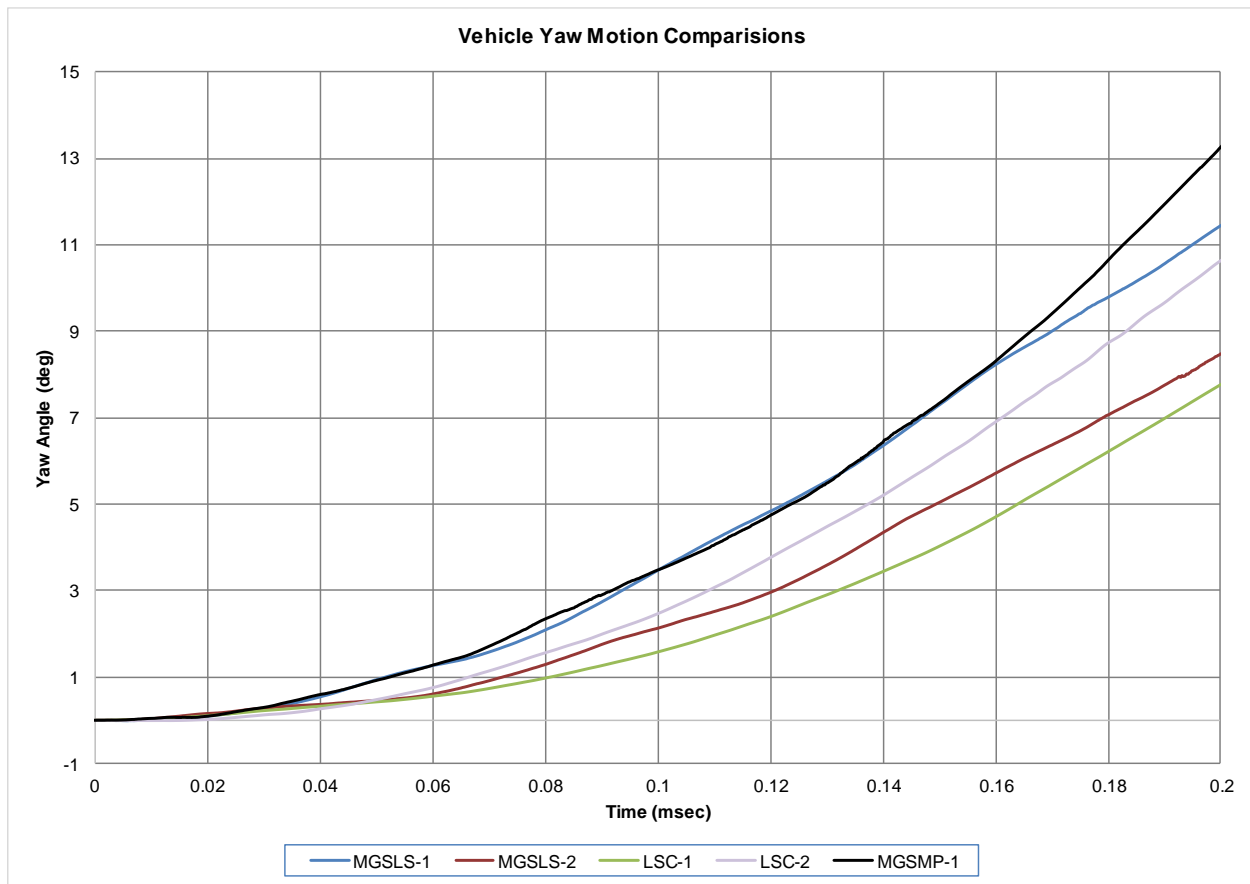
Figure 45. Vehicle Yaw Motion Comparisons

Review of the vehicle roll and pitch data from these five tests showed little to no difference through the first 0.150 sec after impact. All of the vehicles remained very stable with little to no roll or pitch early in the impact. Comparison of the vehicle yaw angles for all five tests is shown in Figure 45. Vehicle roll and pitch was minimal and showed little to no difference prior to anchor failure. The yaw data showed that test no. MGSL-2 redirected the impacting vehicle more slowly than all tests except test no. LSC-1. The slower yaw rate for these two tests correlated with tests that impacted within the unsupported span of the long-span guardrail. The lack of lateral support of the rail led to lower redirective forces and slower vehicle yaw. While the yaw angle data denoted a different system response for those tests, neither the yaw data nor the vehicle roll and pitch indicated any potential effect on end anchorage loading or failure.
