CRASH TESTING AND EVALUATION OF THE HDOT 34-IN. TALL AESTHETIC CONCRETE BRIDGE RAIL: MASH TEST DESIGNATION NOS. 3-10 AND 3-11

MIDWEST ROADSIDE SAFETY FACILITY

MwRSF Research Report No. TRP-03-420-19

October 21, 2019

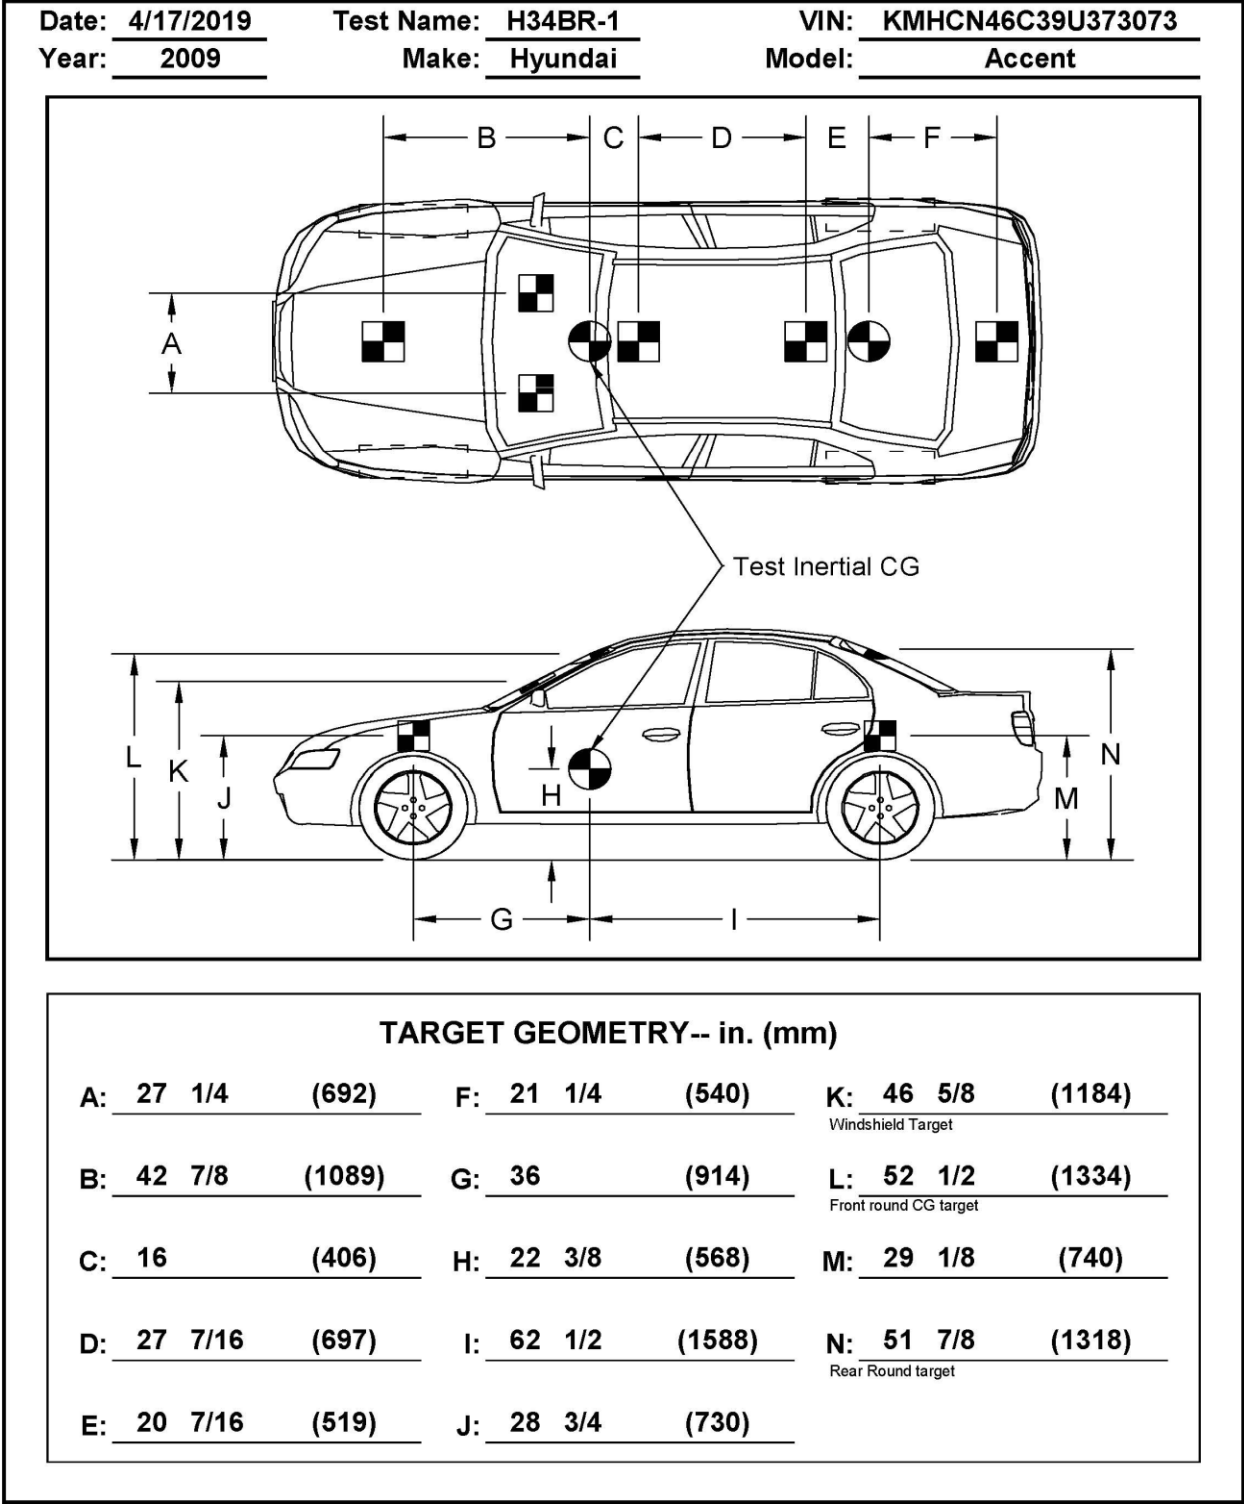
Figure 24. Target Geometry, Test No. H34BR-1

Square, black- and white-checked targets were placed on the vehicles for reference to be viewed from the high-speed digital video cameras and aid in the video analysis, as shown in Figures 24 and 25. Round, checkered targets were placed at the c.g. on the left-side door, the right-side door, and the roof of the vehicles.

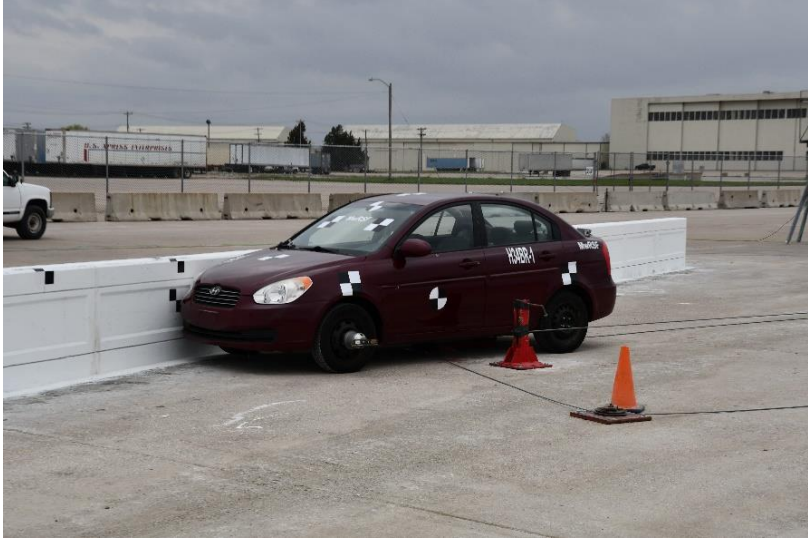
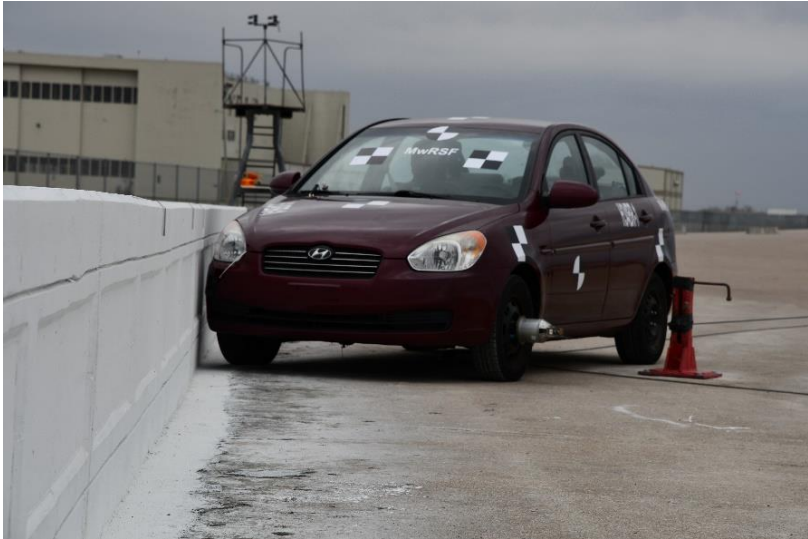
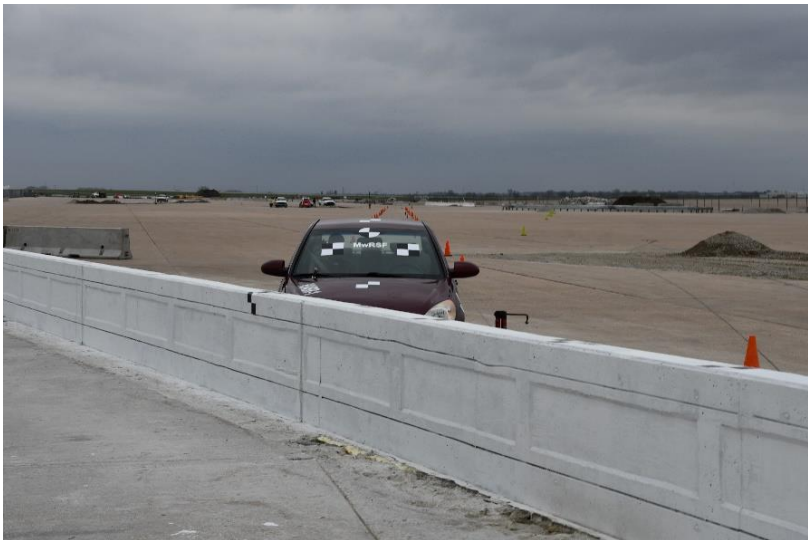
Figure 28. Impact Location, Test No. H34BR-1

Initial vehicle impact was to occur $43\frac{3}{16}$ in. upstream from the expansion joint between barrier segment nos. 3 and 4, as shown in Figure 28, which was selected using the CIP plots found in Table 2.7 of MASH 2016 to increase the probability of vehicle snag and maximize loading of the critical section of the rail expansion joint, which was discussed further in Section 2.1. The 2,430-lb small car impacted the HDOT 34-in. tall, Aesthetic Concrete Bridge Rail at a speed of 62.4 mph and at an angle of 25.7 degrees. The actual point of impact was $\frac{5}{8}$ in. downstream from the targeted point. The vehicle was captured and redirected by the 34-in. tall bridge rail. During the redirection of the vehicle, the right-front fender and right-front wheel experienced snag on the expansion joint and the edge of the aesthetic asperities downstream from impact. The snag was sufficient to push the right-front tire backward and crush the front portion of the right-front fender. However, the snag of the vehicle components did not pose a risk to the vehicle occupant compartment nor did it pose a hazard due to the velocity change or deceleration of the vehicle. The vehicle came to rest 161 ft – 9 in. downstream and 23 ft – 3 in. in front of the system after brakes were applied. Impact Severity (I.S.) is an additional limiting condition required in MASH 2016. The measured I.S. of test no. H34BR-1 was 59.2 kip-ft, which fell into the acceptable range of greater than or equal to 51 kip-ft as defined in MASH 2016 for test designation no. 3-10.

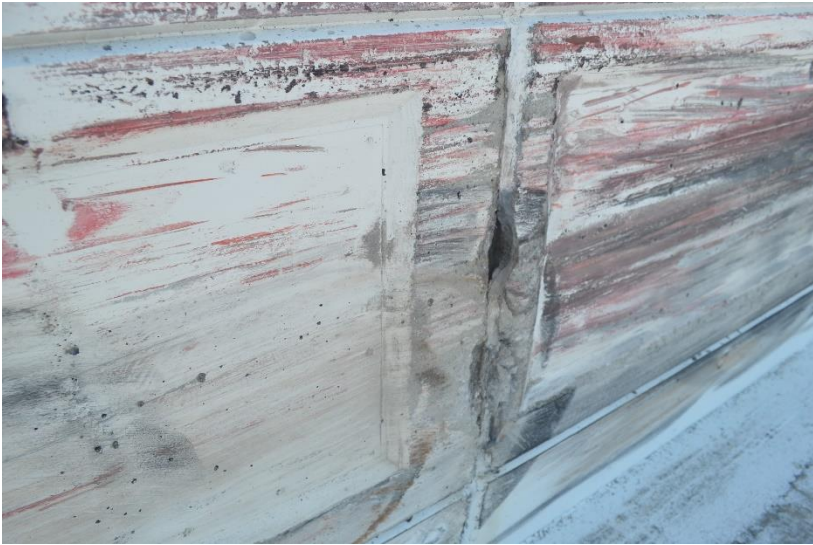
Figure 37. Traffic-Side System Damage, Test No. H34BR-1

Damage to the barrier was minor, as shown in Figures 35 through 39. Barrier damage consisted of minor cracking, spalling, and contact marks on the parapet and minor cracking and spalling at the expansion joint between barrier nos. 3 and 4. The locations for all of the listed damage were measured from the expansion joint between barrier nos. 3 and 4 as a reference point. The length of vehicle contact along the barrier was approximately 11 ft – 3 in. which spanned from 4 ft – 9 in. upstream from the expansion joint to 6 ft – 6 in. downstream from the expansion joint.

A 45-in. long and 1½-in. tall spall on the aesthetic asperity was observed 51 in. upstream from the expansion joint. Spalling measuring 4 in. long and 2½ in. wide was found 45 in. upstream from the expansion joint and 14 in. above the ground. Spalling measuring 11 in. long and ½ in. wide was found 34 in. upstream from the expansion joint and 23 in. above the ground. Spalling measuring 5½ in. long and 2½ in. wide was found 33 in. upstream from the expansion joint and 15 in. above the ground. Spalling measuring 61½ in. long was found 32 in. upstream from the expansion joint to 29½ in. downstream of the expansion joint and 32 in. above the ground. Spalling measuring 5 in. long, 10 in. wide, and ½ in. deep was found 3 in. upstream from the expansion joint and 14 in. above the ground. Spalling measuring 6 in. long was found 2 in. upstream from the expansion joint and 24 in. above the ground. A ½-in. diameter by ½-in. deep hole was observed 53 in. upstream from the expansion joint and 17½ in. above the ground. A 1-in. diameter by ½-in. deep hole was observed 24 in. upstream from the expansion joint and 23½ in. above the ground. Grout was disengaged over a 12½ in. height at the expansion joint was observed located 9½ in. above the ground.

Minor cracking of the barrier was also observed in several locations. A 19½-in. diagonal crack that started 18½ in. above the ground and ended 33½ in. above the ground was found 70½ in. upstream from the expansion joint. An 18½-in. diagonal crack that started 11 in. above the ground and ended 18½ in. above the ground was found 60 in. upstream from the expansion joint. A third smaller crack was noted on the top of the barrier starting near the middle of the expansion joint between barrier nos. 3 and 4 and extending diagonally approximately 8 in. downstream and toward the back of the barrier.

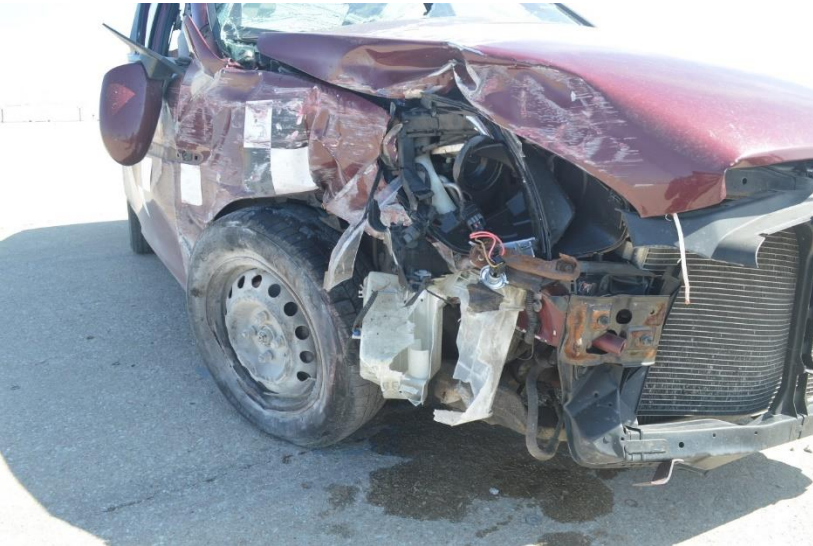
Figure 42. Vehicle Damage, Test No. H34BR-1

The majority of the damage was concentrated on the right-front fender and right-front wheel of the vehicle where the impact had occurred. A small section of the seam where the floor pan and toe pan connected near the left-front corner of the right-side floor pan split due to floor pan deformation. The split seam was not due to intrusion of the barrier or a component of the vehicle. The vehicle's engine hood partially disengaged, but it remained attached to the vehicle's body. The front bumper and bumper cover disengaged from the vehicle. Kinks were found on the bottom support of the radiator, and the right radiator support was bent toward the engine compartment. A 23 $\frac{1}{8}$ -in. dent on the right side of the hood crushed 5 in. inward and toward the engine compartment. The right-front fender was crushed and had contact marks with the most significant occurring near the front of the wheel well. A 38 $\frac{1}{2}$ -in. long x 7 $\frac{1}{8}$ -in. wide x 1 $\frac{1}{2}$ -in. deep dent was found on the right-front door. The right-rear door was dented and scraped just ahead of the rear quarter panel.

It should be noted that the passenger side window fractured, and a large tear was visible in the vehicle windshield. Review of the high-speed video revealed that the side window damage was due to crush of the side of the vehicle door and not due to direct contact with the test article. Similarly, the video data showed that the tearing of the windshield was formed due to crushing of the right front corner of the windshield which propagated a shear crack through the glass and the liner. Neither of these items were in violation of the MASH 2016 criteria as none of the damage occurred due to contact with the test article or debris, nor was there the potential for the barrier to intrude into the occupant compartment.

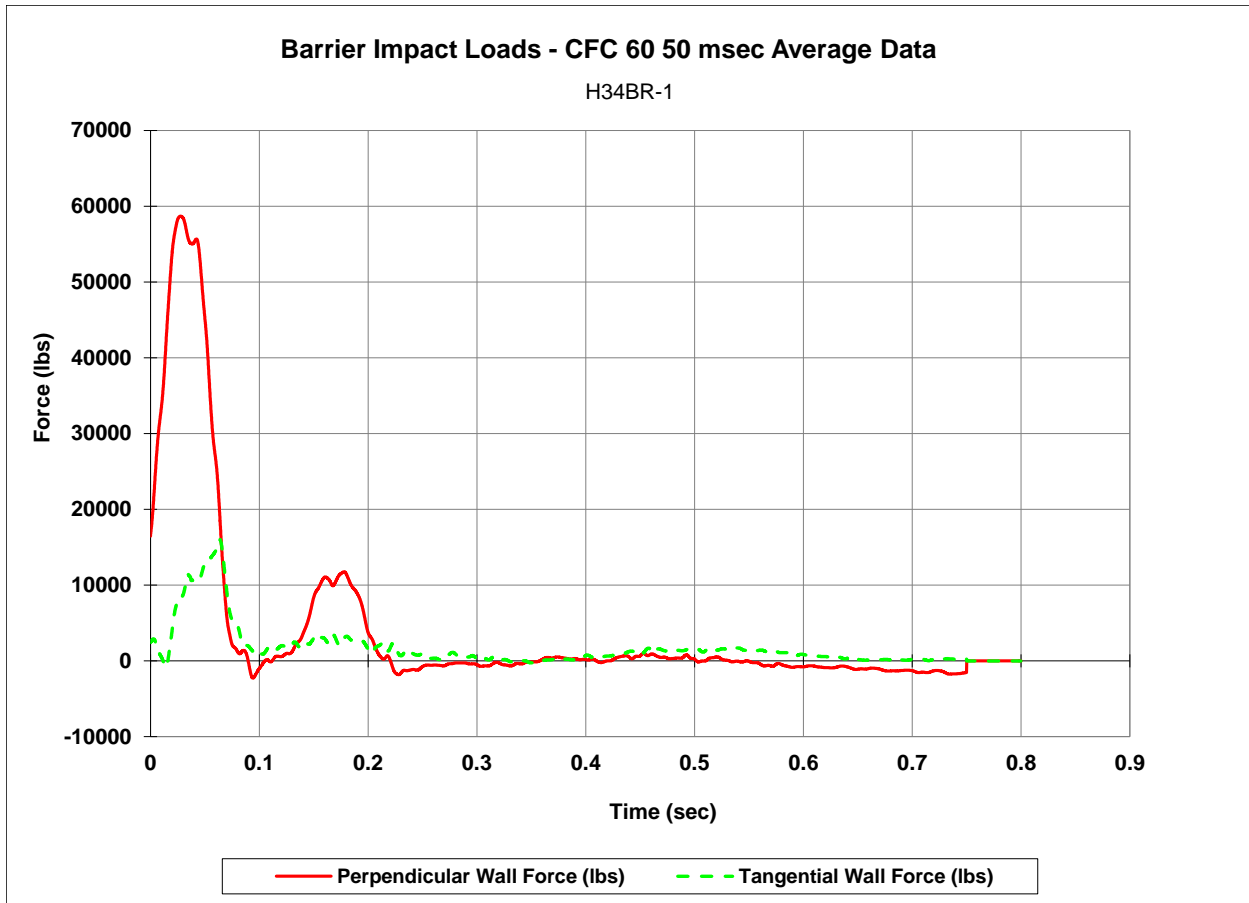
Figure 46. Perpendicular and Tangential Forces Imparted to the Barrier System (SLICE-2), Test No. H34BR-1

The longitudinal and lateral vehicle accelerations, as measured at the vehicle's c.g., were also processed using a SAE CFC-60 filter and a 50-msec moving average. The 50-msec moving average vehicle accelerations were then combined with the uncoupled yaw angle versus time data in order to estimate the vehicular loading applied to the barrier system. From the data analysis, the perpendicular impact forces were determined for the bridge rail, as shown in Figure 46. The maximum perpendicular (i.e., lateral) load imparted to the barrier was 58.8 kips determined by the SLICE-2 (primary) unit.

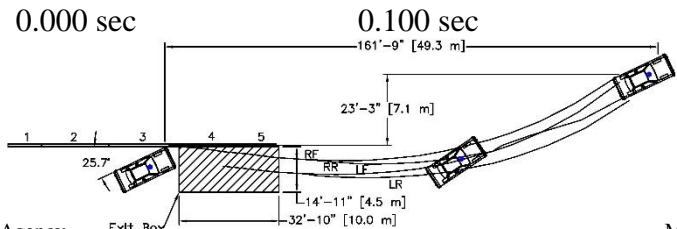
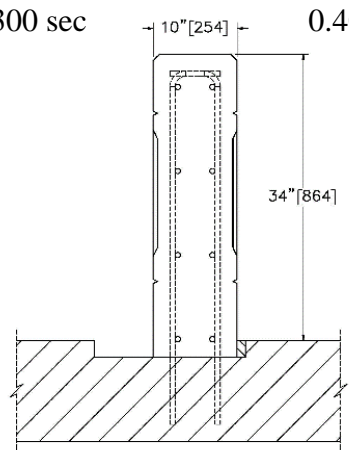
Figure 47. Summary of Test Results and Sequential Photographs, Test No. H34BR-1

The analysis of the test results for test no. H34BR-1 showed that the system adequately contained and redirected the 1100C vehicle with controlled lateral displacements of the barrier. A summary of the test results and sequential photographs are shown in Figure 47. Detached elements, fragments, or other debris from the test article did not penetrate or show potential for penetrating the occupant compartment, or present an undue hazard to other traffic, pedestrians, or work-zone personnel. Deformations of, or intrusions into, the occupant compartment that could have caused serious injury did not occur. The passenger side window shattered due to crush of the side of the vehicle door and not due to direct contact with the test article. The test vehicle did not penetrate nor ride over the barrier and remained upright during and after the collision. Vehicle roll, pitch, and yaw angular displacements, as shown in Appendix D, were deemed acceptable, because they did not adversely influence occupant risk nor cause rollover. After impact, the vehicle exited the barrier at an angle of 6.9 degrees, and its trajectory did not violate the bounds of the exit box. Therefore, test no. H34BR-1 was determined to be acceptable according to the MASH 2016 safety performance criteria for test designation no. 3-10.

- Impact Severity 59.2 kip-ft > 51 kip-ft limit from MASH 2016
- Exit Conditions
 - Speed 43.0 mph
 - Angle 6.9 deg.
- Exit Box Criterion..... Pass
- Vehicle Stability..... Satisfactory

- Vehicle Stopping Distance 161 ft – 9 in. downstream, 23 ft - 3 in. laterally behind
- Vehicle Damage..... Moderate
 - VDS [11] 1-RFQ-4
 - CDC [12]..... 01-RRER-5

- Test Article Damage Minimal
- Maximum Test Article Deflections
 - Permanent Set 0.2 in.
 - Dynamic 0.3 in.
 - Working Width..... 10.3 in.
- Transducer Data

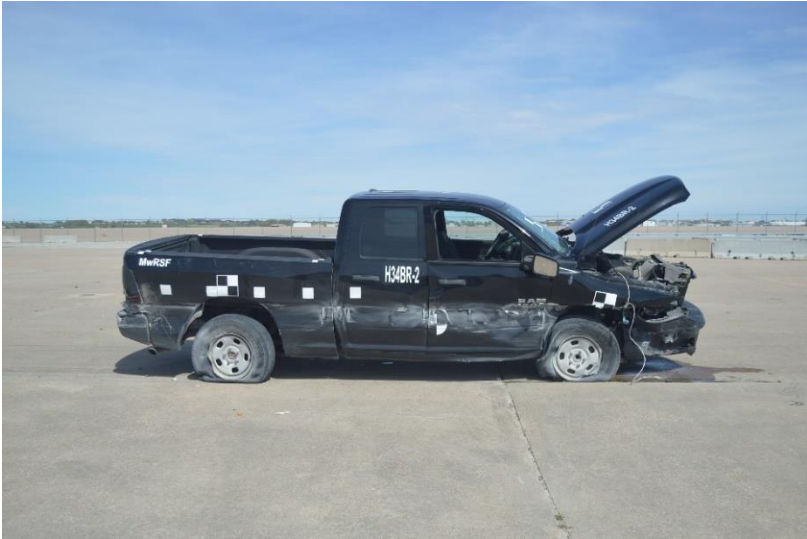
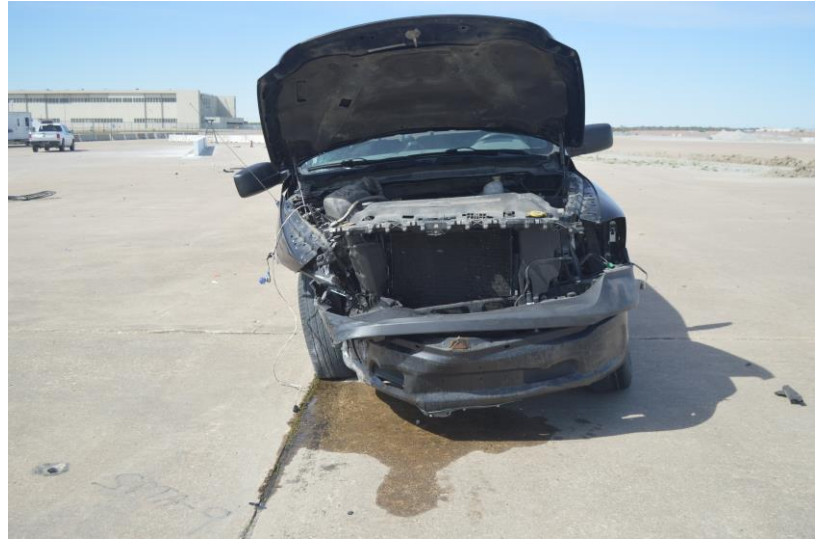
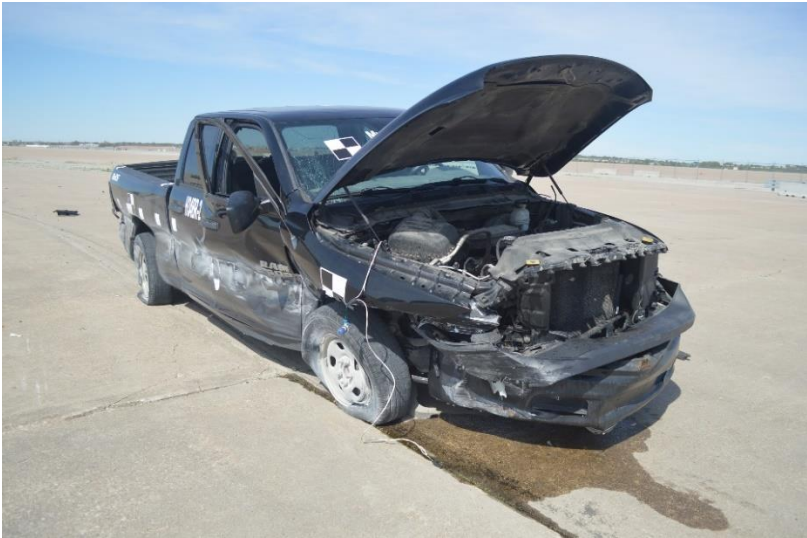
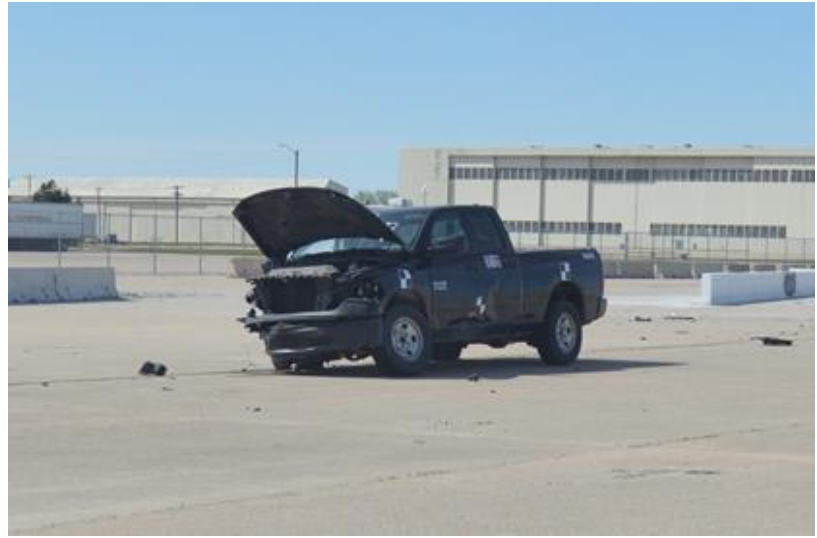
Figure 60. Vehicle Damage, Test No. H34BR-2

The damage to the vehicle was moderate, as shown in Figures 60 through 64. The maximum occupant compartment intrusions are listed in Table 9 along with the intrusion limits established in MASH 2016 for various areas of the occupant compartment. MASH 2016 defines intrusion or deformation as the occupant compartment being deformed and reduced in size with no observed penetration. Note that none of the established MASH 2016 intrusion limits were violated. The lateral A- and B-pillars and the side door above the seat deformed slightly outward, which is not considered crush toward the occupant, is denoted as negative numbers in Table 9, and is not evaluated by MASH 2016 criteria. Complete occupant compartment and vehicle intrusions and the corresponding locations are provided in Appendix C.

The majority of the damage was concentrated on the right-front corner and right side of the vehicle where the impact had occurred. The right side of the bumper was crushed inward and backward. The right-front fender was crushed inward toward the centerline of the vehicle and engine compartment. The right-front steel rim was deformed and crushed, and the right-front tire was torn and deformed. The right upper control arm was fractured. The grille was disengaged away

from the vehicle. The left-side headlight was disengaged away from the vehicle and right-side headlight and fog light were shattered. The right side of the radiator was pushed backward. A 16 $\frac{1}{2}$ -in. long x 21-in. wide x 2 $\frac{1}{2}$ -in. deep dent and scraping were observed on the entire right side. The right-front door was ajar, and creases were found in the door's sheet metal. The right-rear steel rim was crushed, and the tire was torn. The right side of the rear bumper was dented and scuffed. It should be noted that the window on the right-front side was shattered. It should be noted that the passenger side window was fractured. Review of the high-speed video revealed that the side window damage was due to crush of the side of the vehicle door and not due to direct contact with the test article. Thus, the side window damage was not in violation of the MASH criteria as it did not occur due to contact with the test article or debris. The bottom-right side of the windshield had a hairline crack, and no cracks were found on the left side of the windshield. The left-front fender was dented at the top and back. Minor scrapes and dents were found at the left-front and left-rear doors. The roof and remaining window glass remained undamaged.

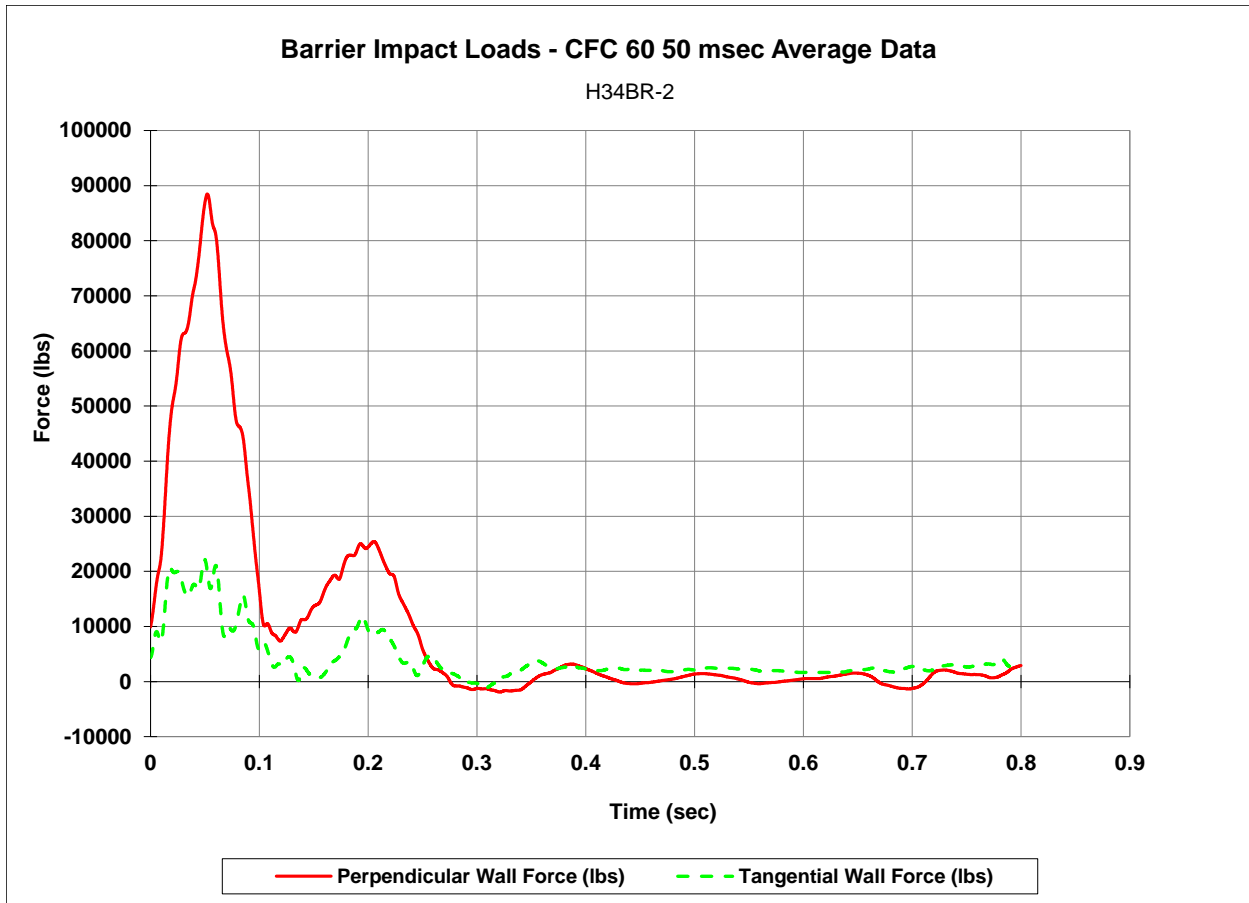
Figure 65. Perpendicular and Tangential Forces Imparted to the Barrier System (SLICE-2), Test No. H34BR-2

The longitudinal and lateral vehicle accelerations, as measured at the vehicle's c.g., were also processed using a SAE CFC-60 filter and a 50-msec moving average. The 50-msec moving average vehicle accelerations were then combined with the uncoupled yaw angle versus time data in order to estimate the vehicular loading applied to the barrier system. From the data analysis, the perpendicular impact forces were determined for the bridge rail, as shown in Figure 65. The maximum perpendicular (i.e., lateral) load imparted to the barrier was 88.6 kips determined by the SLICE-2 (primary) unit.

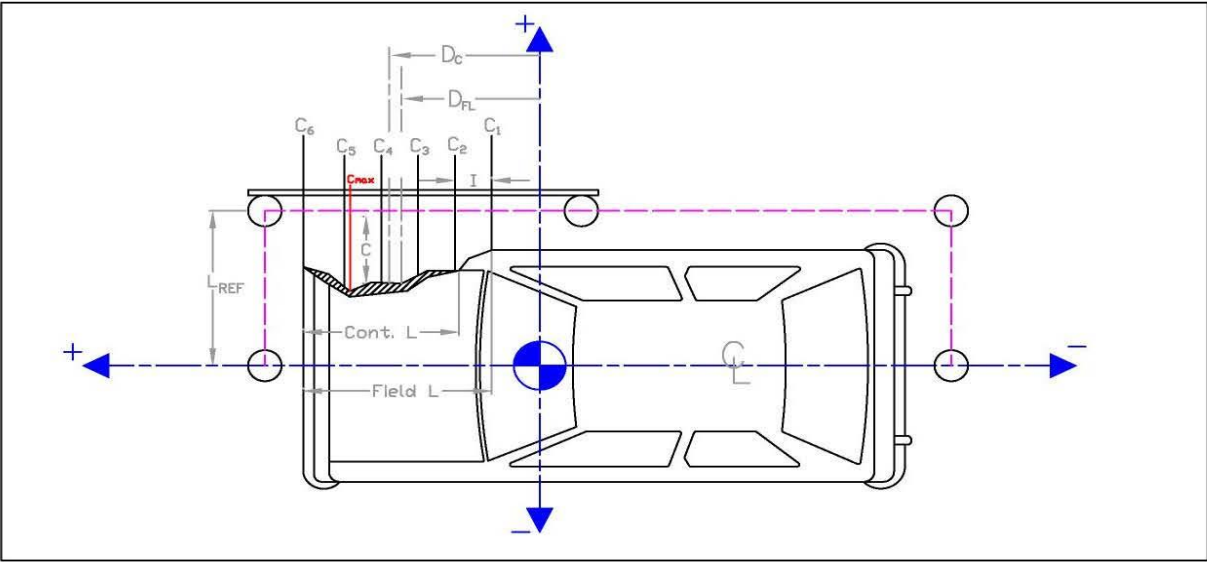
Figure C-6. Exterior Vehicle Crush (NASS) - Side, Test No. H34BR-1

Distance from centerline to reference line - L _{REF} :	in.	(mm)
	36	(914)
Total Vehicle Length:	168 1/8	(4270)
Distance from vehicle c.g. to 1/2 of Vehicle total length:	-11 5/8	(-295)
Width of contact and induced crush - Field L:	168 1/8	(4270)
Crush measurement spacing interval (L/5) - I:	33 5/8	(854)
Distance from vehicle c.g. to center of Field L - D _{FL} :	-11 5/8	(-295)
Width of Contact Damage:	168 1/8	(4270)
Distance from vehicle c.g. to center of contact damage - D _C :	-11 5/8	(-295)

Crush Measurement		Longitudinal Location		Original Profile Measurement		Dist. Between Ref. Lines		Actual Crush	
	in.	(mm)	in.	(mm)	in.	(mm)	in.	(mm)	in.	(mm)
C ₁	N/A	NA	-95 3/4	(-2432)	14 3/4	(375)	0	()	NA	NA
C ₂	N/A	NA	-62 1/8	(-1578)	4	(102)			NA	NA
C ₃	5 3/4	(146)	-28 1/2	(-724)	3 3/8	(86)			2 3/8	(60)
C ₄	8	(203)	5 1/8	(130)	3 1/4	(83)			4 3/4	(121)
C ₅	N/A	NA	38 3/4	(984)	3 1/2	(89)			NA	NA
C ₆	N/A	NA	72 3/8	(1838)	36	(914)			NA	NA
C _{MAX}	24 1/4	(616)	48 1/2	(1232)	3 3/4	(95)			20 1/2	(521)

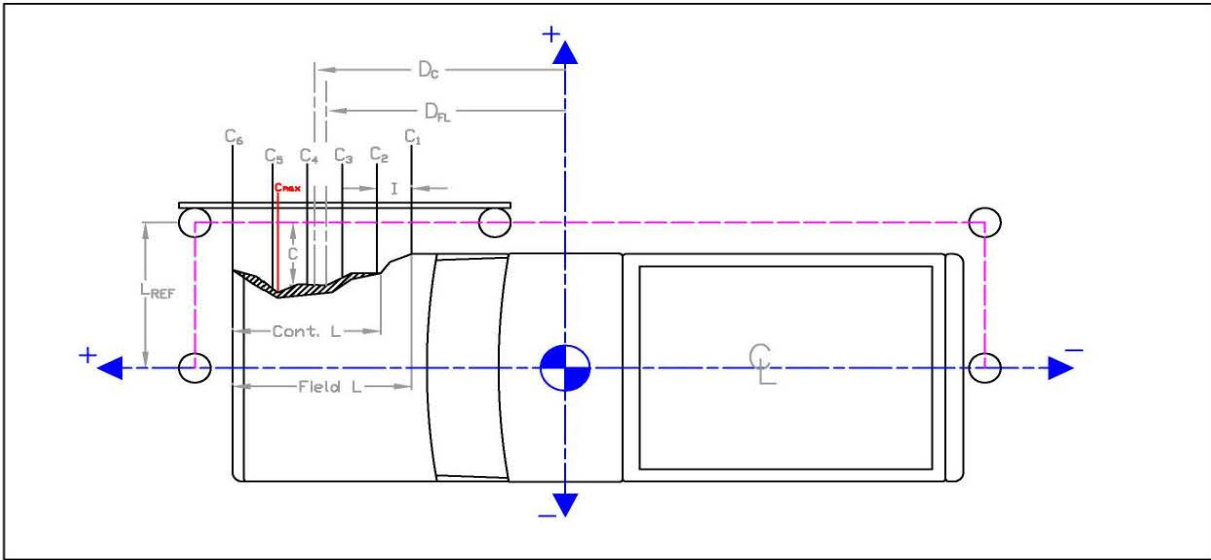
Exterior Vehicle Crush (NASS) - Side, Test No. H34BR-2

Distance from centerline to reference line - L_{REF}: 44 in. (1118) mm
Total Vehicle Length: 229 1/4 (5823)
Distance from vehicle c.g. to 1/2 of Vehicle total length: -6 1/5 (-157)
Width of contact and induced crush - Field L: 229 1/4 (5823)
Crush measurement spacing interval (L/5) - I: 45 7/8 (1165)
Distance from vehicle c.g. to center of Field L - D_{FL}: -6 1/5 (-157)
Width of Contact Damage: 229 1/4 (5823)
Distance from vehicle c.g. to center of contact damage - D_C: -6 1/5 (-157)
