DEVELOPMENT AND TESTING OF A NEW VERTICAL-FACED TEMPORARY CONCRETE BARRIER FOR USE ON COMPOSITE PANEL BRIDGE DECKS

MwRSF Research Report No. TRP-03-220-09

October 13, 2009

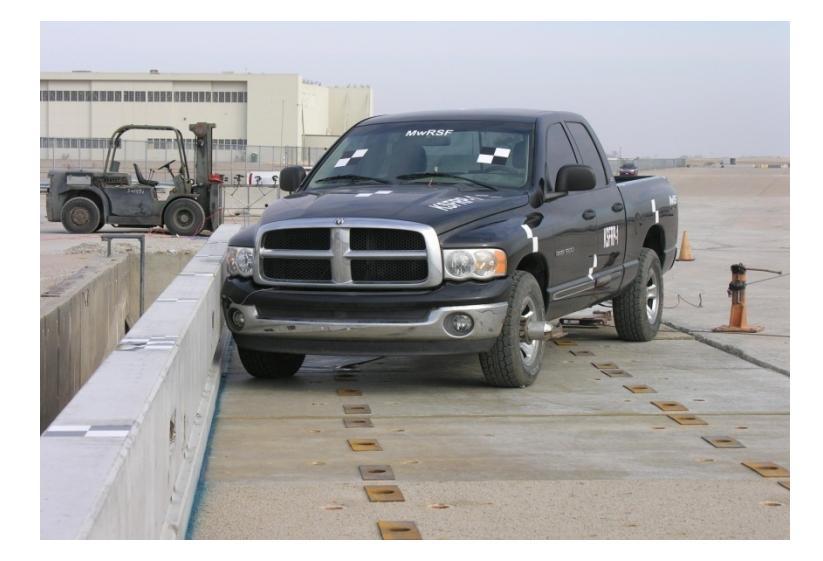
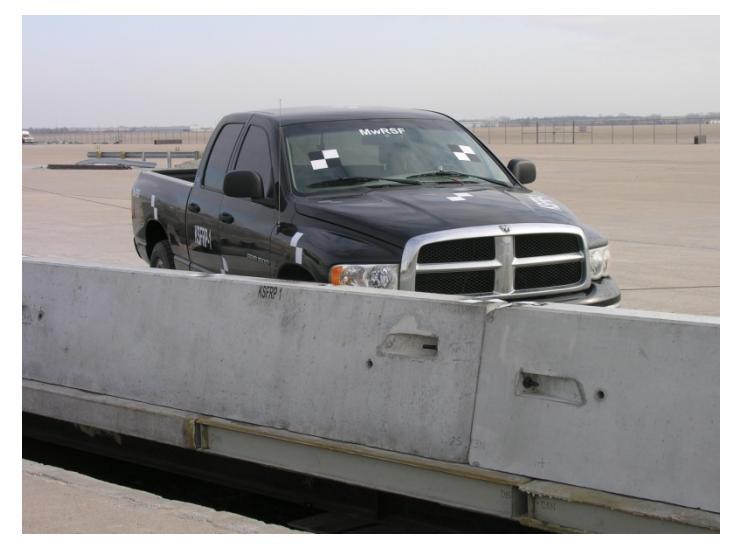
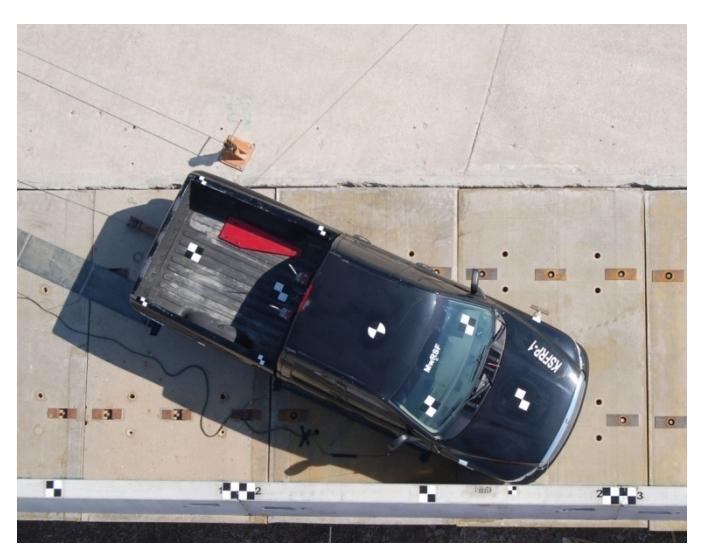
Figure 26. Impact Location, Test No. KSFRP-1

Initial vehicle impact was to occur 4 ft – $3\frac{1}{4}$ in. (1.30 m) upstream from the center of the joint between barrier nos. 2 and 3, as shown in Figure 26. Actual impact occurred at the targeted impact location. A sequential description of the impact events is provided in Table 4. The vehicle came to rest 195 ft – 7 in. (59.61 m) downstream from impact and 3 ft – 4 in. (1.02 m) laterally away from the traffic-side face of the barrier. The vehicle trajectory and final resting position are shown in Figures 22 and 27.
