Approach Slope for Midwest Guardrail System

MIDWEST ROADSIDE SAFETY FACILITY

MwRSF Research Report No. TRP-03-188-08

December 4, 2008

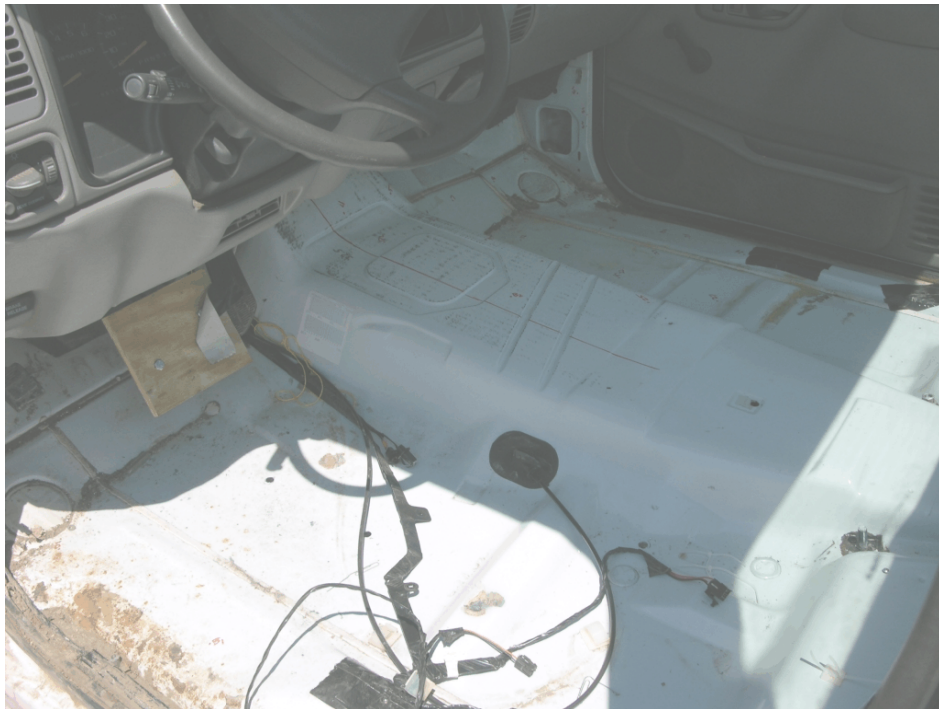
Figure 35. Occupant Compartment Damage, Test No. MGSAS-1

Exterior vehicle damage was minimal, as shown in Figures 33 through 35. Occupant compartment deformations to the right side and center of the floorboard were judged insufficient to cause serious injury to the vehicle occupants, as shown in Figure 35. Maximum longitudinal deflections of 6 mm (0.25 in.) were located near the left side of the right side floorboard. Maximum lateral deflections of 19 mm (0.75 in.) were located near the front of the right-side floorboard. Maximum vertical deflections of 19 mm (0.75 in.) were located near the left side of the right-side floorboard. Complete occupant compartment deformations and the corresponding locations are provided in Appendix C.

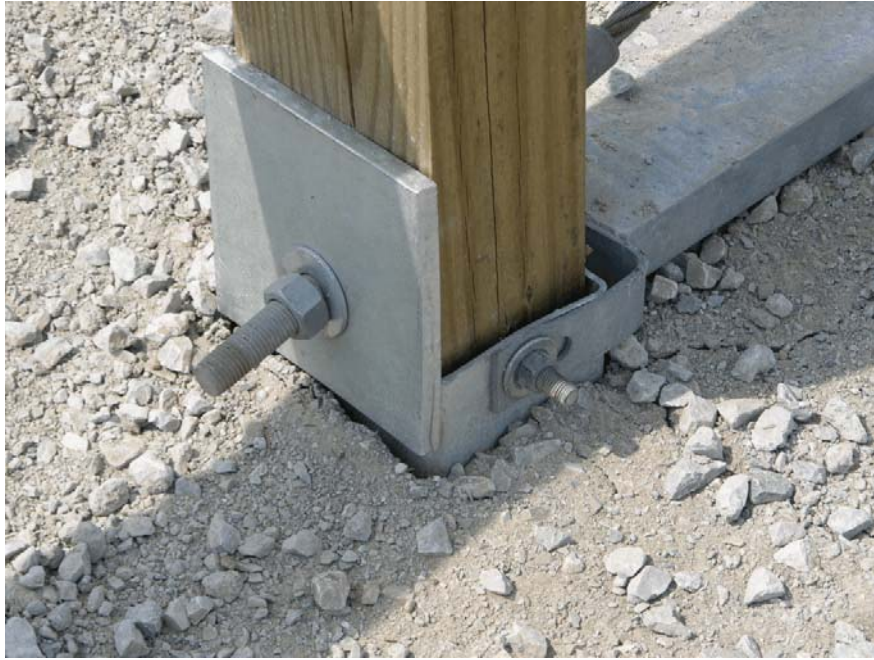
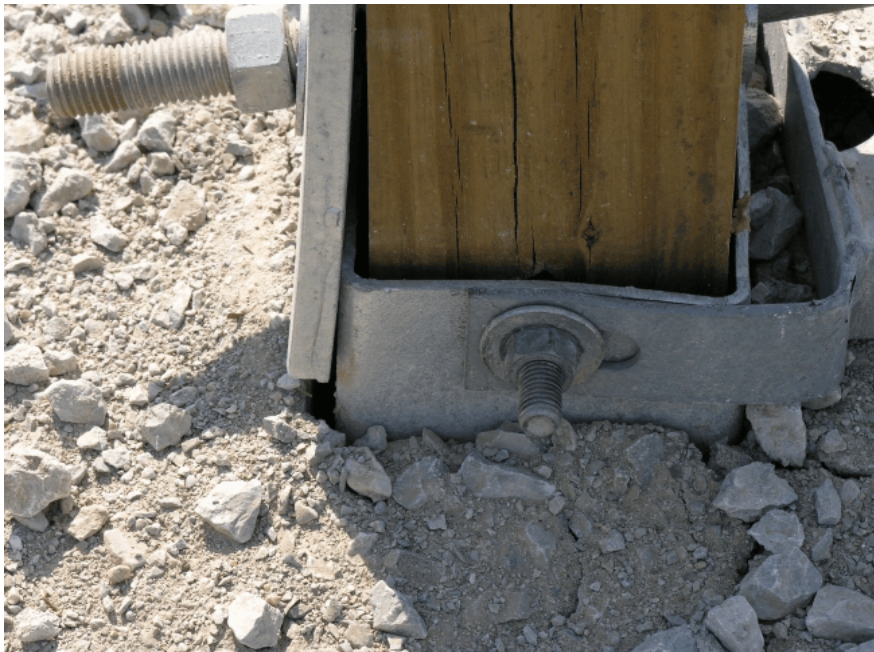
Figure 46. Upstream Anchorage Damage, Test No. MGSAS-2

Damage to the barrier was moderate, as shown in Figures 43 through 46. Barrier damage consisted of deformed guardrail posts, contact marks on a guardrail section and posts, and deformed W-beam rail. The length of vehicle contact along the system was approximately 6.0 m (19 ft - 8 in.), which spanned from 1,359 mm (53.5 in.) downstream from the centerline of post no. 13 through 267 mm (10.5 in.) upstream from the centerline of post no. 17.

Steel post nos. 13 through 17 rotated backward. Steel post nos. 3 through 13 encountered minor twisting. Contact marks were found on the blockouts at post nos. 14 and 15. The blockout at post no. 16 was twisted upstream to an angle of 45 degrees. The upstream anchor moved 12.7 mm (0.5 in.) longitudinally. All four wood BCT posts remained undamaged.
