**FULL-SCALE 4,500 LB. VEHICLE CRASH TEST
ON THE
PERMANENT PRECAST CONCRETE MEDIAN BARRIER**

Project RES1 (0099) P451
TRANSPORTATION RESEARCH REPORT TRP-03-24-90

Midwest Roadside Safety Facility
Civil Engineering Department
W348 Nebraska Hall
University of Nebraska-Lincoln
Lincoln, Nebraska 68588-0531

March 1991

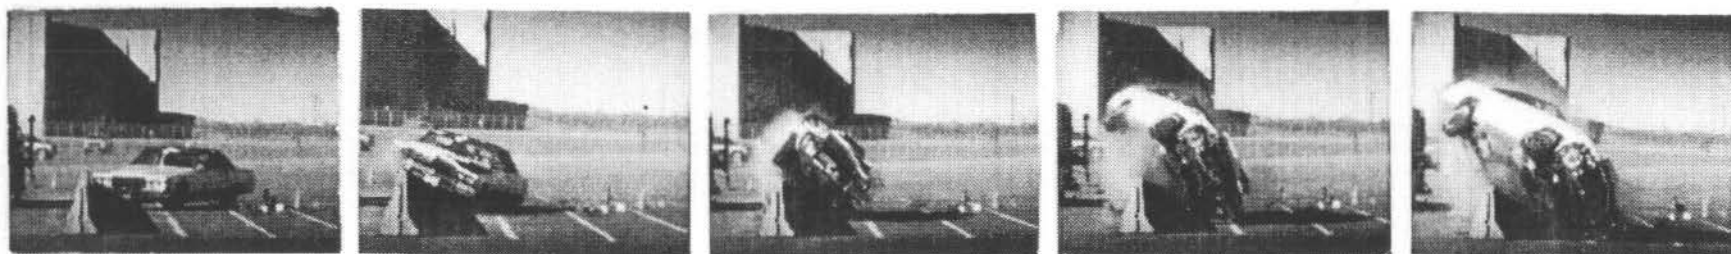
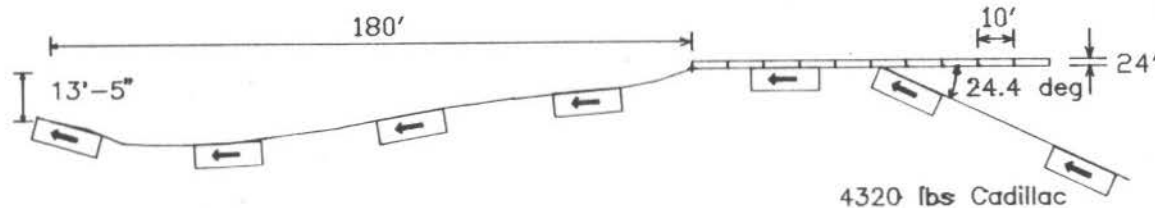
Figure 11 Test KCB-1 Summary and Sequential Photographs

Test KCB-1 was conducted with a 4,320 lb. Cadillac Fleetwood Brougham under the impact conditions of 59.3 mph and 24.4 degrees. The location of impact was 3 ft upstream of the centermost keyway. A summary of the test results is shown in Figure 11. The sequential photographs are shown in Figures 12, 13, and 14.

Upon impact with the permanent precast CMB, the right front corner of the vehicle began to crush inward. At 0.090 sec after impact the rotation of the barrier became noticeable and the vehicle began to ride up on the barrier. At 0.172 sec the barrier fractured after having rotated approximately 15 degrees. At 0.220 sec the vehicle was parallel to the barrier and the right side of the vehicle was completely above the barrier. At approximately 0.300 sec the vehicle was completely airborne and free from the barrier. At 0.500 sec the vehicle reached its maximum roll angle of approximately 75 degrees. At 0.570 sec the left front corner of the vehicle contacted the concrete apron and at 0.724 sec the right underside of the vehicle contacted the top of the barrier on its way down. At 1.070 sec the right tires of the car touched down and the vehicle slid across the concrete, coming to a stop 230 ft downstream from the barrier and offset a distance of 13 ft perpendicular to a line parallel to the barrier.

Vehicle Speed	
Impact	59.3 mph
Exit	38.3 mph
Vehicle Angle	
Impact	24.4 degrees
Exit	0 degrees
Vehicle Snagging	Minor
Vehicle Stability	Excessive Roll Angle
Occupant Impact Velocity	
Longitudinal	18.4 fps (<30 fps)
Lateral	20.7 fps (>20 fps)
Occupant Ridedown Deceleration	
Longitudinal	11.7 g's (<15 g's)
Lateral	6.9 g's (<15 g's)
Vehicle Damage	Marginal
TAD	1-RFQ-4
VDI	01FZEW2
Vehicle Rebound Distance	10'-4" @ 120'
Barrier Damage	Marginal
