PERFORMANCE EVALUATION OF SAFETY GRATES FOR CROSS-DRAINAGE CULVERTS

MIDWEST ROADSIDE SAFETY FACILITY

MwRSF Research Report No. TRP-03-196-08

October 23, 2008

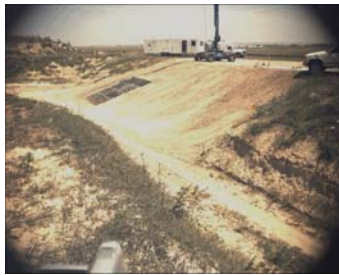
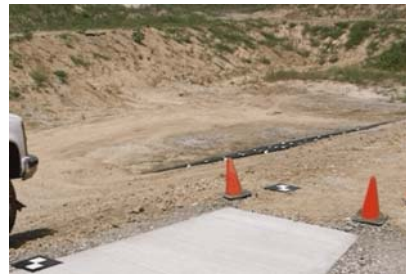
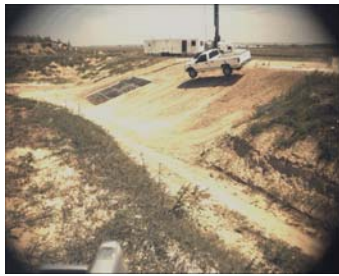
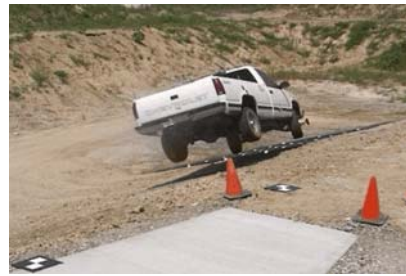
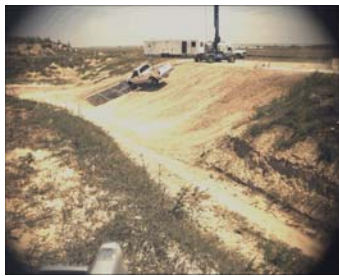
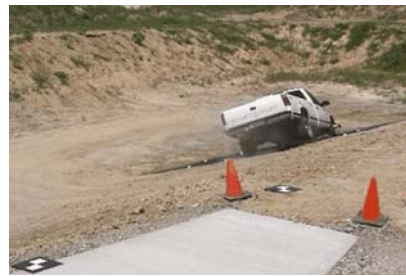
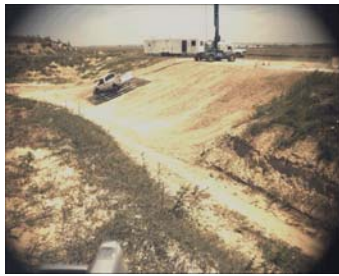
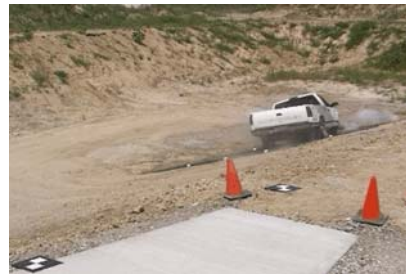
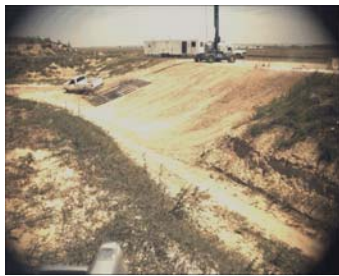
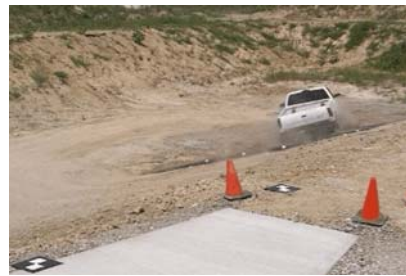
Figure 24. Additional Sequential Photographs, Test KSCG-1

The 2,034-kg (4,484-lb) pickup truck encroached onto a 3:1 slope approximately 16.9 m (55 ft - 6 in.) upstream of the culvert grate at a speed of 97.9 km/h (60.8 mph) and at an angle of 25.4 degrees. No steer input was imparted to the airborne vehicle prior to landing on the slope. A summary of the test results and sequential photographs are shown in Figure 22. The summary of the test results and sequential photographs in English units are shown in Appendix C. Additional sequential photographs are shown in Figures 23 and 24. Documentary photographs of the crash test are shown in Figures 25 through 27.

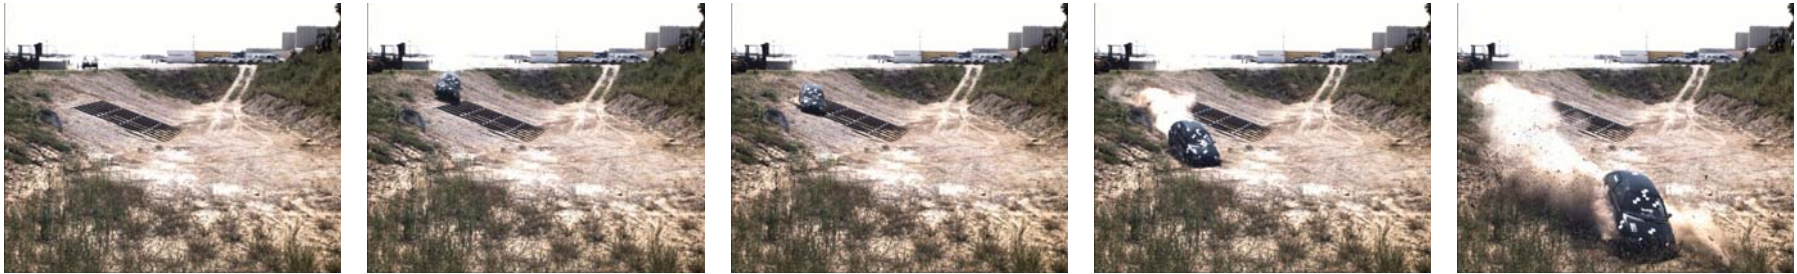
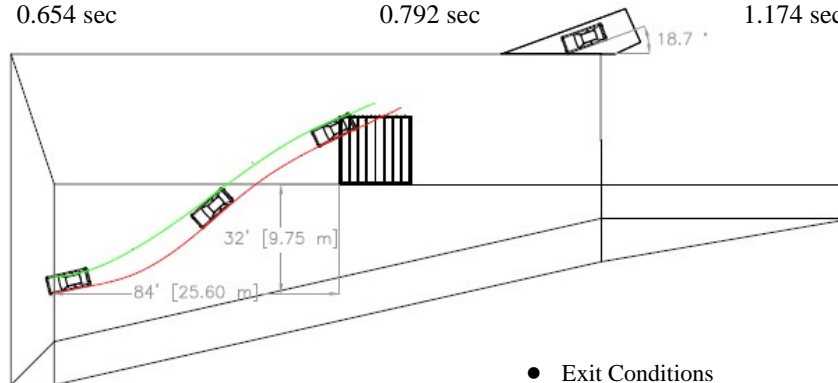
Figure 34. Summary of Test Results and Sequential Photographs, Test No. KSCG-2

The longitudinal and lateral occupant impact velocities were determined to be 3.80 m/s (12.47 ft/s) and 2.03 m/s (6.65 ft/s), respectively. The maximum 0.010-sec average occupant ridedown decelerations in the longitudinal and lateral directions were 14.38 g's and 3.58 g's, respectively. It is noted that the occupant impact velocities (OIVs) and occupant ridedown decelerations (ORDs) were within the suggested limits provided in NCHRP Report No. 350. The THIV and PHD values were determined to be 4.36 m/s (14.30 ft/s) and 14.65 g's, respectively. The results of the occupant risk, as determined from the accelerometer data, are summarized in Figure 34. Results are shown graphically in Appendix F. The results from the rate transducer are shown graphically in Appendix F.

The analysis of the test results for test no. KSCG-2 showed that the 820C vehicle was capable of safely traversing the culvert grate system with the largest recommended unsupported pipe length. There were no detached elements nor fragments which showed potential for penetrating the occupant compartment nor presented undue hazard to other traffic. Deformations of, or intrusions into, the occupant compartment that could have caused serious injury did not occur. The test vehicle remained upright during and after the collision. Vehicle roll, pitch, and yaw angular displacements were noted, but they were deemed acceptable because they did not adversely influence occupant risk safety criteria nor cause rollover. It is noted that the occupant impact velocities (OIV) and occupant ridedown decelerations (ORD) were within the suggested limits provided in NCHRP Report No. 350. After collision, the vehicle's trajectory did not intrude into adjacent traffic lanes. In addition, the vehicle's exit angle was less than 60 percent of the impact angle. Therefore, test no. KSCG-2

- Test Agency MwRSF
- Test Number KSCG-2
- Date 8/23/06
- NCHRP 350 Test Designation 3-10
- Test Article Transverse Culvert Safety Grate
- Total Length 6.1 m
- Total Width 6.1 m
- Placement 5.81 m down from the 3:1 slope breakpoint
- Key Elements - Grate Piping
 - Type Schedule 40 pipe
 - Diameter 102 mm
 - Length 6.1 m
 - Spacing 762 mm
- Type of Soil NA
- Test Vehicle
 - Type/Designation 820C
 - Make and Model 1999 Chevrolet Metro
 - Curb 836 kg
 - Test Inertial 831 kg
 - Gross Static 906 kg
- Impact Conditions
 - Speed 98.6 km/h
 - Angle (trajectory) 18.7 deg

- Exit Conditions
 - Speed NA
 - Angle NA
- Post-Impact Trajectory
 - Vehicle Stability Satisfactory
 - Stopping Distance 25.60 m downstream and 9.75 m laterally from lower-downstream corner of culvert
- Occupant Impact Velocity
 - Longitudinal 3.80 m/s < 12 m/s
 - Lateral 2.03 m/s < 12 m/s
- Occupant Ridedown Deceleration (10 msec avg.)
 - Longitudinal 14.38 g's < 20 g's
 - Lateral 3.58 g's < 20 g's
- THIV (not required) 4.36 m/s
- PHD (not required) 14.65 g's
- Test Article Damage Minimal
- Test Article Deflections
 - Permanent Set 0 mm
 - Dynamic NA
 - Working Width NA
- Vehicle Damage Minimal
 - VDS¹⁰ 1-FD-1
 - CDC¹¹ 1-FDWW1
 - OCDI F000000000
 - Maximum Deformation None observed

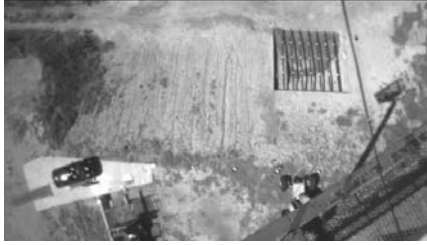
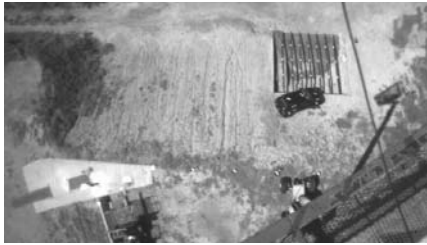
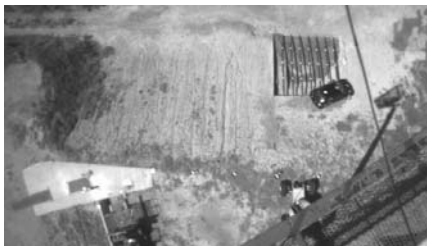
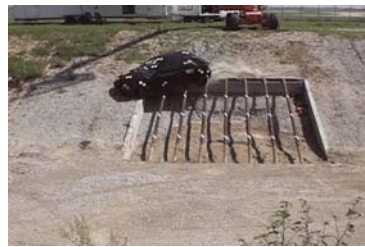
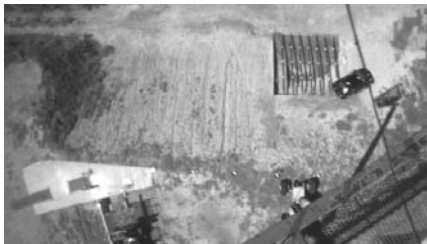
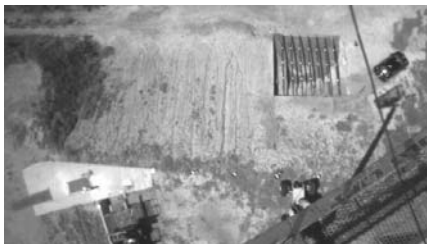
The 906-kg (1,997-lb) small car was propelled off of the edge of a 3:1 slope approximately 14.0 m (45 ft - 11 in.) upstream of the culvert grate at a speed of 98.6 km/h (61.3 mph) and at an angle of 18.7 degrees. No steer input was imparted to the airborne vehicle prior to landing on the slope. A summary of the tests results and sequential photographs are shown in Figure 34. The summary of the test results and sequential photographs in English units are shown in Appendix C. Additional sequential photographs are shown in Figure 35. Documentary photographs of the crash test are shown in Figures 36 and 37.

continued downstream until it came to rest on the 1:1 upslope approximately 25.60 m (84 ft) downstream and 9.75 m (32 ft) laterally away from the lower-downstream corner of the culvert grate. The trajectory and final position of the small car are shown in Figures 34 and 38.
