SAFETY PERFORMANCE EVALUATION OF THE NON-BLOCKED MIDWEST GUARDRAIL SYSTEM (MGS)

MwRSF Research Report No. TRP-03-262-12

January 24, 2013

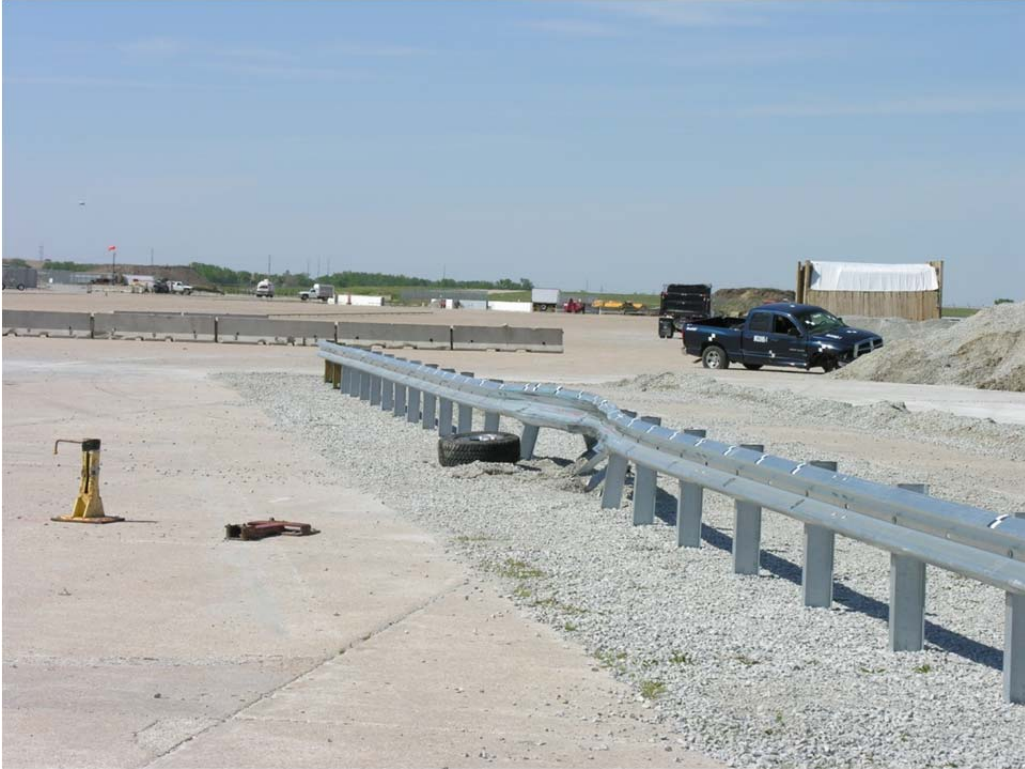
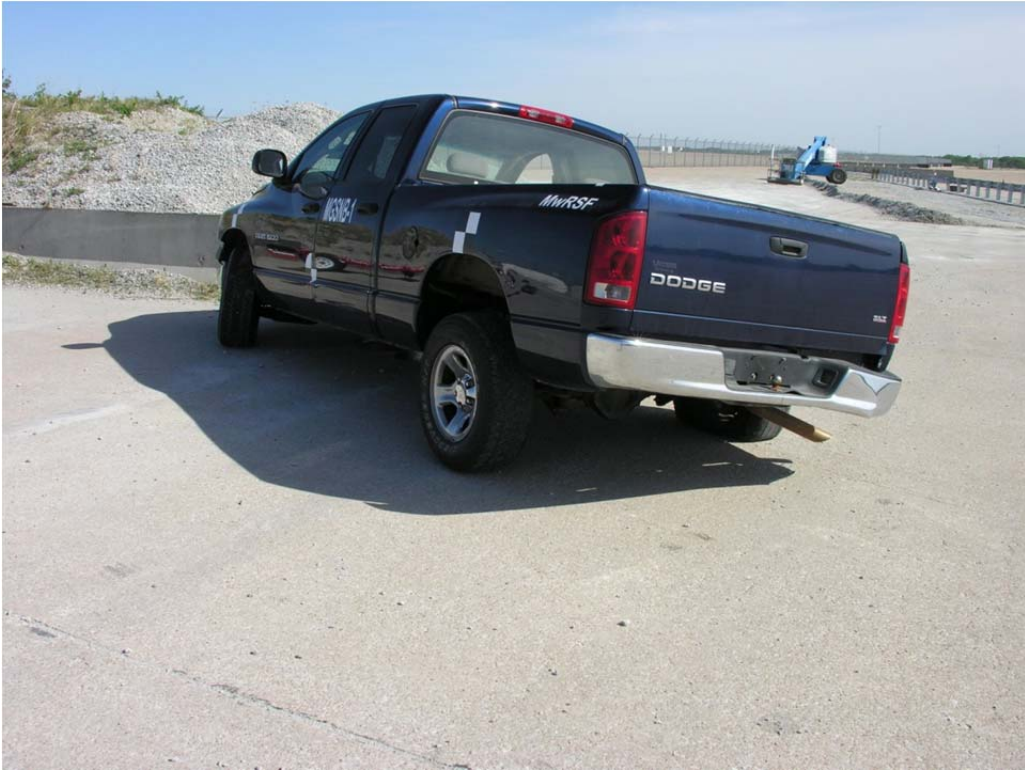
Figure 38. Vehicle Final Position and Trajectory Marks, Test No. MGSNB-1

Initial vehicle impact was to occur 13 ft – 3½ in. (4.1 m) upstream of the centerline of post no. 15, as shown in Figure 37, which was selected using the critical impact point (CIP) plots found in Section 2.3 of MASH. The actual point of impact was the intended impact point. A sequential description of the impact events is contained in Table 4. The vehicle came to rest located 190 ft – 4 in. (58.0 m) downstream from impact and 51 ft (15.6 m) laterally behind the traffic-side face of the rail. The vehicle trajectory and final position are shown in Figures 32 and 38.

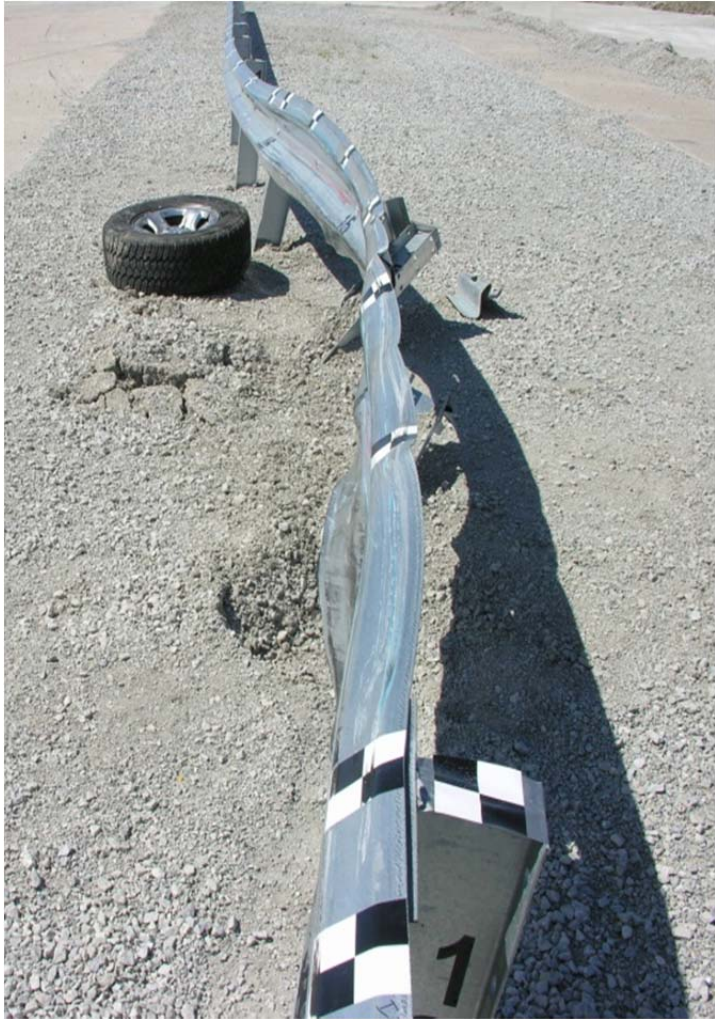
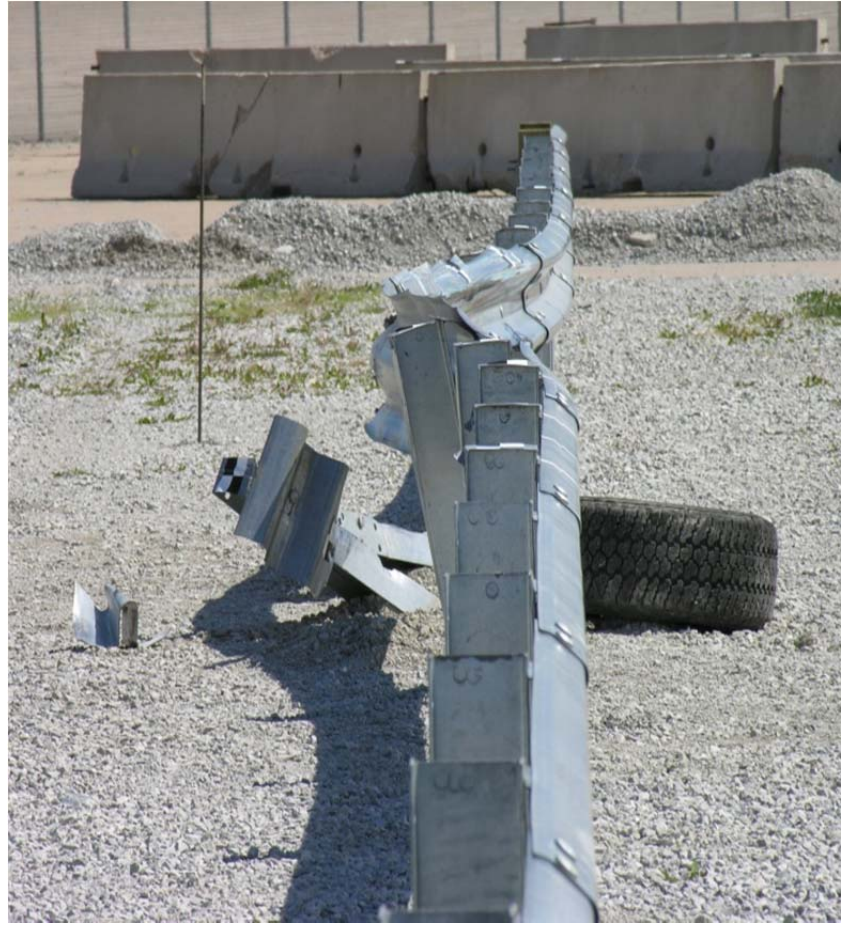
Figure 39. System Damage, Test No. MGSNB-1

Damage to the barrier was moderate, as shown in Figures 39 through 42. Barrier damage consisted of deformed W-beam rail, deformed posts, and contact marks on sections of guardrail and posts. The length of vehicle contact along the barrier was approximately 23 ft – 6 in. (7.2 m) which spanned from 21 in. (533 mm) upstream of the centerline of post no. 13 to 41¾ in. (1,060 mm) downstream of the centerline of post no. 16.

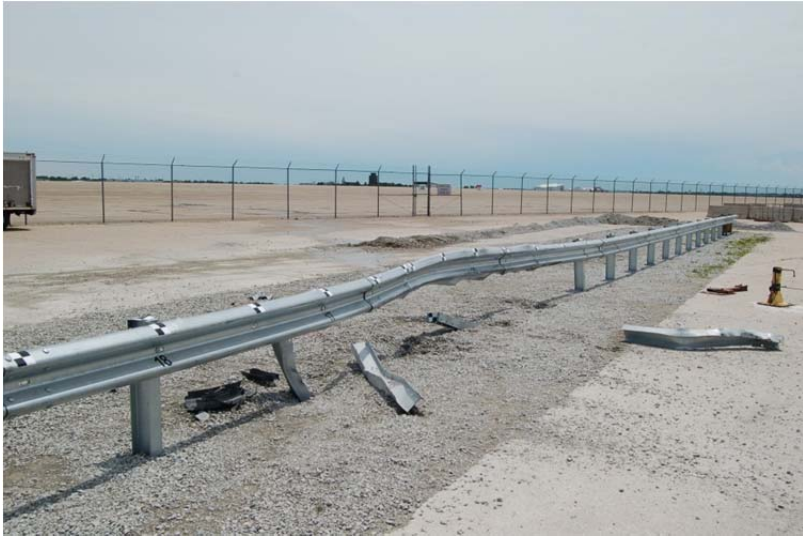
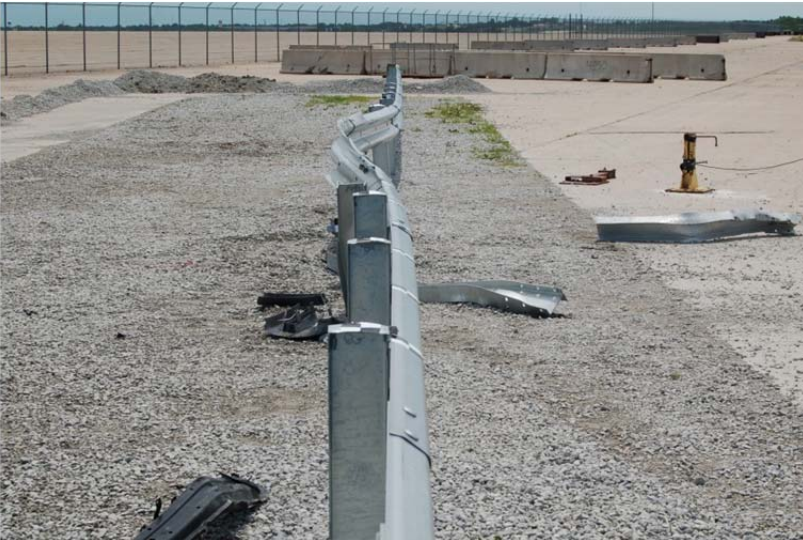
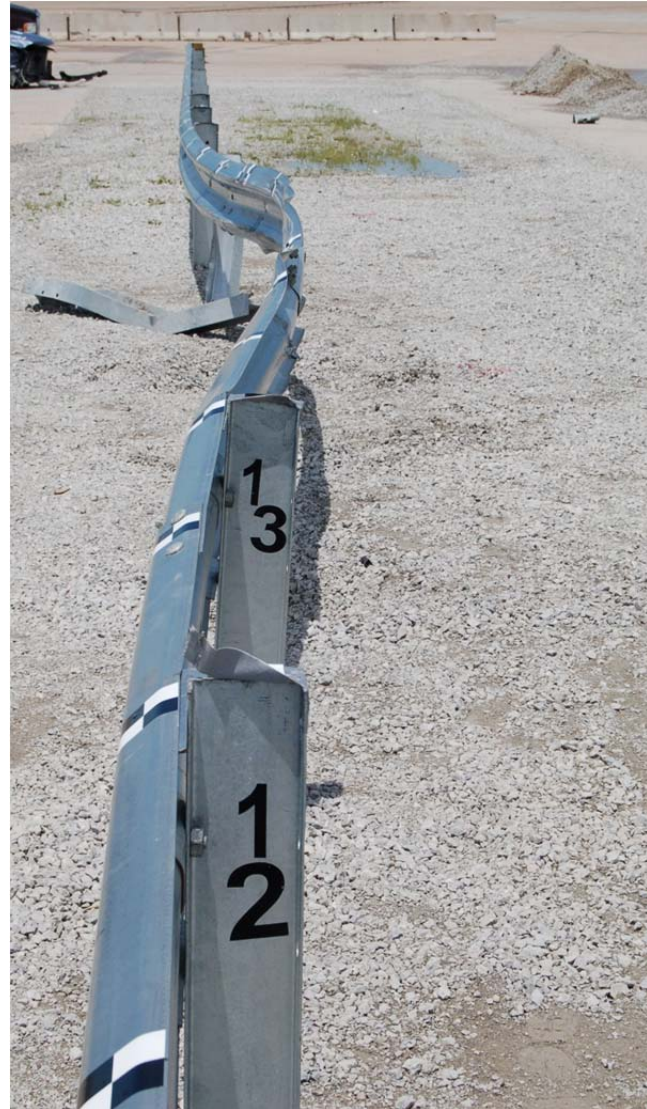
Figure 54. System Barrier Damage, Test No. MGSNB-2

Damage to the barrier was moderate, as shown in Figures 54 through 56. Barrier damage consisted of deformed W-beam rail, deformed posts, and contact marks on sections of guardrail and posts. The length of vehicle contact along the barrier was approximately 20 ft – 7¼ in. (6.3 m) which spanned from 2 ft – 8¼ in. (0.8 m) upstream from the center of post no. 14 to 10 in. (254 mm) upstream from the center of post no. 17. Secondary vehicle contact was 9 ft – 10 in.

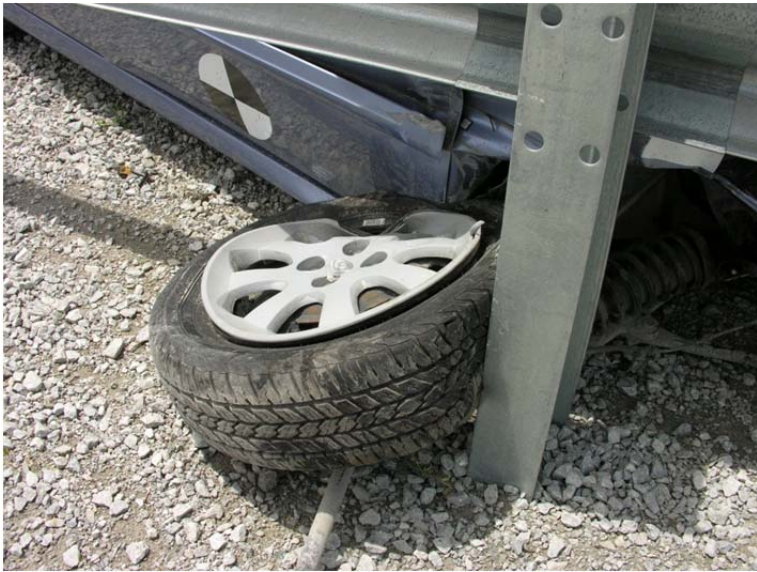
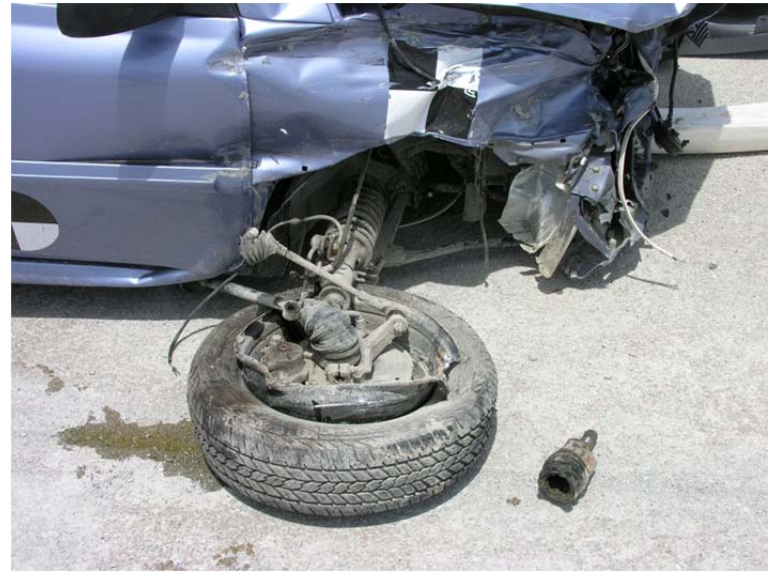
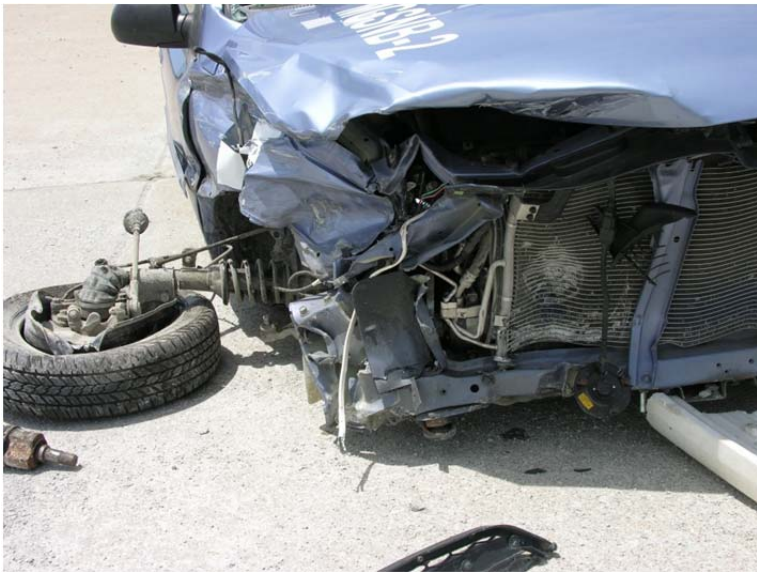
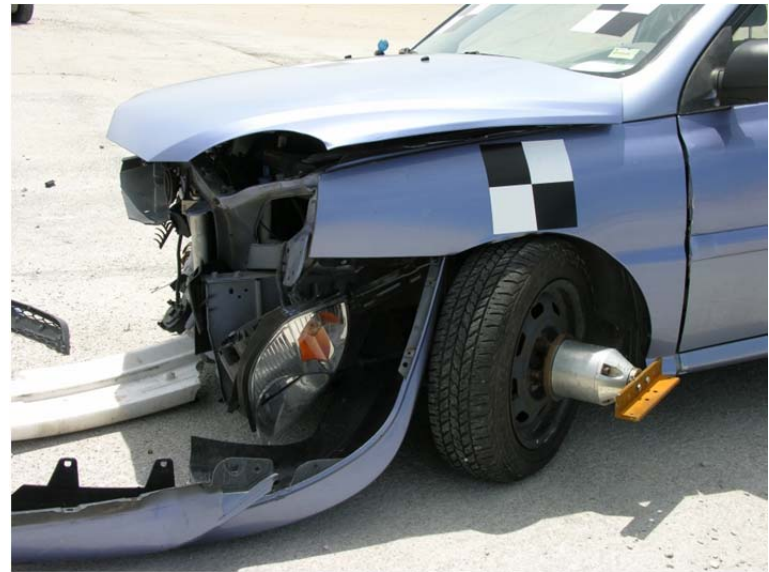
Figure 58. Vehicle Damage, Test No. MGSNB-2

Damage to the vehicle was moderate, as shown in Figures 57 and 58. The maximum occupant compartment deformations are listed in Table 9 along with the deformation limits established in MASH for various areas of the occupant compartment. None of the MASH established deformation limits were violated. Complete occupant compartment and vehicle deformations and the corresponding locations are provided in Appendix D.

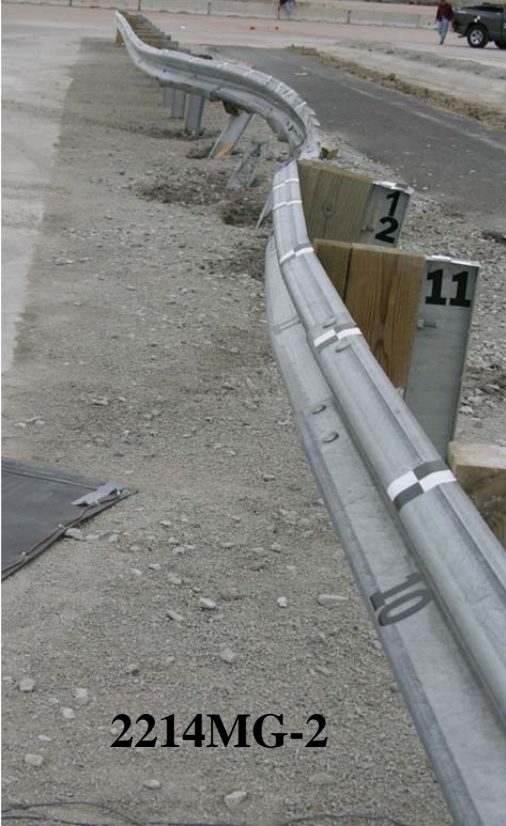
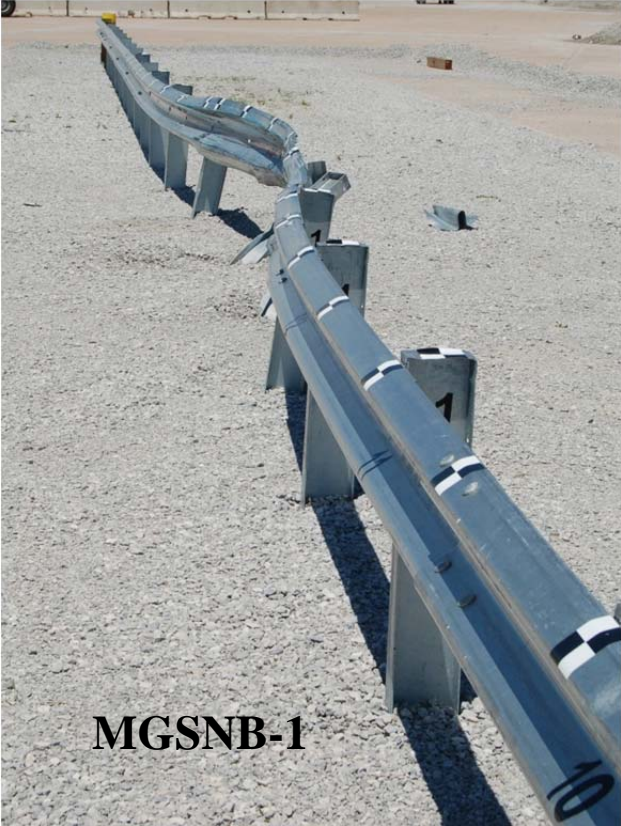
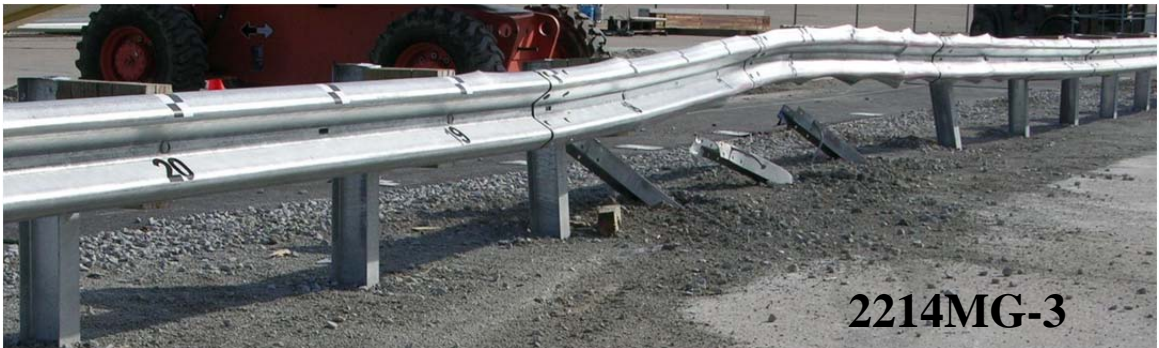
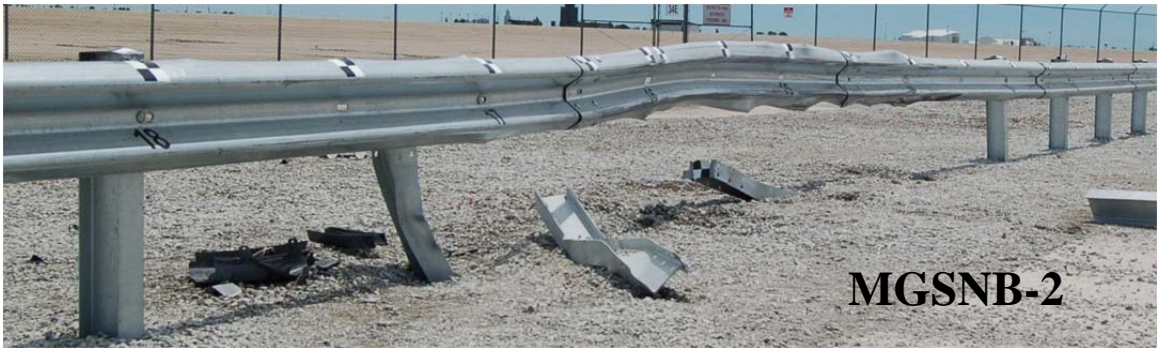
Figure 62. Barrier Damage

A comparison between the blocked and non-blocked MGS for both the 2270P truck and 1100C small car is presented in Table 11. Rear-view sequentials for the 2270P and 1100C tests are shown in Figures 60 and 61, respectively. Barrier damage and vehicle damage are shown in Figures 62 and 63, respectively. Longitudinal and lateral change in velocity plots are shown in Figure 64.

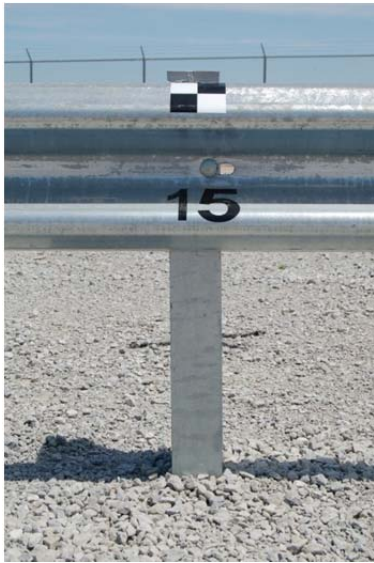
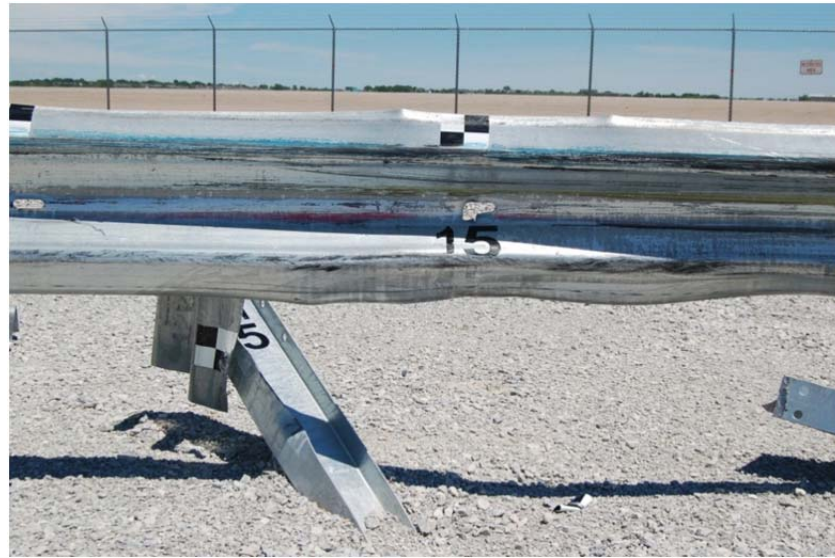
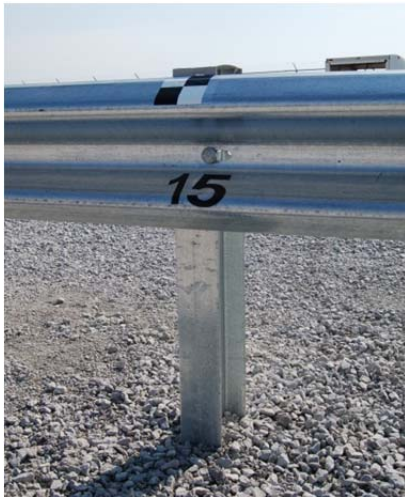
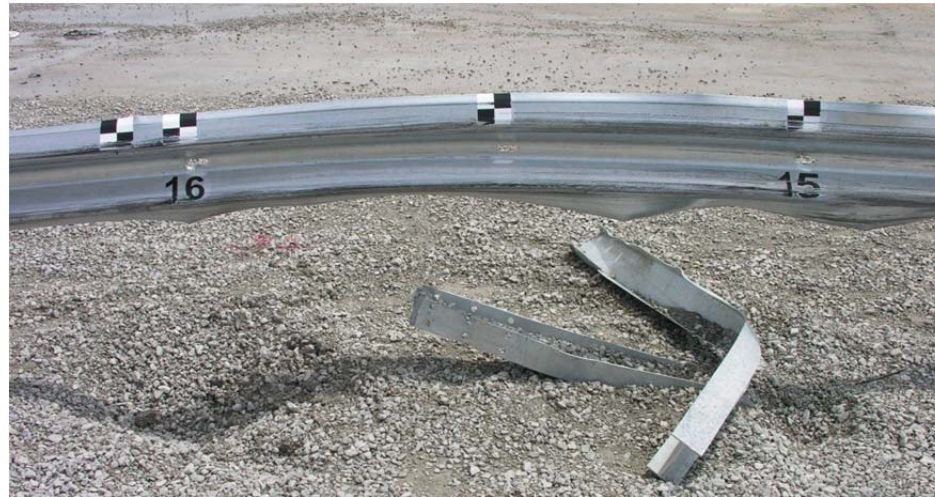
Figure 65. Bolt Located in Worst Case Location – Pull-Through Behavior Still Occurred

During test nos. MGSNB-1 and MGSNB-2, the locations of the post bolts were varied within the rail slots in order to investigate rail release away from the posts, as indicated in Figure 1 and shown in Figure 65. Post no. 15 was most likely the worst case scenario if the rail did not release from the post during impact. As a result, the post bolt was located at the downstream end of the rail slot. For both the pickup and small car tests, the guardrail detached from post no. 15 as the bolt head was pulled through the rail. Slight tearing of the rail was evident around the rail bolt hole, but nothing of significance was observed to cause concern for rail rupture. Video analysis also showed that the release of the rail occurred considerably before the post could pull the rail down as the posts rotated in the soil.

In order to prevent the rail from being pulled down as a post rotates in the soil as well as a possible vehicle override of the barrier during an impact event, the rail may need to detach away from the post. Fortunately, it has been shown that the bolt attachment mechanism used for the MGS, the same one used for standard W-beam guardrail systems for several decades, provides for satisfactory rail detachment.

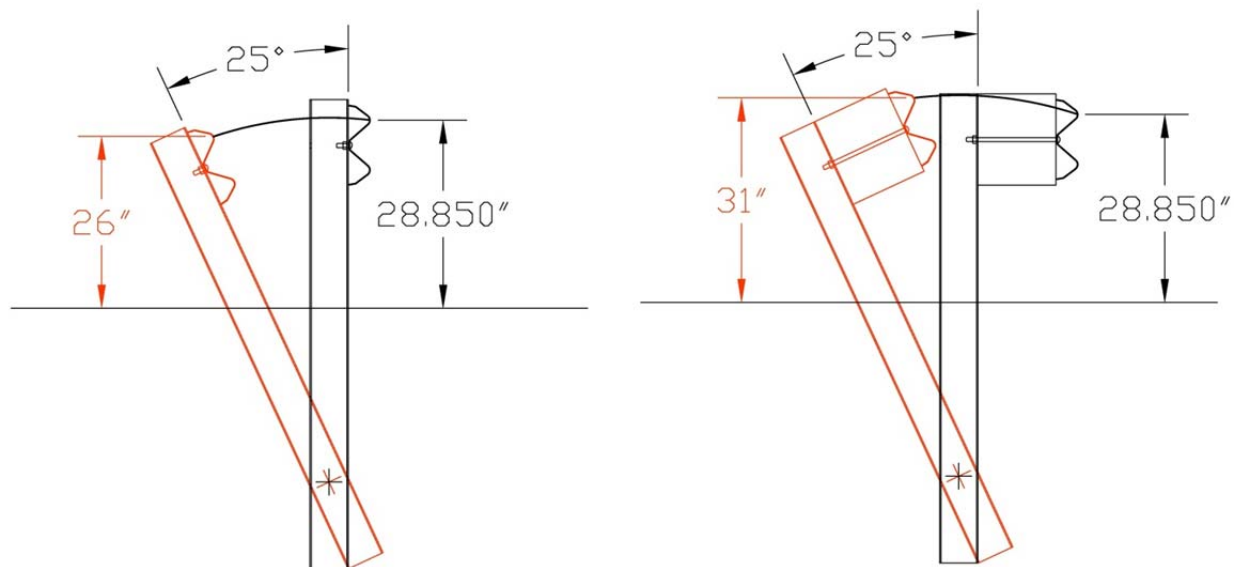
Figure 66. Blockout Holds Rail Up

The 31-in. (787-mm) mounting height is only one component which contributes to the enhanced performance of the MGS. It is well acknowledged that blockouts serve two primary purposes in the strong-post system. The first, and most important, is causing the rail to rise during an impact. As illustrated in Figure 66, during an impact, the rotation of the posts in conjunction with the blockout causes the rail to rise in the MGS (as well as in Standard W-Beam Guardrail Systems). This is not the case for the 31-in. (787-mm) W-Beam guardrail system without blockouts; where the rail immediately begins to drop as the post rotates in the soil. The deeper blockout on the MGS has significantly improved performance in concert with the increased mounting height.

A comparison of the rotated rails in the schematic above would not lead one to conclude that the non-blocked MGS system is unsafe; since, successful crash testing was performed. Even though the rail is dropping upon post rotation in the non-blocked system, it is not dropping below a critical height during the initial 25 degrees of rotation. In fact, the rail of the 31-in. (787-mm)

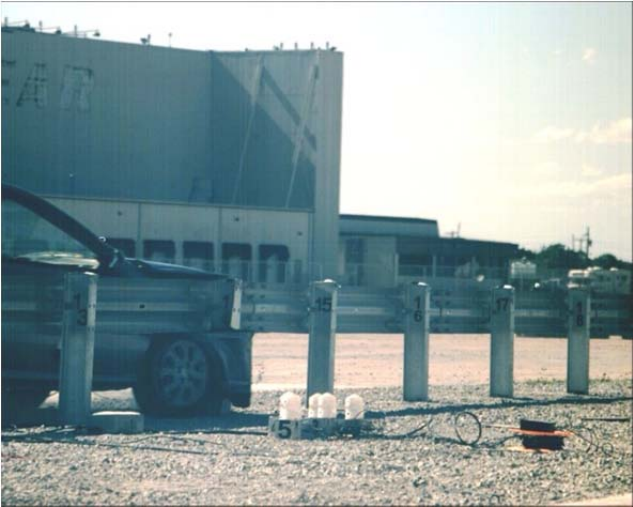
Figure 67. 1100C Crash Tests at Post No. 14 – Blockout Reduces Wheel Snag

A significant wheel snag occurred at post 14 during test no. MGSNB-2, which did not occur during test no. 2214MG-3, as shown in Figure 67. Initial impact for both tests was just upstream of post no. 13, and each vehicle easily cleared post no. 13 without tire-post overlap. The wheel snag at post no. 14 during test no. MGSNB-1 was the cause for the relatively abrupt change in longitudinal velocity (see Figure 64), as well as the relatively high OIV compared to the blocked test, test no. 2214MG-3 (31.3 ft/s versus 14.8 ft/s). It also helped pull post no. 14 out-of-the-ground as well as helped disengage the tire/wheel during the test.

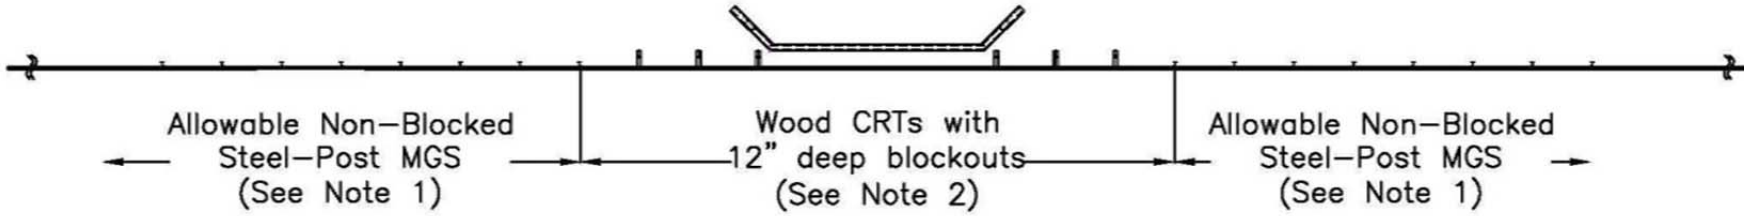
Figure 68. MGS Long-Span System with Non-Blocked Steel Post MGS

Occasionally, it may be desirable to attach a non-blocked version of the MGS to the MGS long-span guardrail system as there may be limited roadway width near concrete box culverts. However, there are concerns regarding the removal of the blockouts in the MGS long-span guardrail system. First, the removal of the blockouts on the six CRT posts would increase the likelihood for wheel snag on these posts. In addition, removal of the blockouts adjacent to the unsupported span would cause rail height to decrease immediately upon impact and through subsequent lateral post deflections, which could potentially reduce vehicle containment within the unsupported span. Finally, removal of the blockouts on the CRT posts would effectively move the front face of the guardrail closer to the culvert, thus allowing an impacting vehicle to deflect farther past the exterior edge of the headwall. This increased vehicle and barrier deflection beyond the exterior face of the headwall could increase the potential for vehicle instabilities upon redirection, promote excessive vehicle/wheel snag on the downstream wingwall, allow for excessive vehicle decelerations, and/or reduce the safety performance of the barrier system. Based on these concerns, it is recommended that 12-in. (305-mm) deep blockouts be retained on the six CRT posts.

the safety performance of the MGS long-span guardrail system when attached to guardrail beyond the upstream and downstream CRT wood posts. Therefore, it would seem reasonable to allow for the non-blocked MGS to be attached to the MGS long-span guardrail system as shown in Figure 68.

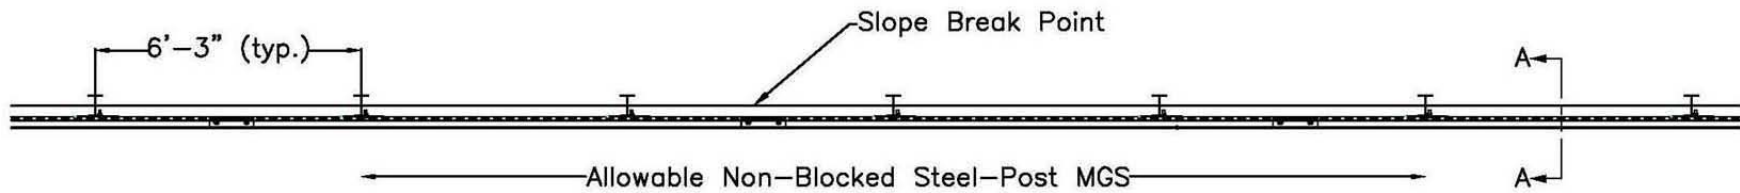
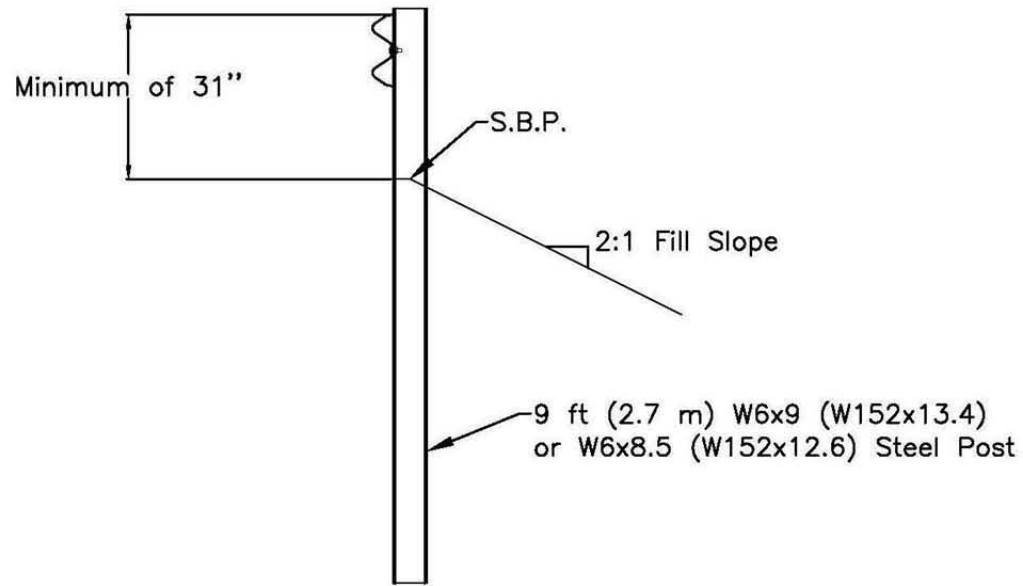
Figure 69. Non-Blocked Steel-Post MGS Adjacent to 2:1 Fill-Slope

Using the results from these successful crash testing programs, it is believed that satisfactory performance would also be provided by a non-blocked version of the MGS when installed adjacent to a 2:1 fill slope as shown in Figure 69. Thus, the use of non-blocked MGS guardrail installed adjacent to a 2:1 slope would likely be acceptable. However, it should be noted that no crash tests have been performed on this exact variation and that the minimum recommended top mounting height would likely be affected, similar to the blocked version of the MGS adjacent to 2:1 fill slopes. As such, it is highly recommended that a non-blocked version of the MGS adjacent to 2:1 fill slopes utilize a minimum top mounting height of 31 in. (787 mm) in combination with longer steel posts.

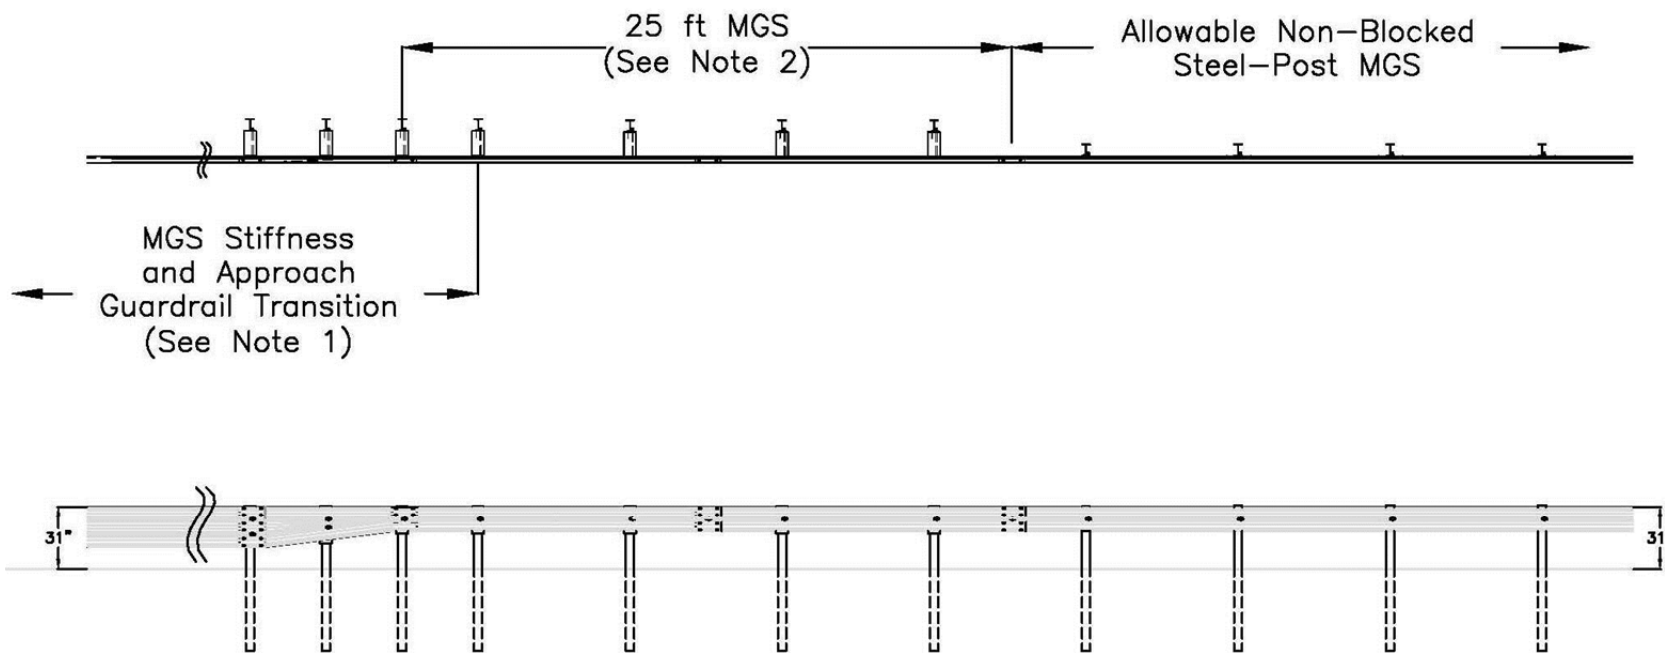
Historically, spacer blocks have been used in approach guardrail transition systems to laterally offset the face of the support posts away from the face of the stiffened guardrail sections. This lateral offset has been used to reduce or eliminate severe wheel snag on the closely-spaced, deeply-embedded, transition posts. Severe wheel snag on transition posts can contribute to vehicular instabilities and/or rapid vehicle decelerations. In addition, these transition posts often utilize increased section size in conjunction with thicker gauge rail segments or nested rail. Based on these factors, it is very difficult to anticipate the effect of blockout removal for the transition posts within approach guardrail transitions. Thus, MwRSF researchers do not recommend the removal of the blockouts in the transition region without further analysis and crash testing.

While removal of blockouts is not recommended in common approach guardrail transition systems or within the MGS stiffness transition, it is believed that blockouts can be removed from the posts in locations farther upstream from the stiffness transition. However, it is recommended that a minimum of 25 ft (7.62 m) of standard MGS with spacer blocks be placed adjacent to the new stiffness transition prior to transitioning to any of the non-blocked, 31-in. (787-mm) tall, W-beam guardrail systems, as shown in Figure 70.
