**SAFETY PERFORMANCE EVALUATION
OF MISSOURI'S SELF-DRIVING
TEMPORARY SIGN STANDS**

MISSOURI DEPARTMENT OF TRANSPORTATION

MwRSF Research Report No. TRP-03-97-00

December 13, 2000

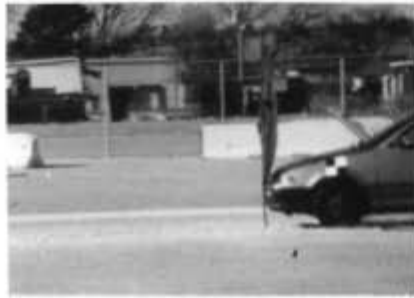
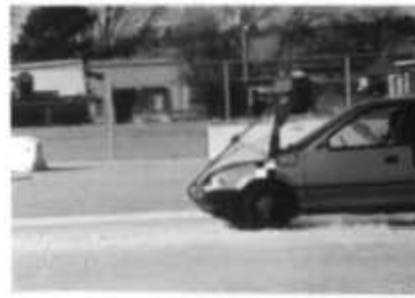
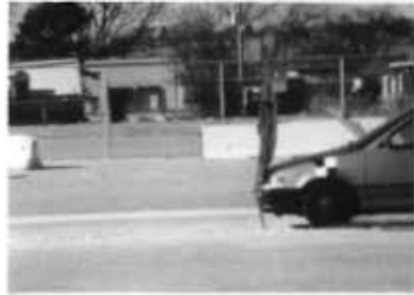
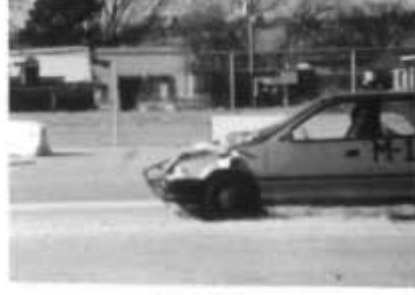
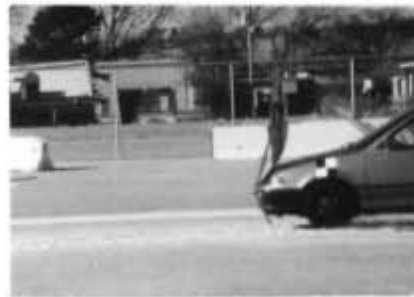
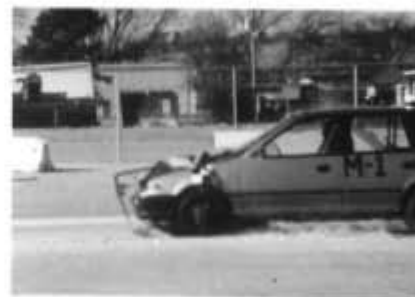
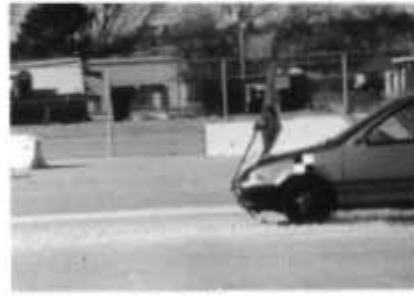
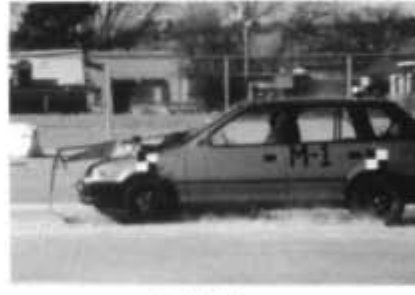
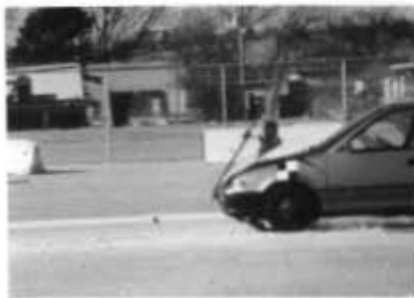
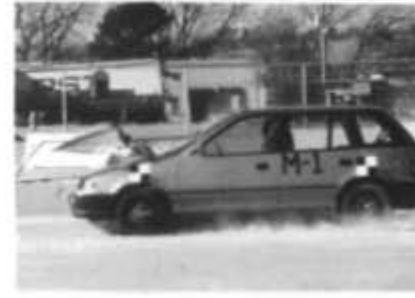
Figure 13. Additional Sequential Photographs, Test M-1

The test vehicle impacted System No. 1 with the centerline point of the vehicle's bumper aligned with the centerline of the sign support, as shown in Figure 14. At 0.004 sec after initial impact, the sign post deformed around the front of the vehicle. At 0.008 sec, the sign post began to pull out of the ground and continued to deform. At this same time, the bottom of the sign panel flexed and deformed around the vehicle's front nose. At 0.014 sec, the sign post continued to bend about the vehicle's contact point, and the bottom half of the sign panel rested on the hood of the vehicle. At 0.020 sec, the anchor pulled completely out of the ground. At this same time, the top of the sign post rotated toward the vehicle while the horizontal crossbraces flexed toward the vehicle. At 0.030 sec, the sign post deformed to approximately a 90-degree angle, and the sign panel traveled along with the vehicle with the sign post wrapped around the vehicle's front nose. At this same time, the ends of the horizontal crossbrace contacted the vehicle. At 0.045 sec, the top of the sign post impacted the center of the windshield as the sign panel rested across the vehicle's hood. At 0.057 sec, the bottom of the sign post rotated upward and was no longer under the front of the vehicle. At 0.075 sec, the sign post continued to rotate about the windshield contact point. At this same time, the anchor portion of the stand was perpendicular to the ground. At 0.109 sec, the sign post was

embedded in the windshield and was positioned nearly parallel to the ground except for the fractured anchor portion. At this same time, the sign post continued to rotate upward. The self-driving sign post support came to rest 49.68 m-downstream from the original position. The sign panel was located 47.24-m downstream from the initial position. The vehicle subsequently came to rest 112.17-m downstream from the midpoint of the impact point and 7.62-m left from the centerline of the vehicle's original path. The final positions of the vehicle and the sign support are shown in Figures 12 and 15.

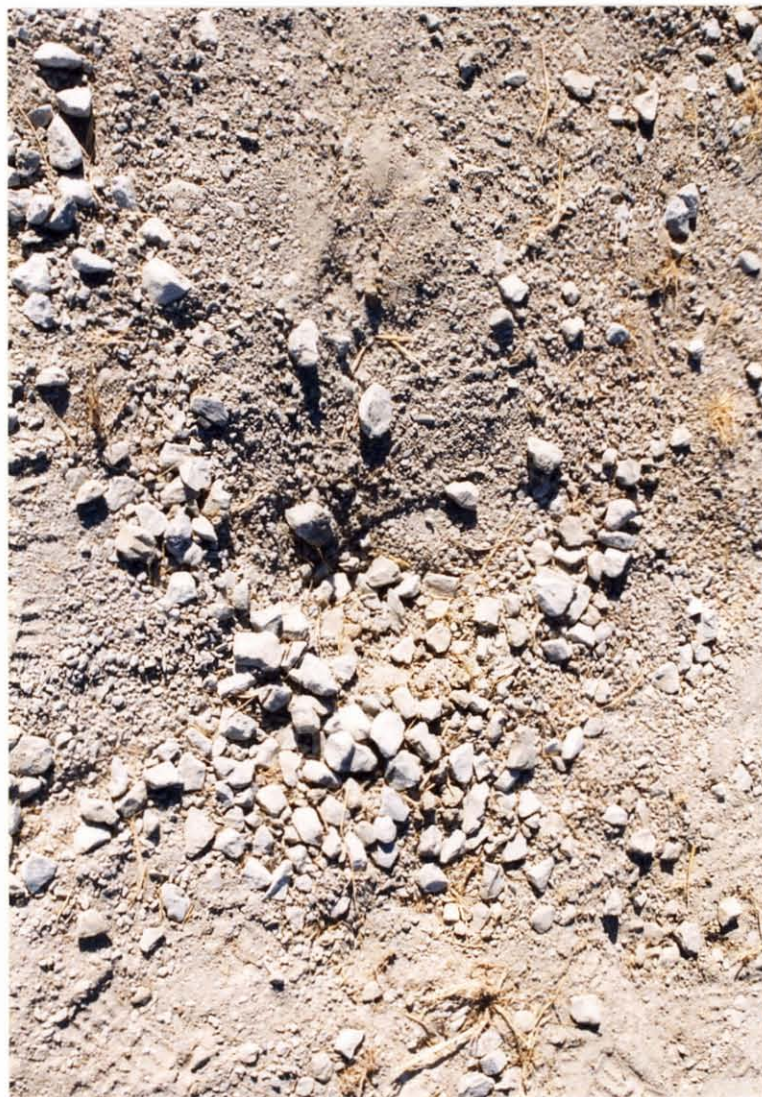
Figure 16. Final Soil Conditions at Embedment Point, Test M-1

Damage to System No. 1 is shown in Figures 15 through 18. System No. 1 encountered moderate damage. The sign panel was removed from the horizontal and vertical crossbraces, except for the top of the vertical crossbrace. The velcro straps were removed from the sign support and the sign panel. The self-driving sign post fractured above the bottom sign panel bracket. The self-driving sign post also pulled completely out of the ground. The vinyl sign panel and the fiberglass crossbraces remained undamaged.

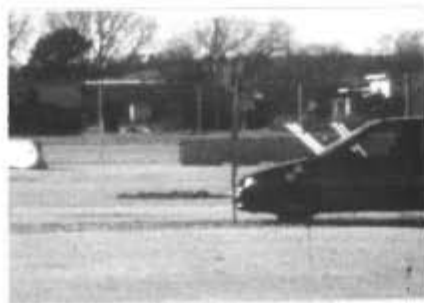
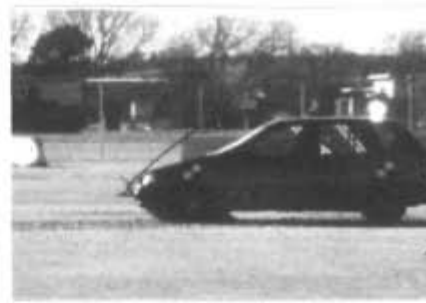
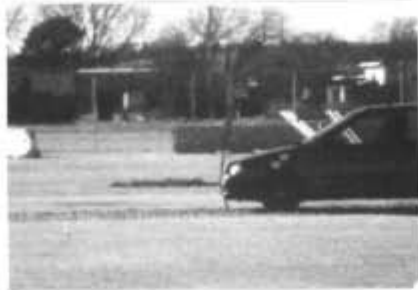
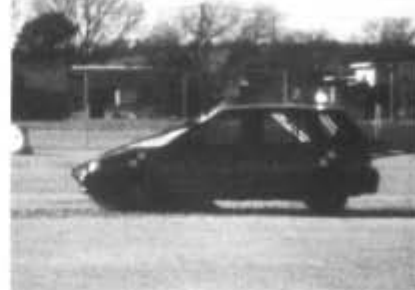
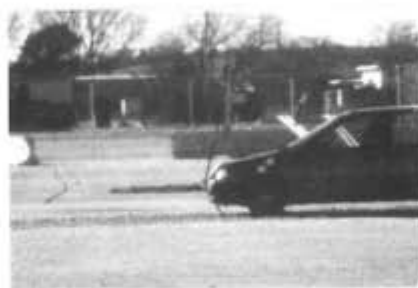
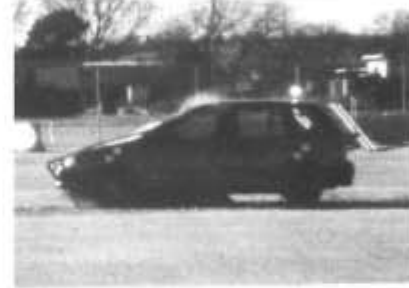
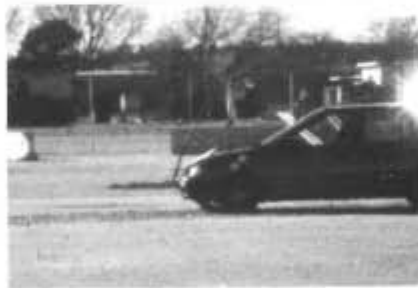
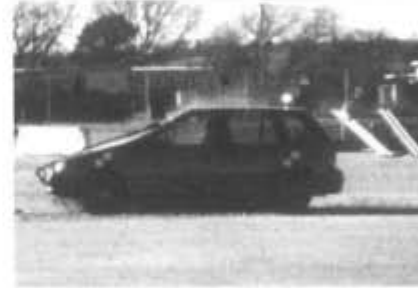
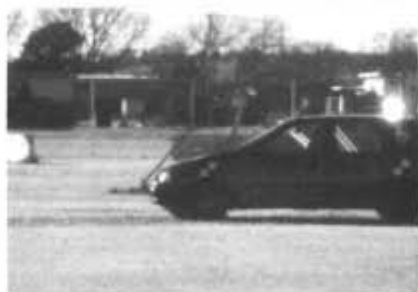
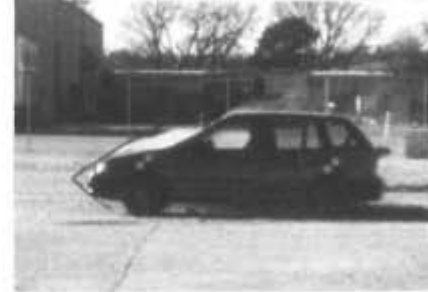
Figure 22. Additional Sequential Photographs, Test M-2

panel rebounded off of the windshield with the sign panel still positioned in the bottom sign bracket. The self-driving sign post came to rest 69.80-m downstream and 1.52-m left from the original position. The sign panel was located 22.86-m downstream and 11.58-m left from the initial position. The vehicle subsequently came to rest 51.82-m downstream from the midpoint of the impact point and 0.0-m laterally from the centerline of the vehicle's original path. The final positions of the vehicle and the sign support are shown in Figures 21 and 24.

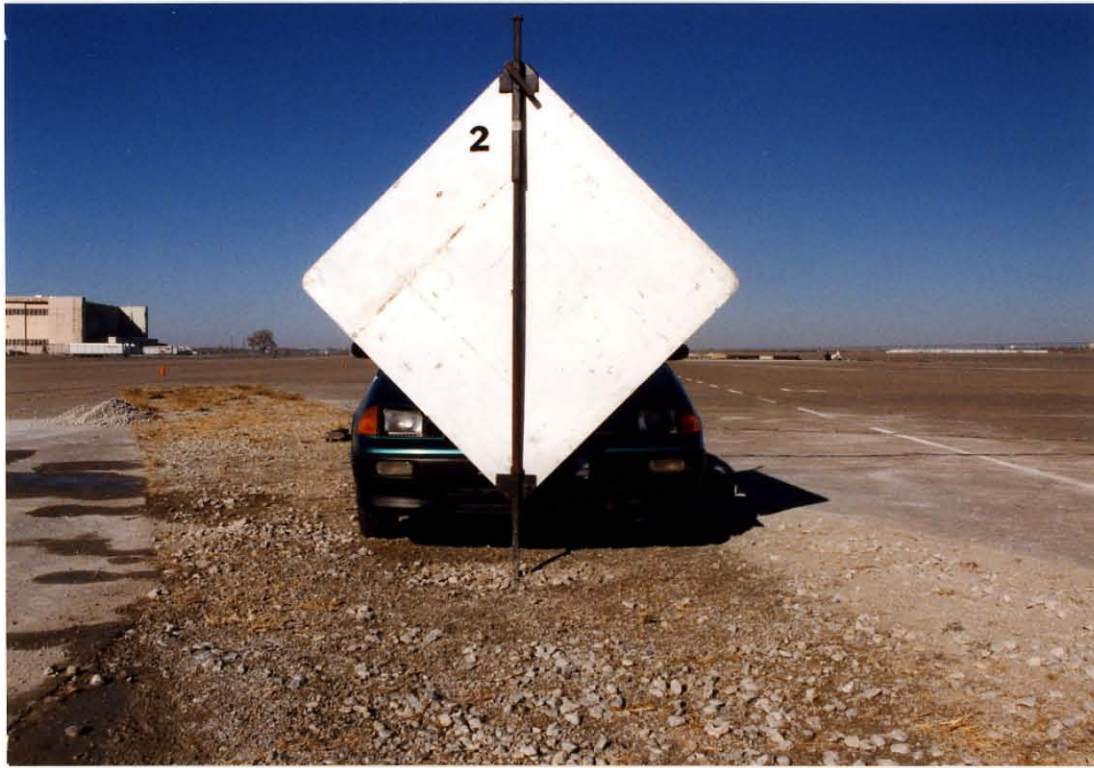
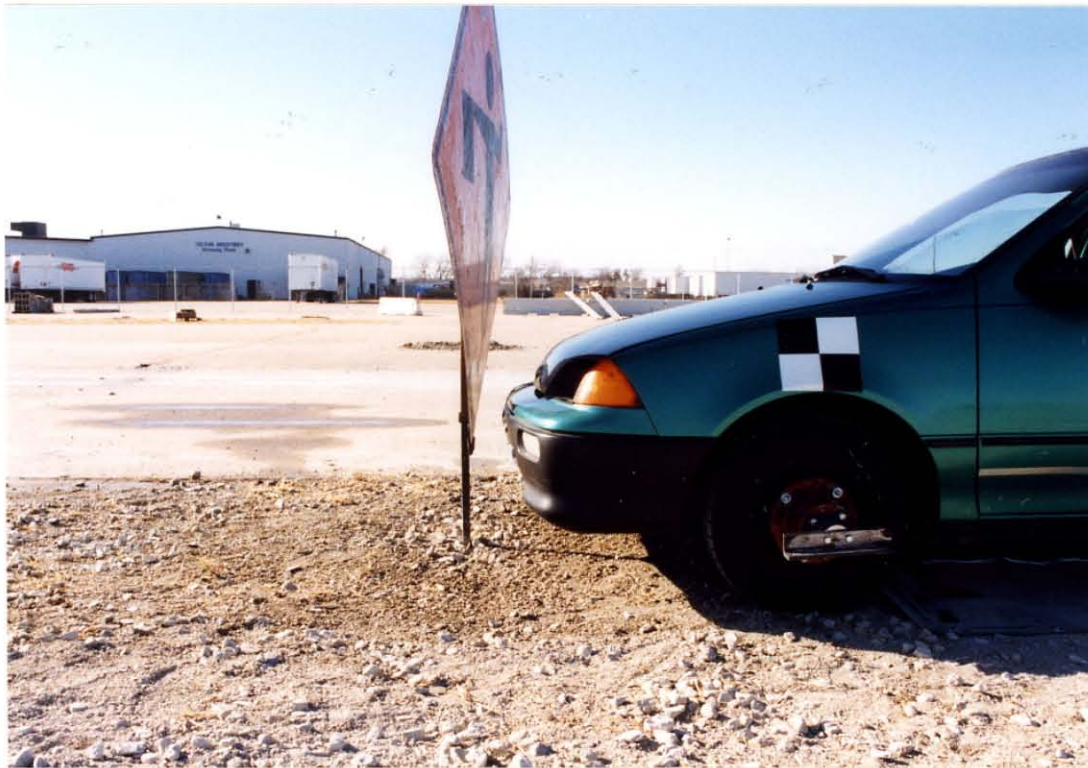
Figure 23. Impact Locations, Test M-2

The test vehicle impacted System No. 2 with the centerline point of the vehicle's bumper aligned with the centerline of the sign support, as shown in Figure 23. At 0.004 sec after initial impact, the sign post deformed around the front nose of the vehicle. At this same time, the sign panel flexed away from the sign post. At 0.010 sec, the sign post continued to deform about the front nose of the vehicle. At this same time, the top of the sign post and the sign panel rotated toward the vehicle about the contact point with the vehicle. At 0.022 sec, the embedded anchor pulled completely out of the ground. At 0.036 sec, the bottom of the sign post deformed to nearly a 90-degree angle as the top of the sign post and the sign panel continued to rotate toward the vehicle. At this same time, the sign panel released from the top sign bracket. At 0.048 sec, the sign panel impacted and fractured the windshield. At this same time, the sign post was positioned nearly parallel with the windshield. At 0.065 sec, the top of the sign post impacted the center of the sign panel which was resting on the windshield, thus causing additional glass to fracture off of the windshield. At 0.083 sec, the sign panel deformed and rested on the windshield. At this same time, the sign post rested across the hood and the windshield. At 0.111 sec, the top of the sign post rebounded off of the vehicle's front end with the bottom portion of the sign post deformed to a 90-degree angle. At 0.176 sec, the sign post rotated away from the vehicle. At this same time, the sign

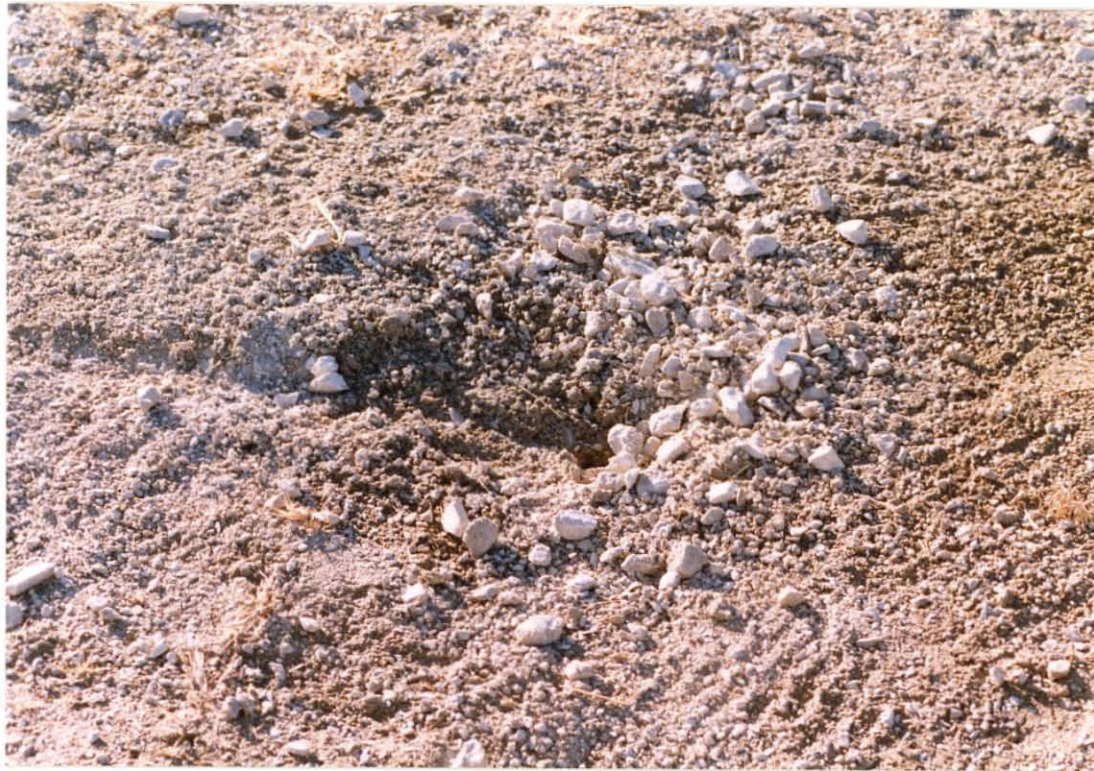
Figure 25. Final Soil Conditions at Embedment Point, Test M-2

Damage to System No. 2 is shown in Figures 24 through 26. System No. 2 encountered moderate damage. The aluminum sign panel encountered slight deformations. Light scuff marks were found on the front side of the sign panel. The sign panel also disengaged from the sign panel locking brackets. The self-driving sign post fractured above the bottom sign panel bracket. The self-driving sign post also pulled completely out of the ground.

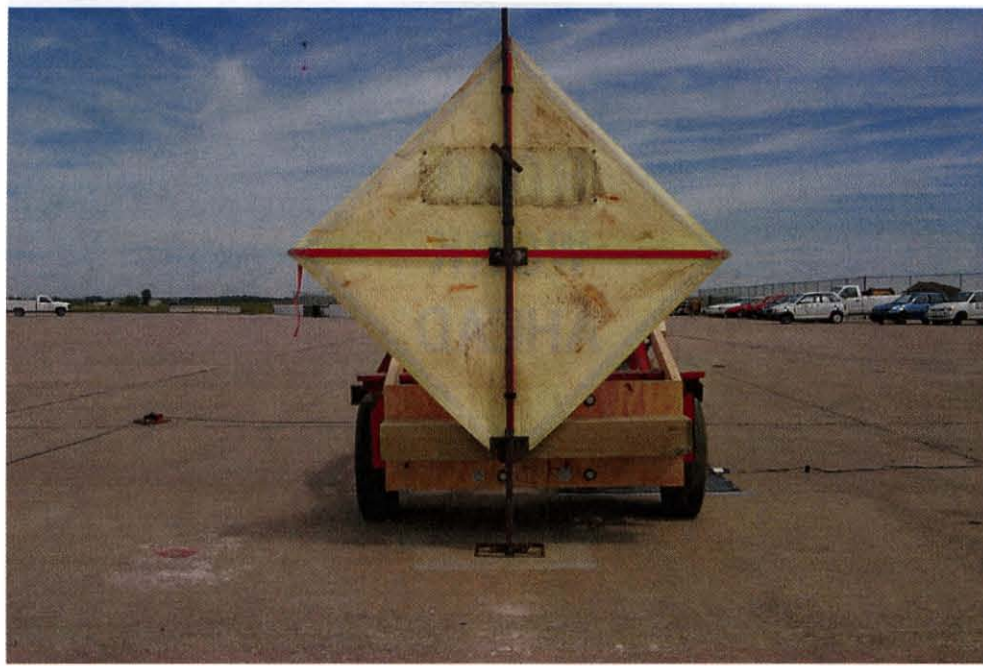
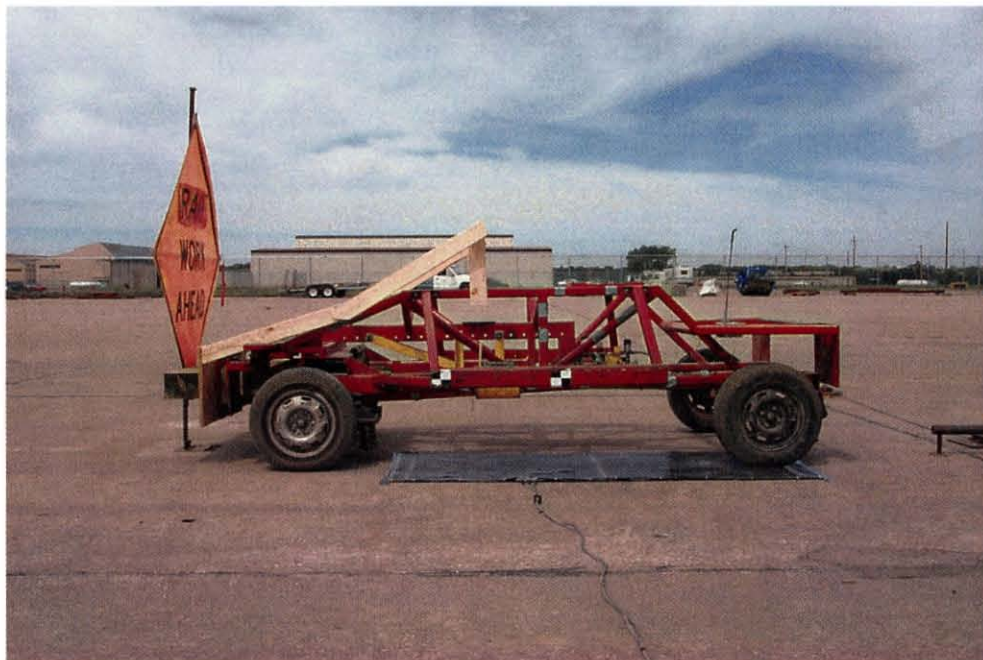
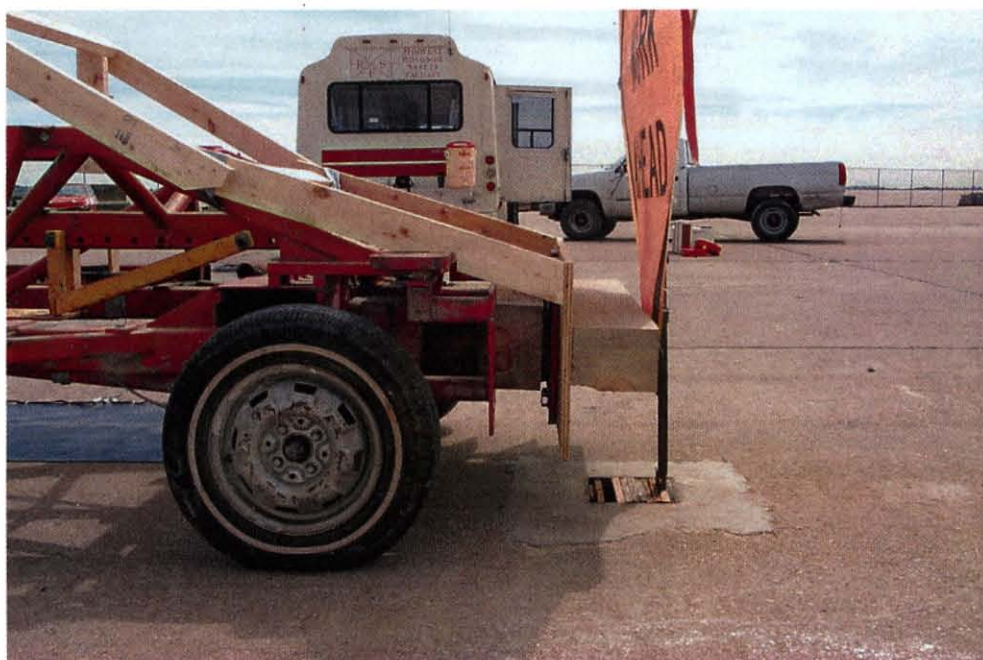
Figure 35. Impact Location, Bogie Test MOBOG1

The bogie vehicle impacted the modified system with the centerline point of the vehicle’s bumper aligned with the centerline of the sign support, as shown in Figure 35. At 0.006 sec initial impact, the sign post deformed around the bumper while the top of the sign post remained perpendicular to the ground. At 0.008 sec, the sign post continued to deform around the bumper, and the top of the sign post dropped down due to the deformation of the sign post. At 0.016 sec, the top of the sign post and sign panel rotated toward the simulated windshield. At this same time, the lower portion of the sign post rotated away from the bogie toward the ground. At 0.028 sec, the sign panel flexed toward the bogie windshield frame while the sign post partially fractured at the stress concentration points. At 0.040 sec, the sign post began to pull out of the fixed base with the lower section of the sign post parallel to the ground. At this same time, the sign panel flexed toward the
