Phase IV Development of a Short-Radius Guardrail for Intersecting Roadways

MwRSF Research Report No. TRP-03-199-08

February 29, 2008

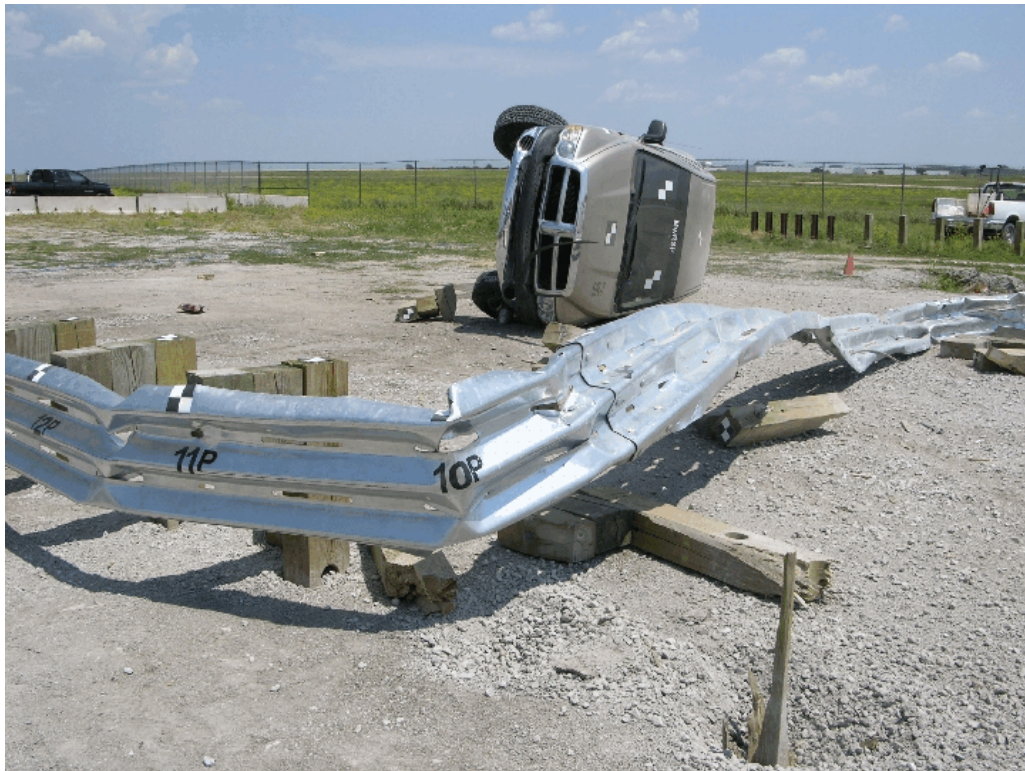
Figure 44. System Damage, Test SR-7

Barrier damage was extensive, as shown in Figures 43 through 58. Damage consisted mostly of fractured posts, fractured blockouts, damaged cable anchor hardware, and flattened and deformed guardrail.

Post nos. 1P, 1S and 2S fractured at the foundation tubes. The foundation tube at post no. 2S was dented and bent along the bolt centerline. Post nos. 2P through 10P fractured and disengaged from the rest of the system. Post no. 11P rotated backwards in the soil and cracked at the groundline. Post nos. 12P and 13P rotated backwards in the soil. Post nos. 1S and 2S fractured in the foundation tubes and were disengaged from the rest of the system. Post nos. 3S through 8S fractured at ground level and disengaged from the rest of the system. Post no. 9S rotated backwards in the soil and cracked through the transverse CRT hole, but remained in the ground.

The blockouts at post nos. 2P through 10P deformed and were damaged around the bolt holes. The blockout at post no. 11P twisted on the bolt and the front face was deformed. The blockout at post no. 9S was compressed on the traffic-side face and the upstream top edge of the traffic face was chipped.

Contact marks were found between the nose section of the rail and post no. 8P. The guardrail was flattened and deformed between post nos. 5P and 3S. Rail buckling was observed in the nose section and between post nos. 1P through 13P and 1S through 8S. The post bolts pulled through the

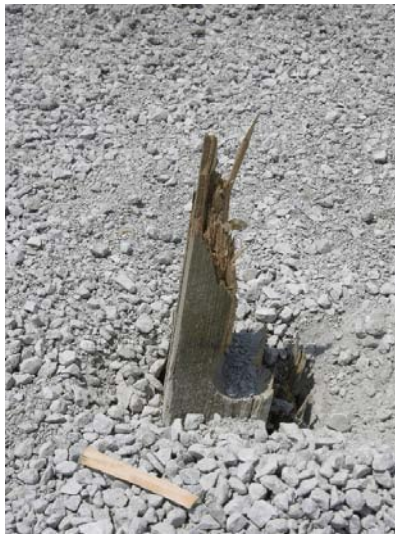
Figure 51. Post Nos. 6S through 8S Damage, Test SR-7

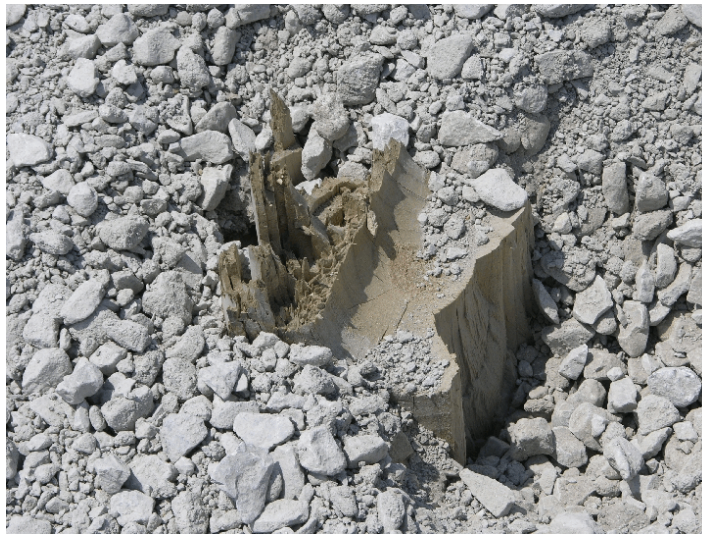
Figure 52. Post Nos. 3S through 5S Damage, Test SR-7

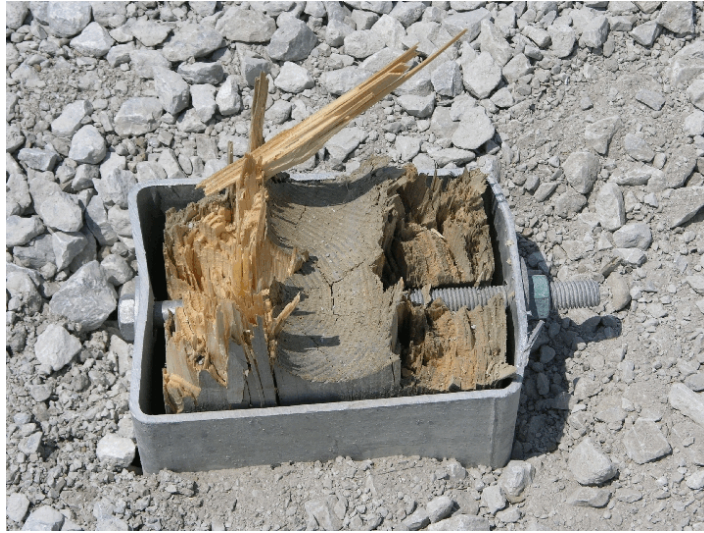
Figure 53. Post Nos. 1P, 1S and 2S Damage, Test SR-7

- (2) Post no. 1S did not fracture completely during the crash test. The poor release of the cable at post no. 1S allowed the cable to propel a broken section of post no. 1S under the wheels of the vehicle, adding to the debris under the wheels and the instability of the vehicle.

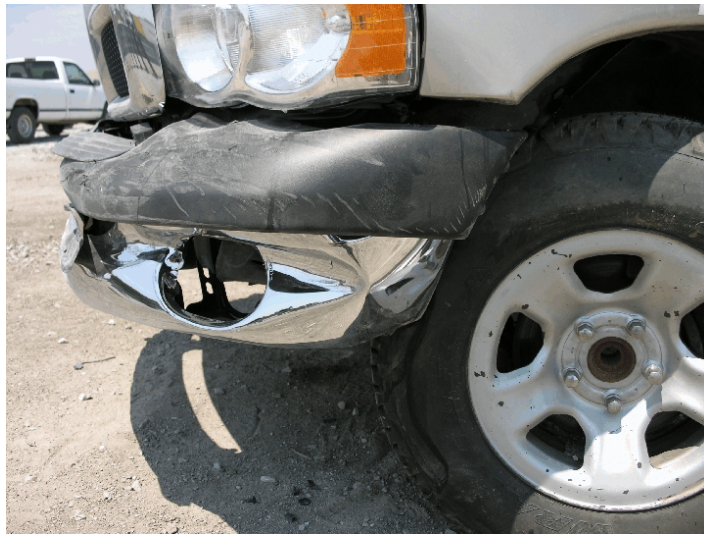
Figure 59. Vehicle Damage, Test SR-7

Exterior vehicle damage was moderate, as shown in Figures 59 through 62. Occupant compartment deformations to the right side and center of the floorboard were judged insufficient to cause serious injury to the vehicle occupants. A maximum longitudinal deflection of 13 mm (0.5 in.) was located in the right-front corner of the right-side floor pan. A maximum lateral deflection of 13 mm (0.5 in.) was located at the center of the right side of the right-side floor pan. Maximum vertical deflections of 6 mm (0.25 in.) were located throughout the right-side floor pan. Complete occupant compartment deformations and the corresponding locations are provided in Appendix C.

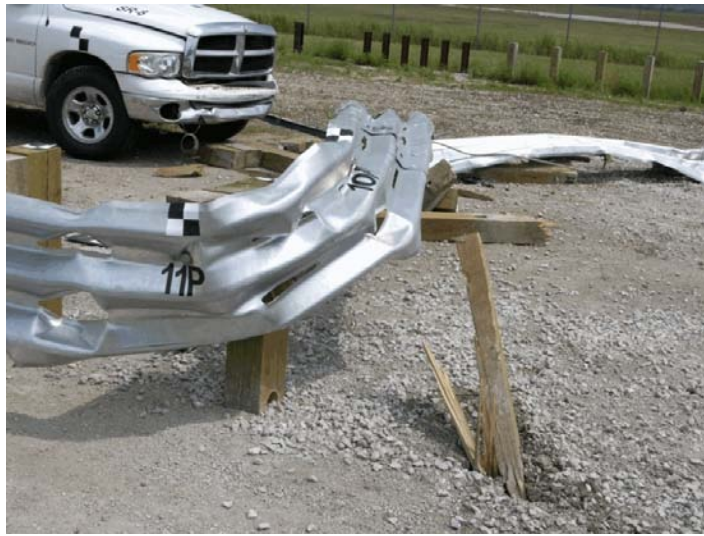
Figure 85. System Damage, Test SR-8

Barrier damage was extensive, as shown in Figures 85 through 93. Damage consisted mostly of flattened, deformed and torn guardrail, fractured posts, blockouts, and bolts, and deformed cable anchor hardware. System damage occurred between post nos. 8S and post no. 11P. The maximum permanent set of the guardrail was 6,518 mm (21 ft - 4.5 in.) from the primary side and 8,448 mm (27 ft - 9 in.) from the secondary side, measured to the center of the nose.

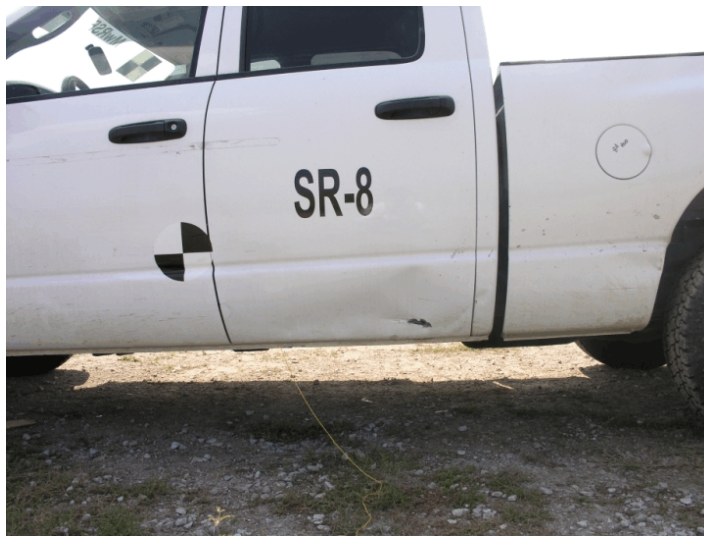
Figure 94. Vehicle Damage, Test SR-8

Exterior vehicle damage was minimal, as shown in Figures 94 through 96. Occupant compartment deformations to the right side and front of the floorboard were deemed insufficient to cause injury to the vehicle occupants. Maximum longitudinal displacements of 6 mm (0.25 in.) occurred throughout the right side of the floorboard. Maximum lateral displacements of 19 mm (0.75 in.) occurred at the left-front corner of the right-side floorboard. Maximum vertical displacements of 6 mm (0.25 in.) were located throughout the right-side floorpan. Complete occupant compartment deformations and the corresponding locations are provided in Appendix G.
