Midwest States' Regional Pooled Fund Research Program

UNIVERSAL BREAKAWAY STEEL POST FOR OTHER APPLICATIONS

MIDWEST ROADSIDE SAFETY FACILITY

MwRSF Research Report No. TRP-03-288-14

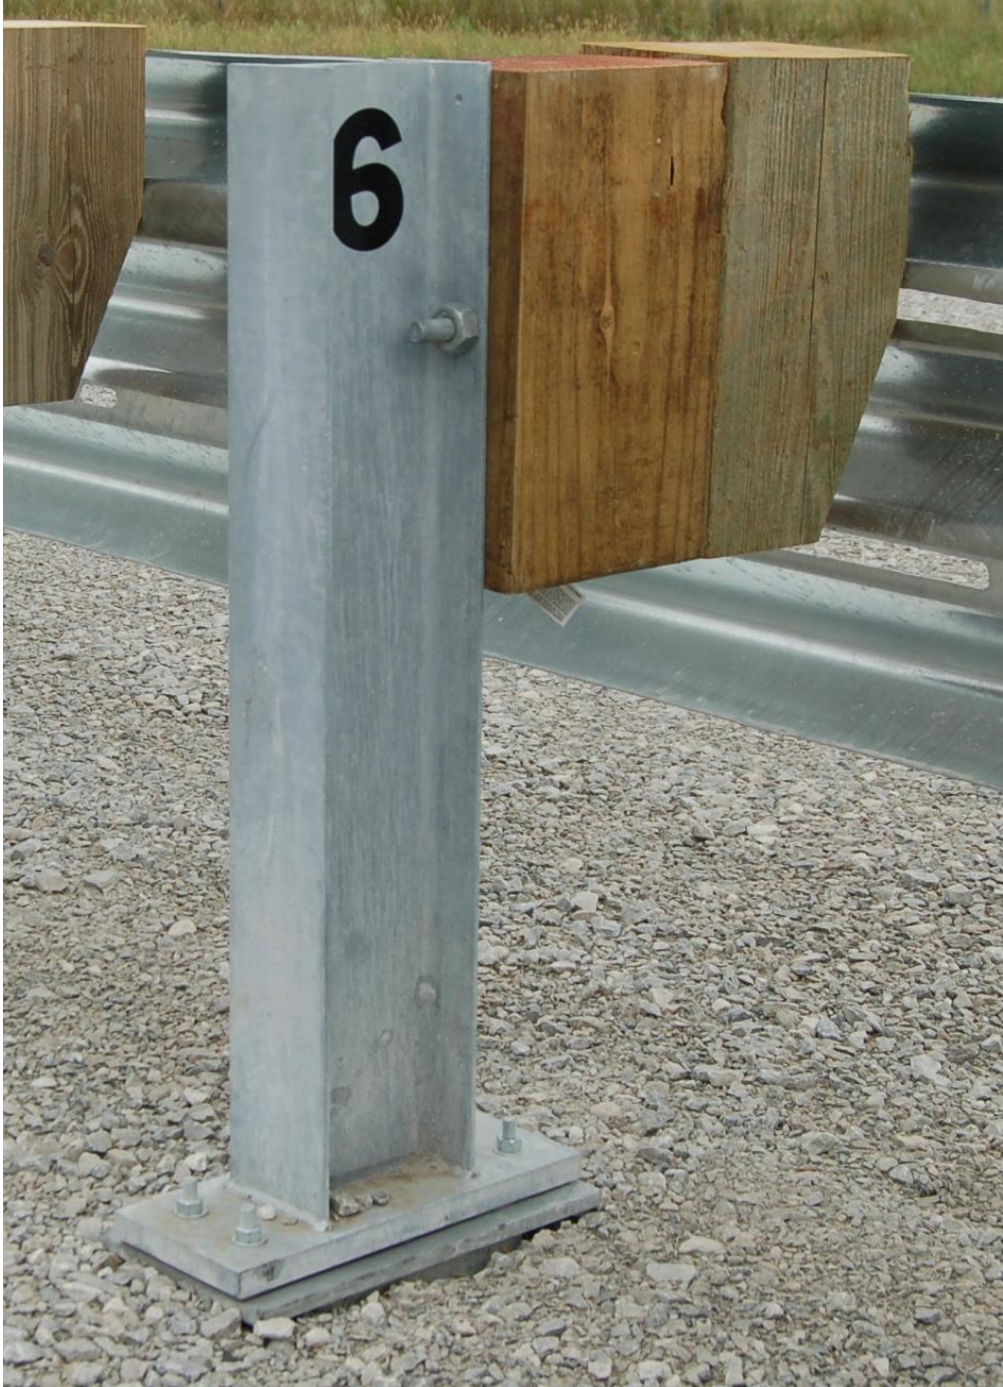
Figure 1. UBSP Installed in the Thrie Beam Bullnose

In order to address this need, MwRSF developed the Universal Breakaway Steel Post (UBSP) to replace the CRT wood posts in the three beam bullnose system [6-9]. The design goal of the new, non-proprietary, UBSP was to mimic the strength and behavior of the wooden CRT post. The UBSP, as shown in Figure 1, consisted of a W6x9 (W152x13.4) steel post top section, which was the standard steel section used in strong-post guardrail, and a 6-in. x 8-in. x $\frac{3}{16}$ -in.

(152-mm x 203-mm x 5-mm) steel tube bottom section. The bottom section was designed with the same cross-section size as the CRT post to ensure similar post-soil resistive forces. The two post sections were welded to base plates and connected by four $\frac{7}{16}$ -in. (11-mm) diameter, ASTM A325 bolts. The new post design released through fracturing the four vertical bolts connecting the top and bottom halves of the post. Different strong- and weak-axis capacities were generated by the spacing of the bolts in the base plates.

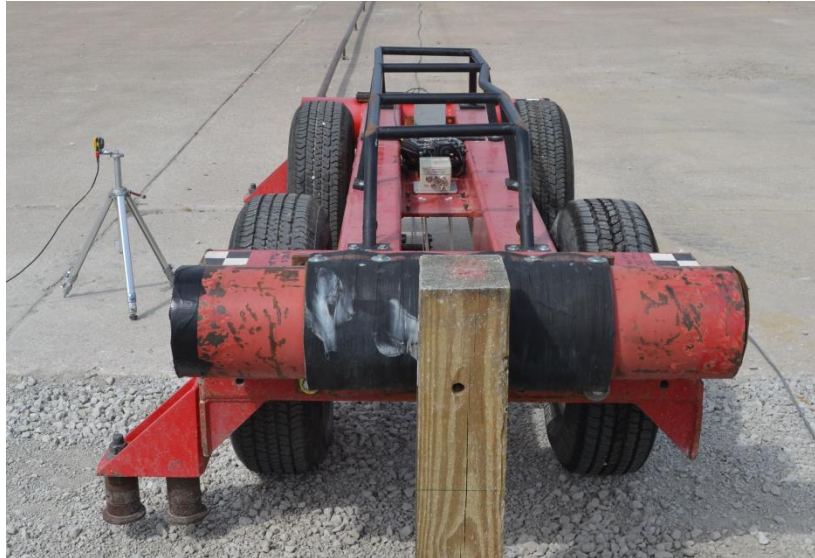
Figure 2. Rigid Frame Bogie and Guidance Track

A rigid-frame bogie was used to impact the posts. A variable-height, detachable impact head was used in the testing. The bogie head was constructed of 8-in. (203-mm) diameter, 1/2-in. (13-mm) thick standard steel pipe, with 3/4-in. (19-mm) neoprene belting wrapped around the pipe to prevent local damage to the post from the impact. The impact head was bolted to the bogie vehicle, creating a rigid frame with an impact height of 24⁷/₈ in. (632 mm). The bogie with the impact head is shown in Figure 2. The weight of the bogie with the addition of the mountable impact head and accelerometers was 1,875 lb (850 kg).

A pickup truck with a reverse cable tow system was used to propel the bogie to a target impact speed of 20 mph (32 km/h). When the bogie approached the end of the guidance system, it was released from the tow cable, allowing it to be free rolling when it impacted the post. A remote braking system was installed on the bogie allowing it to be brought safely to rest after the test.

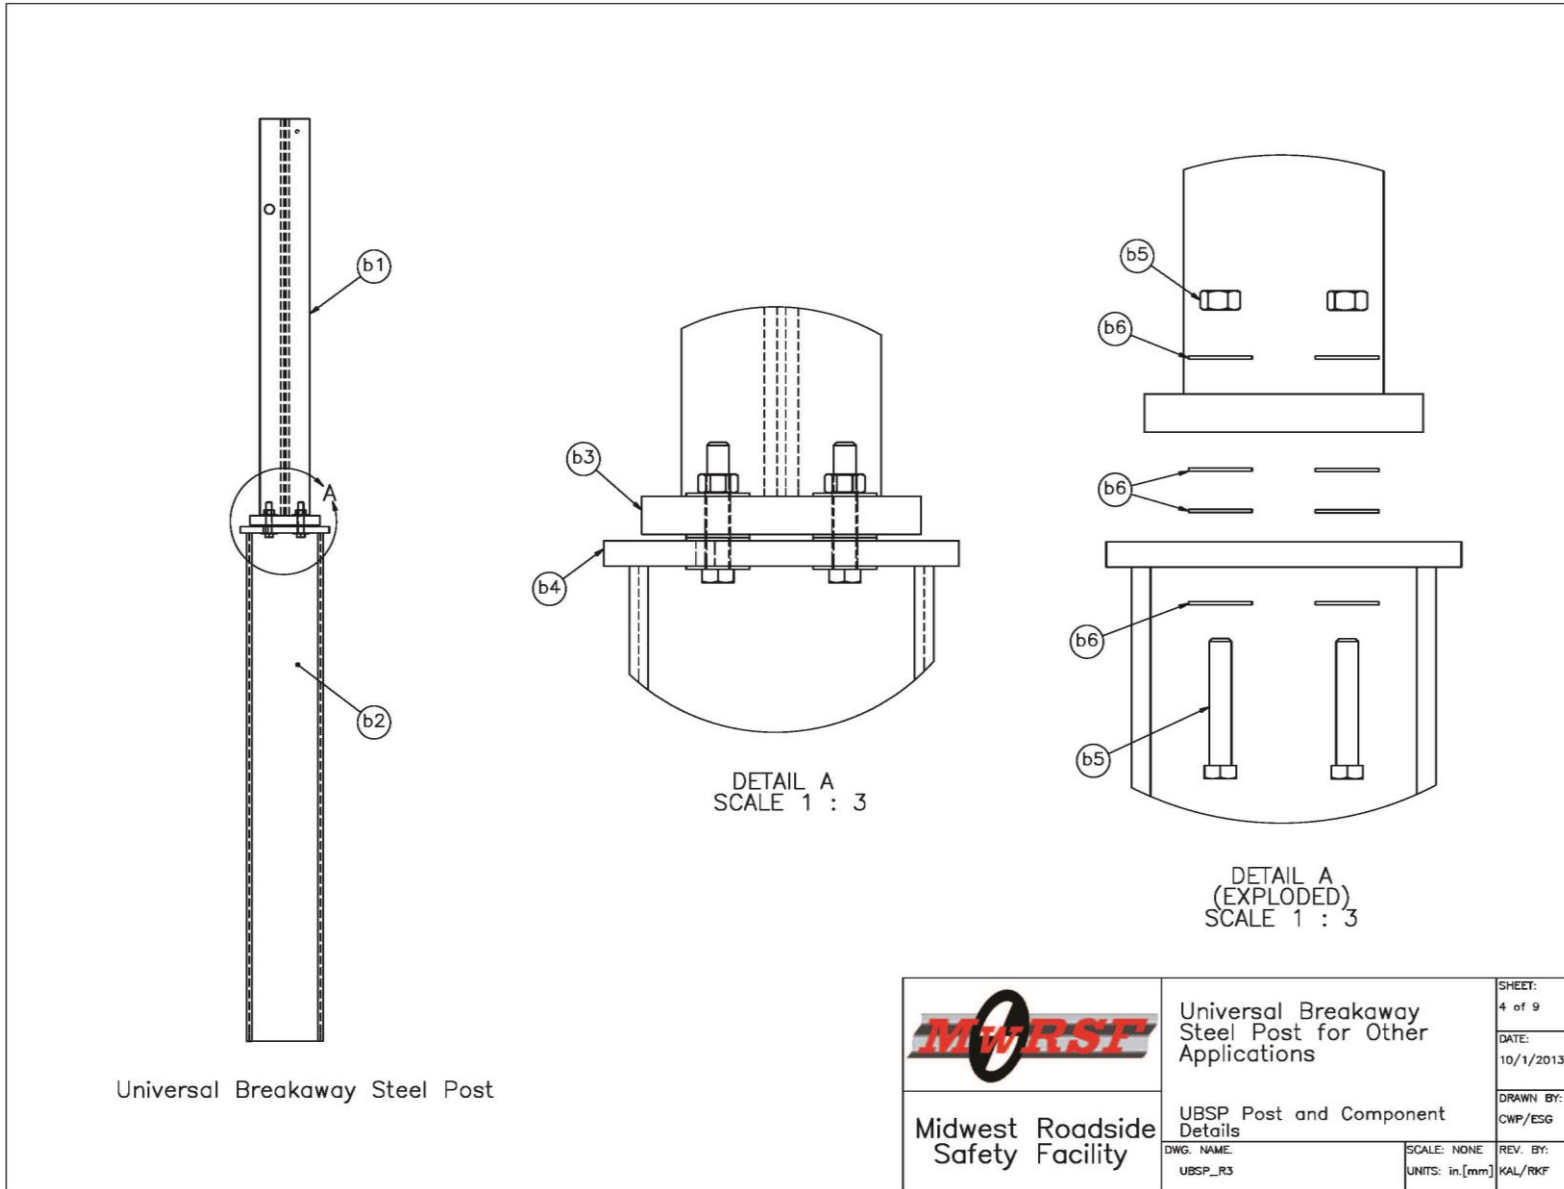
Figure 6. Breakaway Steel Post Details

The UBSP was comprised of an upper W6x9 (W152x13.4) beam which was connected to the lower 6-in. x 8-in. (152-mm x 203-mm) foundation tube. A ¾-in. (19-mm) thick steel plate was rigidly welded to the bottom of the W6x9 (W152x13.4) beam and a ½-in. (13-mm) thick steel plate was rigidly welded to the top of the foundation tube. Four breakaway steel bolts, four nuts and sixteen washers were used to connect the two different components as shown in Figure 6. It should be noted that the testing detailed herein used F844 standard washers for the four washers located at each of the bolts connecting the top and bottom halves of the UBSP. Previous component testing and full-scale crash testing have demonstrated that F844 and F436 washers both perform acceptably when used in the UBSP.

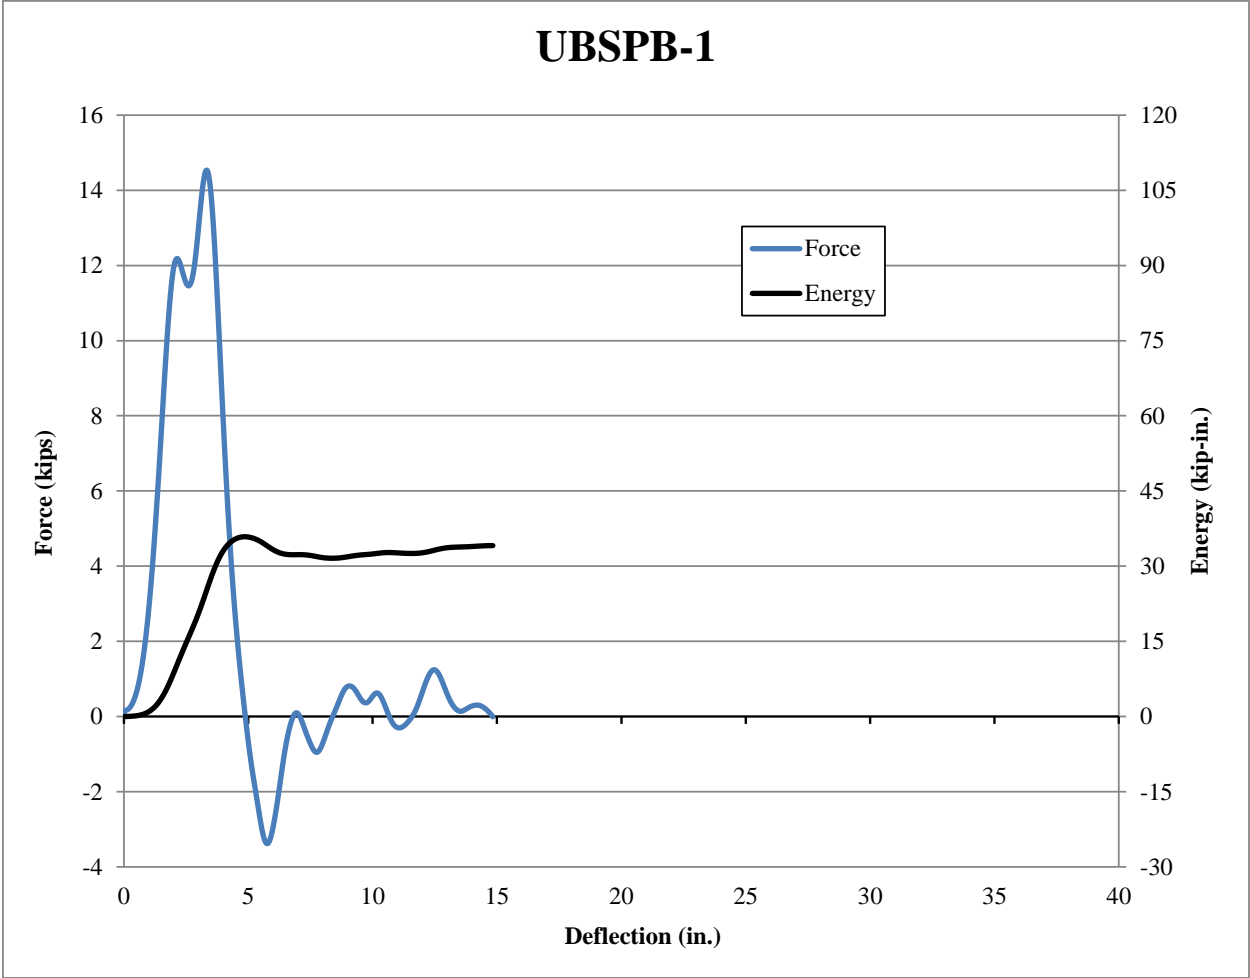
Figure 11. Force vs. Deflection and Energy vs. Deflection, Test No. UBSPB-1

Force vs. deflection and energy vs. deflection curves created from the SLICE accelerometer data are shown in Figure 11. The post reached a peak force of 14.5 kips (64.5 kN) at 3.3 in. (84 mm) of deflection. At this point, the post began to fracture, and the resistive forces rapidly declined. By the completion of fracture, the post absorbed 35.9 kip-in. (4.1 kJ) of energy at a deflection of 4.9 in. (124 mm). A pre-test photograph is shown in Figure 12. Time-sequential and post-impact photographs are shown in Figure 13.

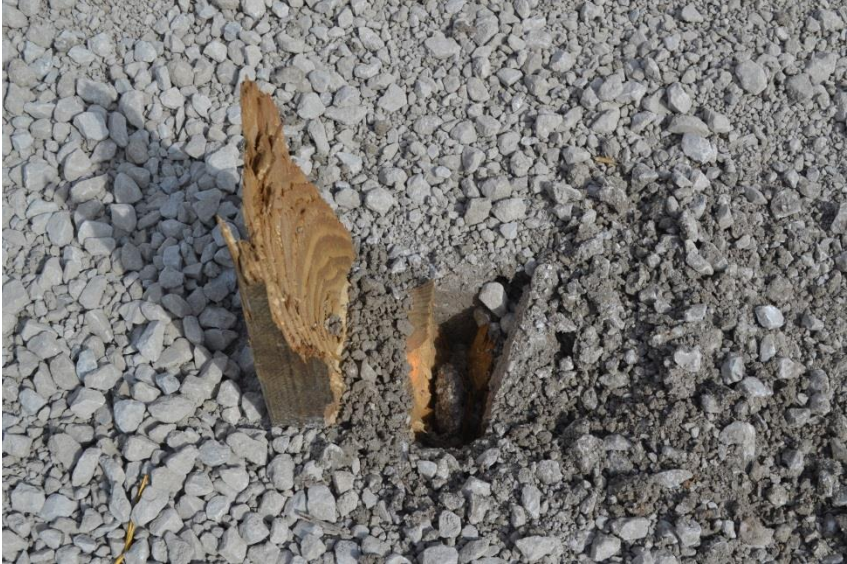
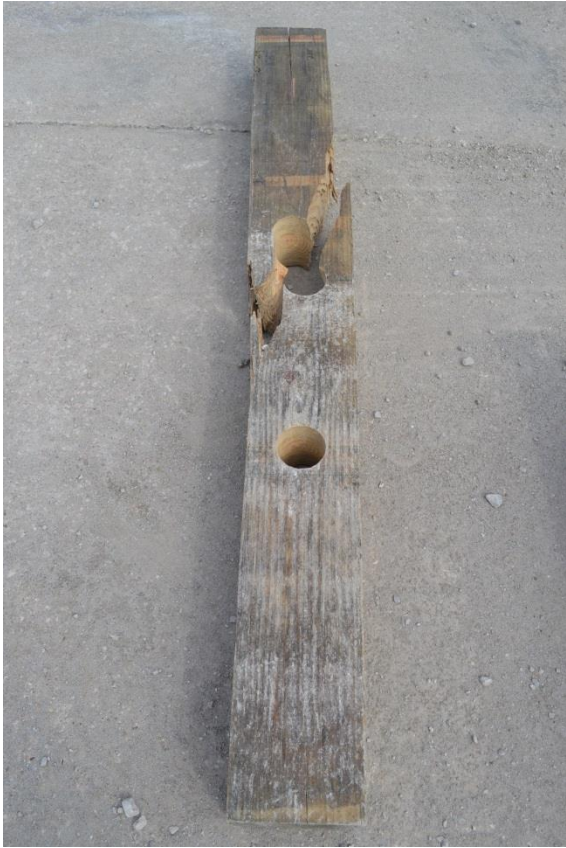
Figure 13. Time-Sequential and Post-Impact Photographs, Test No. UBSPB-1

During test no. UBSPB-1, the bogie impacted the CRT wood post, which created strong-axis bending a speed of 21.1 mph (34.0 km/h). Initially, the post began to rotate backward. However, by 8 ms, the post began to fracture. The top of the post continued to rotate backward until the bogie overrode it. Upon post-test examination, the post was found to have fractured through the hole at ground level.

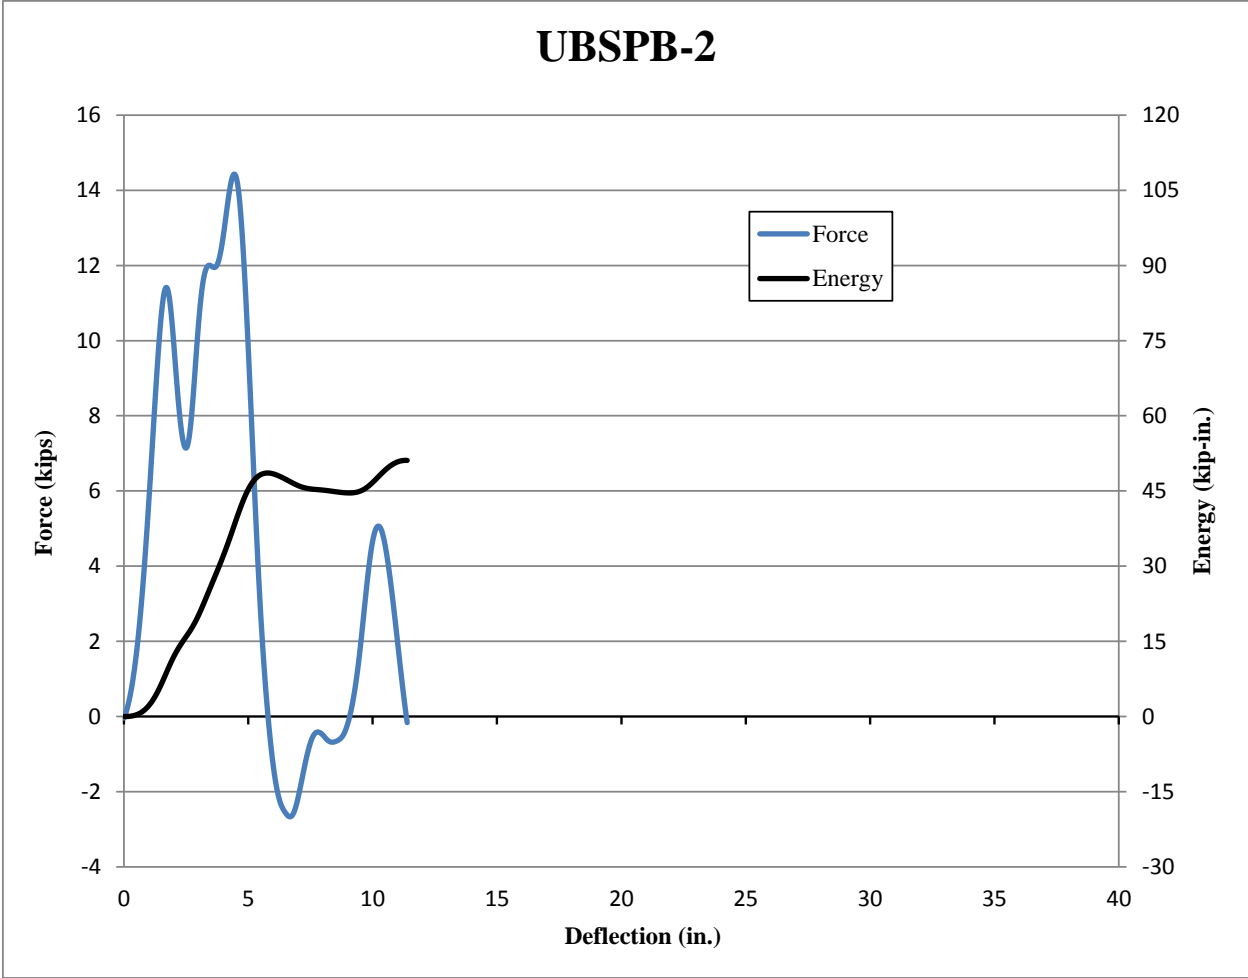
Figure 14. Force vs. Deflection and Energy vs. Deflection, Test No. UBSPB-2

Force vs. deflection and energy vs. deflection curves created from the SLICE accelerometer data are shown in Figure 14. The post reached a peak force of 14.4 kips (64.1 kN) at 4.4 in. (112 mm) of deflection. Due to fracture of the post, the force quickly dropped to zero as the bogie lost contact with the post momentarily, followed by a second force spike. By the completion of fracture at a deflection of 11.4 in. (290 mm), the post absorbed 48.6 kip-in. (5.5 kJ) of energy. A pre-test photograph is shown in Figure 15. Time-sequential and post-impact photographs are shown in Figure 16.

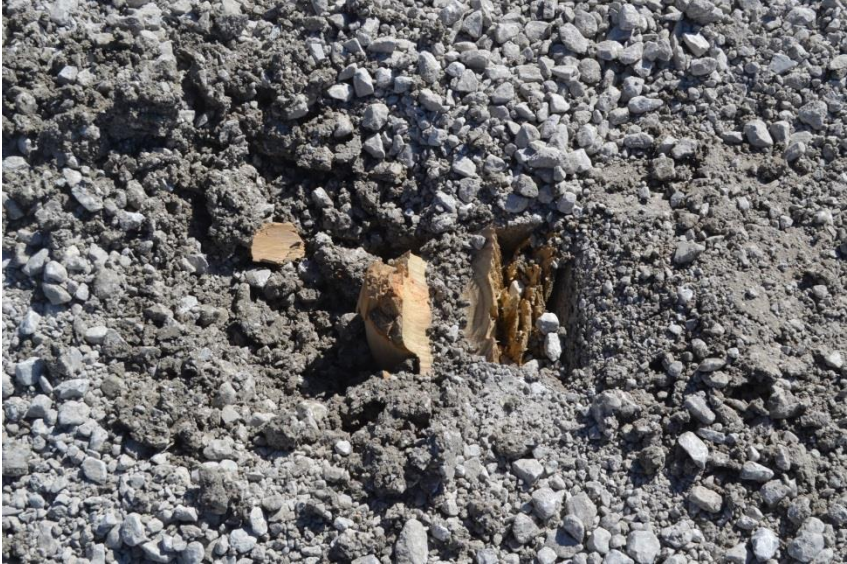
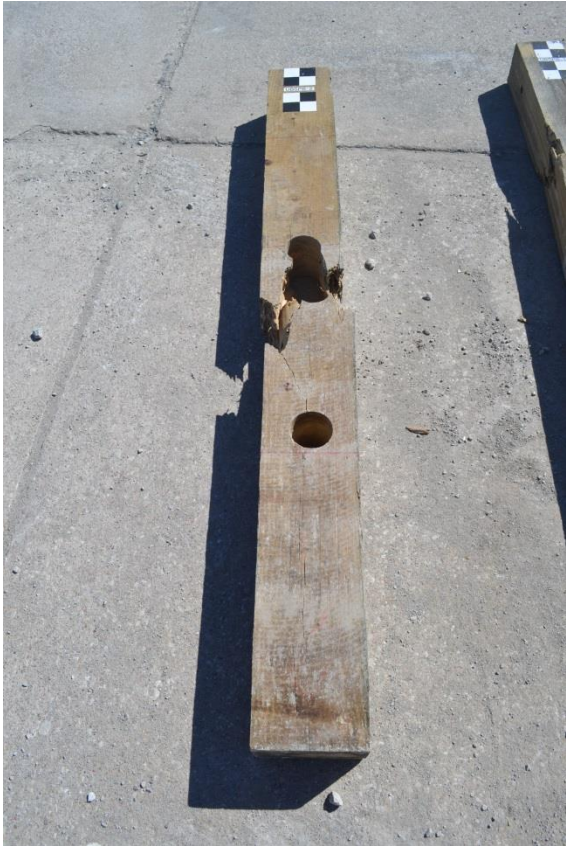
Figure 16. Time-Sequential and Post-Impact Photographs, Test No. UBSPB-2

During test no. UBSPB-2, the bogie impacted the CRT wood post, which created strong-axis bending at a speed of 21.2 mph (34.1 km/h). Initially, the post began to rotate backward. However, by 13 ms, the post began to fracture. The top of the post continued to rotate backward until the bogie lost contact with it and overrode it. Upon post-test examination, the post fractured through the hole at ground level.

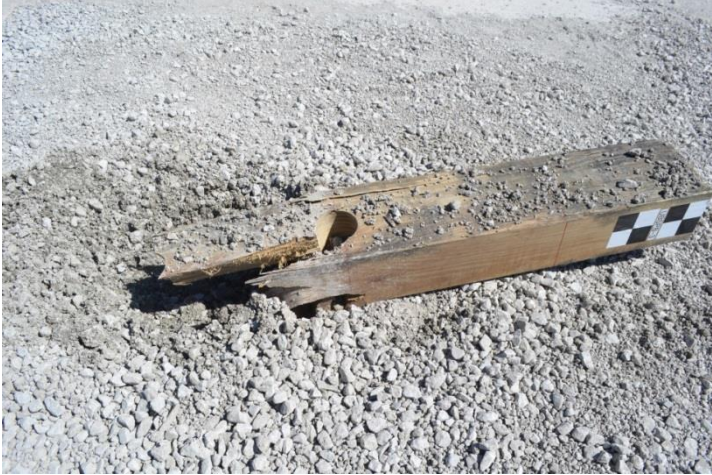
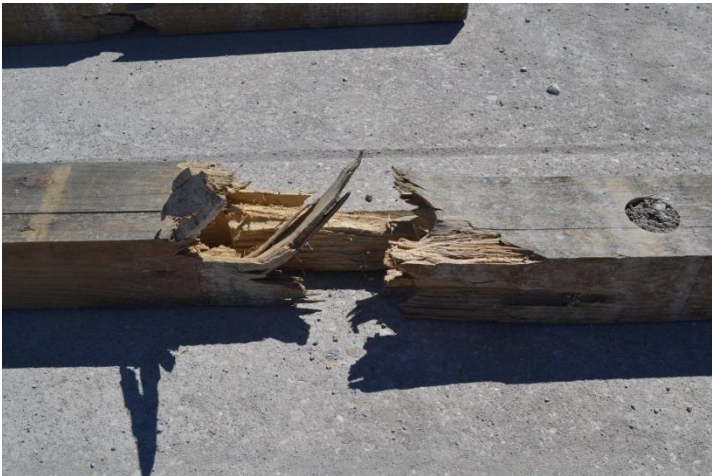
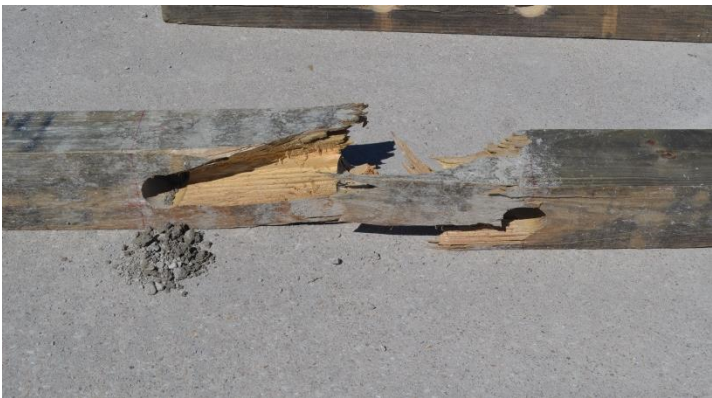
Figure 19. Time-Sequential and Post-Impact Photographs, Test No. UBSPB-3

During test no. UBSPB-3, the bogie impacted the CRT wood post, which created weak-axis bending at a speed of 20.0 mph (32.2 km/h). Initially, the post began to rotate backward. However, by 20 ms, the post began to fracture. The top of the post continued to rotate backward until the bogie lost contact with it and overrode it at 120 ms. Upon post-test examination, the post was found to have fractured along a diagonal line extending from the lower CRT hole on the back side of the post to the upper CRT hole on the impact side of the post.

Force vs. deflection and energy vs. deflection curves created from the SLICE accelerometer data are shown in Figure 17. The post reached a peak force of 11.1 kips (49.4 kN) at 1.7 in. (43 mm) of deflection. Around 7 in. (178 mm) of deflection, the force quickly dropped and then gradually decreased to zero. At a deflection of 36.4 in. (925 mm), the post absorbed 101.8 kip-in. (11.5 kJ) of energy. A pre-test photograph is shown in Figure 18. Time-sequential and post-impact photographs are shown in Figure 19.

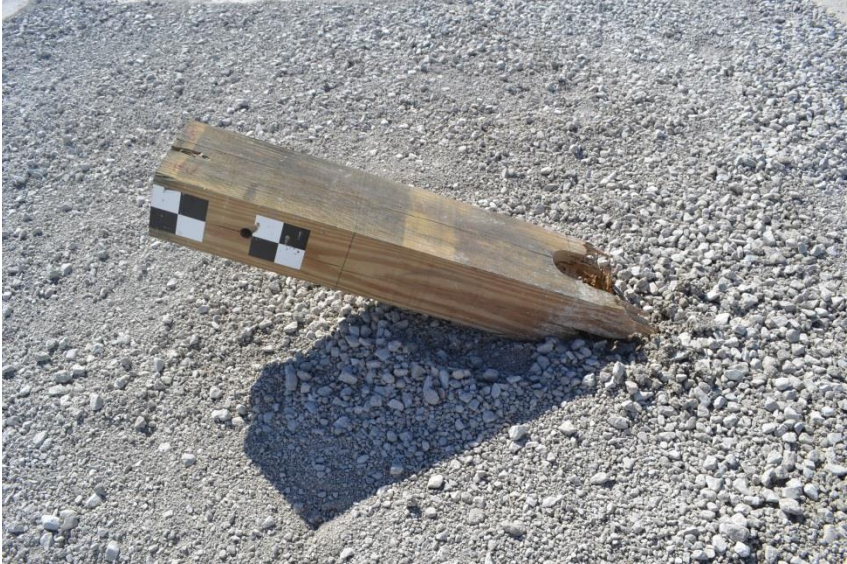
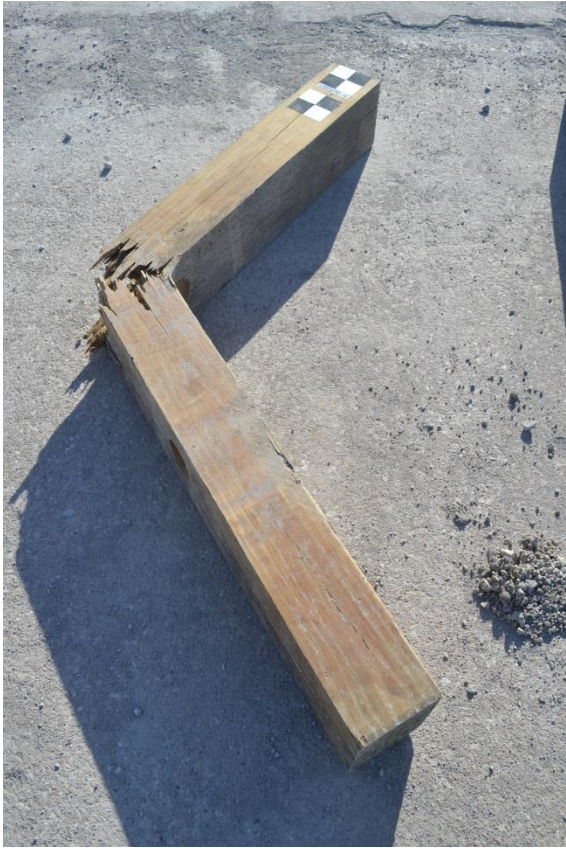
Figure 22. Time-Sequential and Post-Impact Photographs, Test No. UBSPB-4

During test no. UBSPB-4, the bogie impacted the CRT wood post, which created weak-axis bending at a speed of 20.9 mph (33.6 km/h). Initially, the post began to rotate backward. However, by 13 ms, the post began to fracture. The top of the post continued to rotate backward until the bogie lost contact with it at 54 ms. Upon post-test examination, the post fractured on the front face through the hole at ground level, but it did not fracture completely through the post and remained attached on the backside.

Force vs. deflection and energy vs. deflection curves created from the SLICE accelerometer data are shown in Figure 20. The post reached a peak force of 10.8 kips (48.0 kN) at 1.6 in. (41 mm) of deflection. Around 5 in. (127 mm) of deflection, the force quickly dropped and then gradually decreased to zero at the end of the impact event. At a deflection of 18.3 in. (465 mm), the post absorbed 54.3 kip-in. (6.1 kJ) of energy. A pre-test photograph is shown in Figure 21. Time-sequential and post-impact photographs are shown in Figure 22.

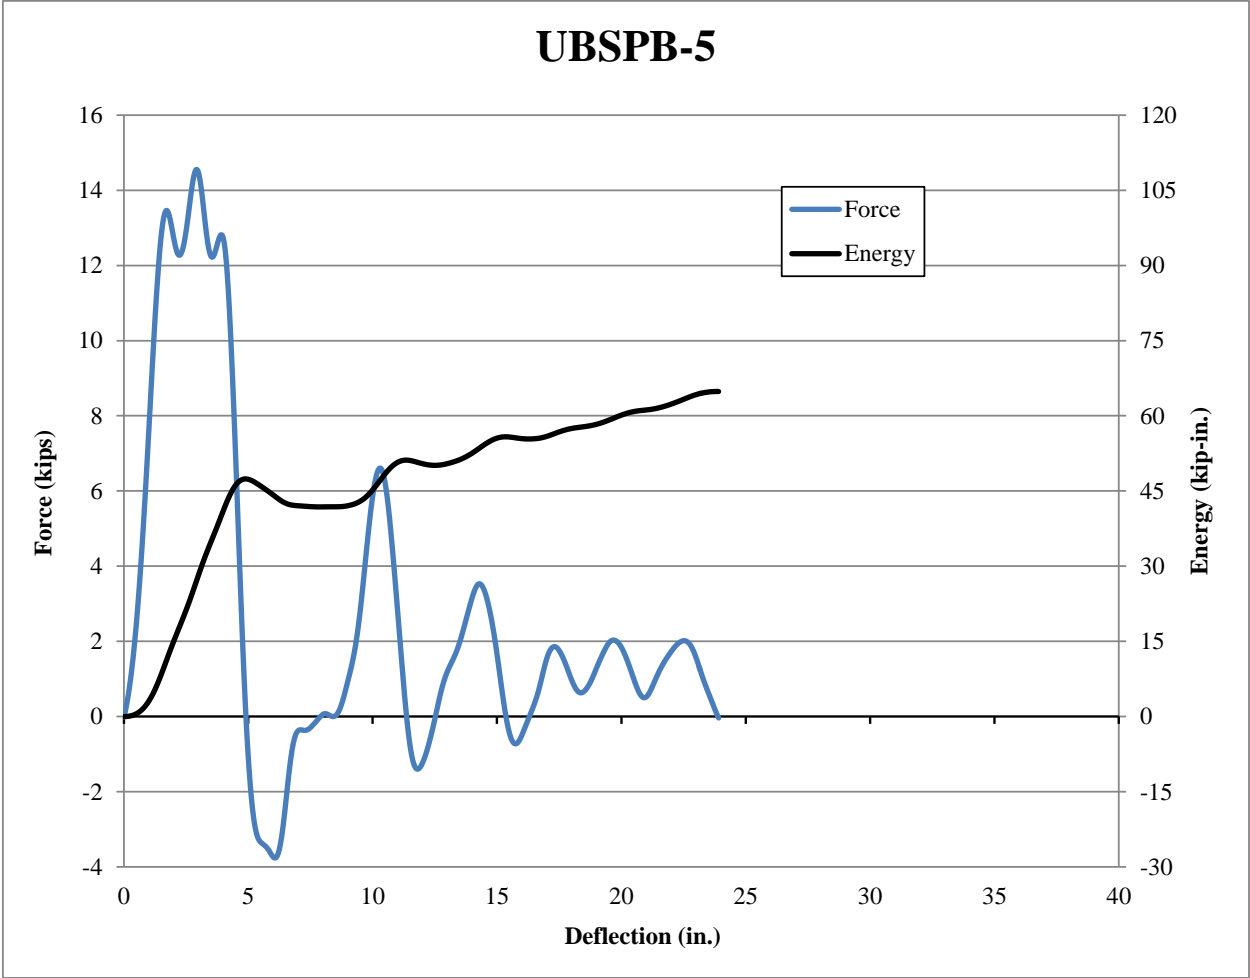
Figure 23. Force vs. Deflection and Energy vs. Deflection, Test No. UBSPB-5

Force vs. deflection and energy vs. deflection curves created from the SLICE accelerometer data are shown in Figure 23. A pre-test photograph is shown in Figure 24. Time-sequential and post-impact photographs are shown in Figure 25. The post reached a peak force of 14.6 kips (64.9 kN) at 2.9 in. (74 mm) of deflection. Due to breakaway of the top post, the resistive force rapidly declined. At a maximum deflection of 23.9 in. (607 mm), the post absorbed 64.9 kip-in. (7.3 kJ) of energy.

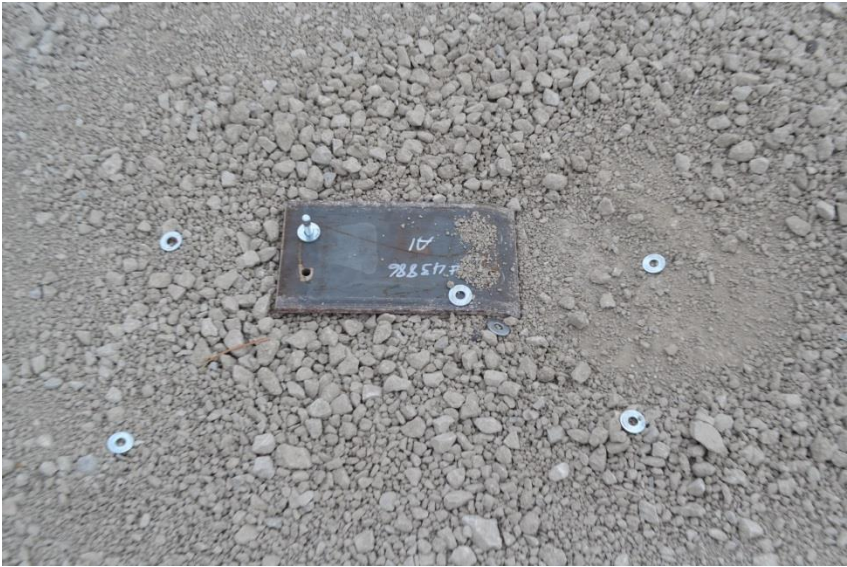
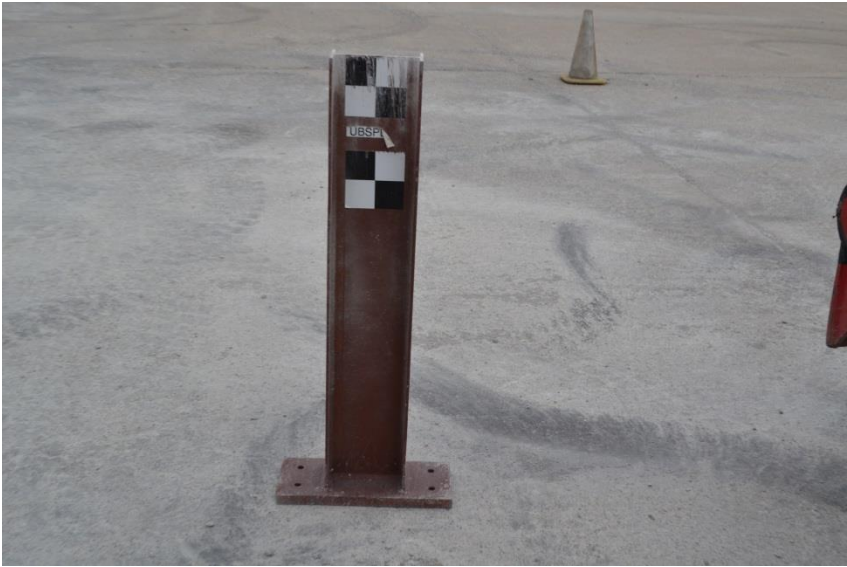
Figure 25. Time-Sequential and Post-Impact Photographs, Test No. UBSPB-5

Test no. UBSPB-5 was a strong-axis impact on the UBSP. The bogie impacted the UBSP at a speed of 21.3 mph (34.3 km/h). Upon impact, the UBSP began to rotate in the soil until the impact-side bolts released in tension at approximately 12 ms. The bogie continued to rotate the top section of the UBSP until the non-impact-side bolts fractured at approximately 66 ms, which corresponded to a deflection of approximately 23.9 in. (607 mm). Following the release of the post, the bogie continued downstream and overrode the post.

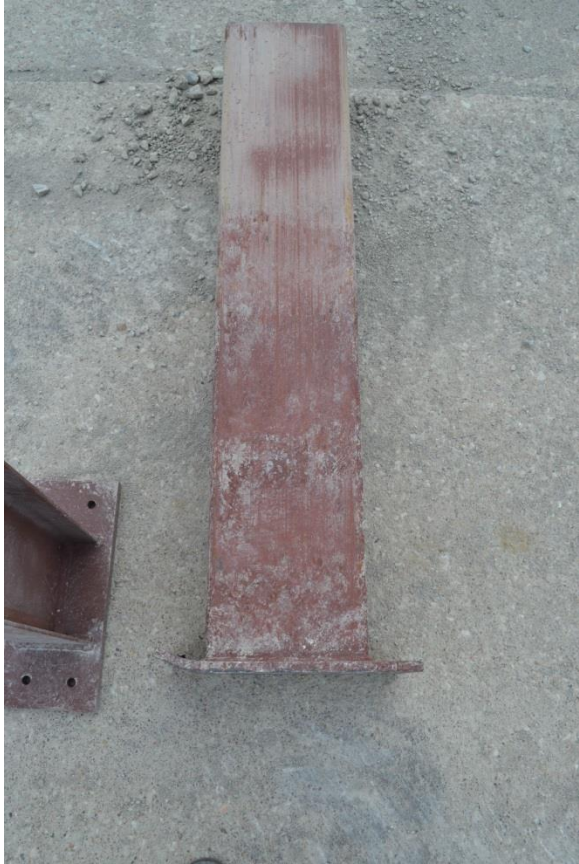
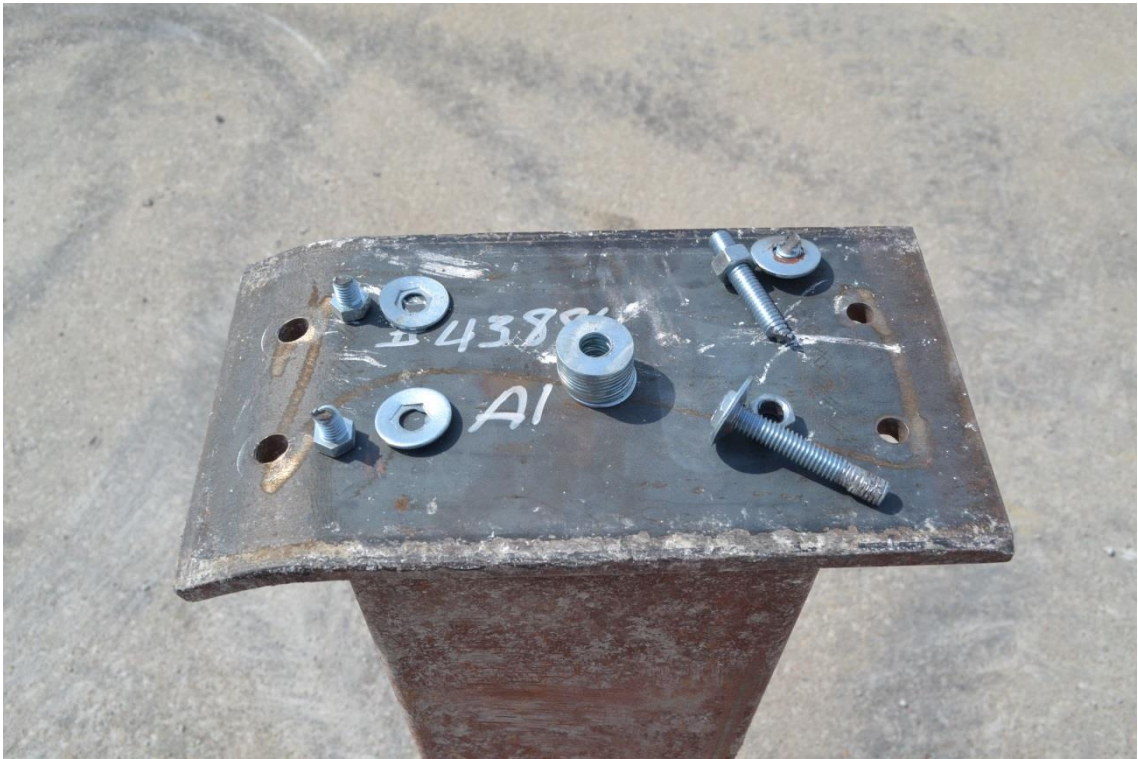
Figure 26. Bolts and Lower Base Plate, Test No. UBSPB-5

Damage to the UBSP is shown in Figure 26. Upon post-test examination, it was found that three of the four bolts had fractured in tension. The remaining bolt, which was located on the impact-side, was stripped of its threads as the nut slid off. The non-impact side of the bottom post plate was bent downward. The upper section and lower tube section did not experience noticeable deformation.

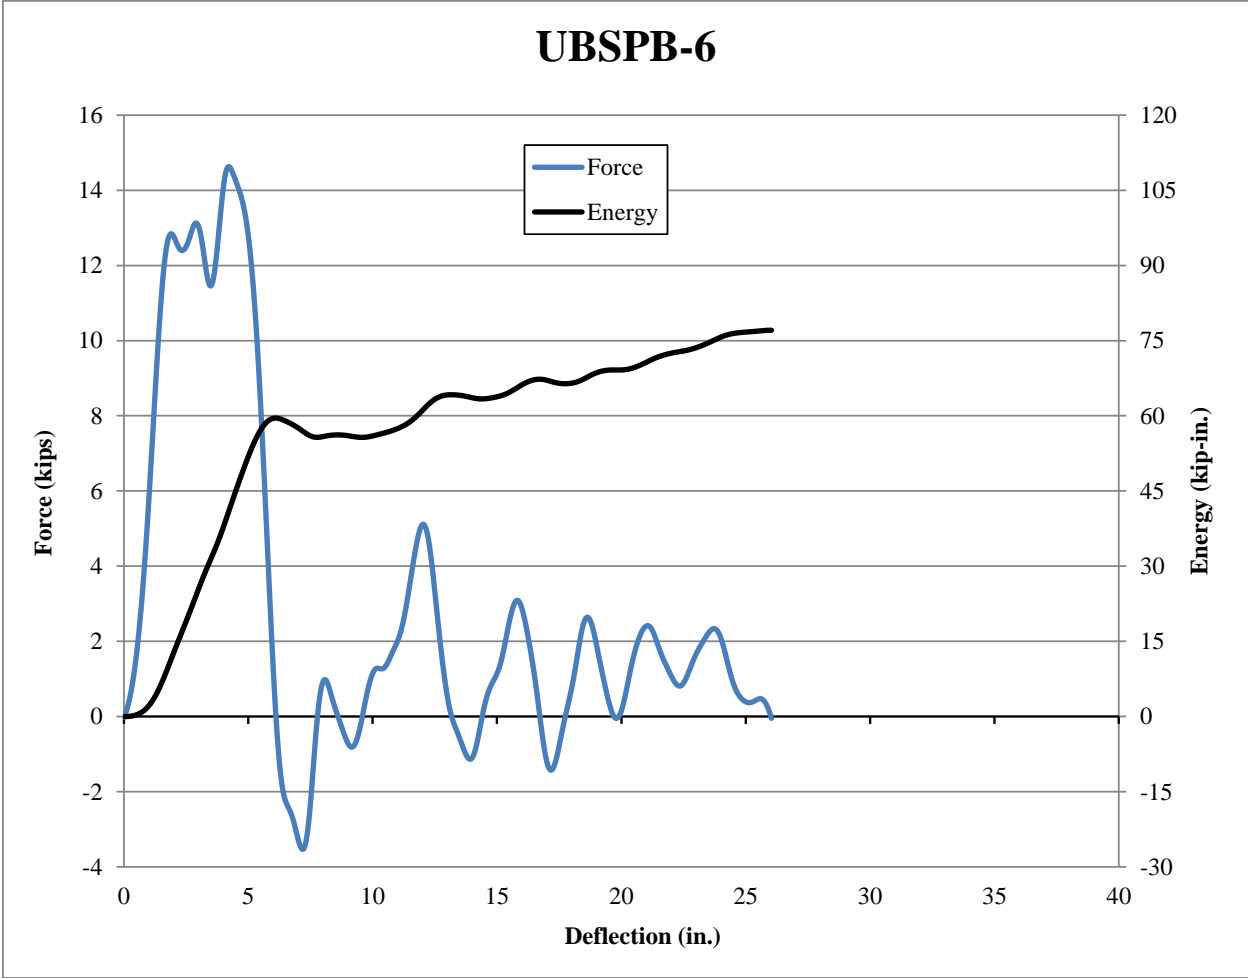
Figure 27. Force vs. Deflection and Energy vs. Deflection, Test No. UBSPB-6

Force vs. deflection and energy vs. deflection curves created from the SLICE accelerometer data are shown in Figure 27. A pre-test photograph is shown in Figure 28. Time-sequential and post-impact photographs are shown in Figure 29. The post reached a peak force of 14.6 kips (64.9 kN) at 4.2 in. (107 mm) of deflection. When the top of the post broke away, the resistive force rapidly decreased. At the maximum deflection of 26.0 in. (660 mm), the post absorbed 77.1 kip-in. (8.7 kJ) of energy.

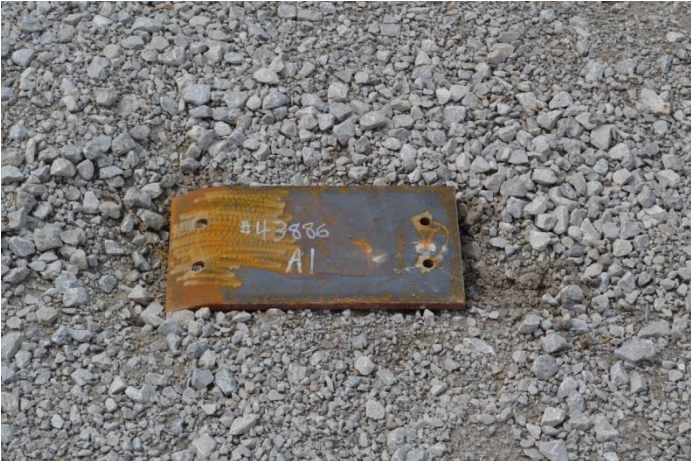
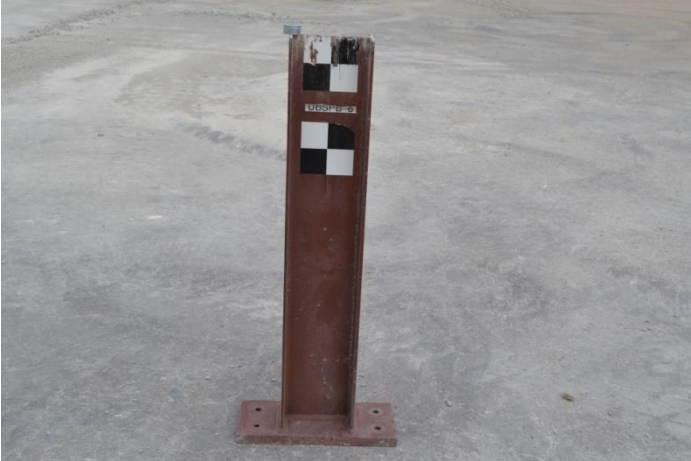
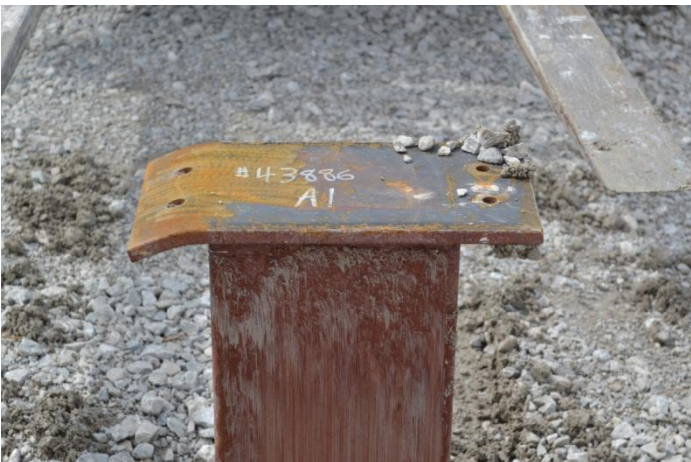
Figure 29. Time-Sequential and Post-Impact Photographs, Test No. UBSPB-6

Test no. UBSPB-6 was a strong-axis impact on the UBSP. The bogie impacted the UBSP at a speed of 21.0 mph (33.8 km/h). Upon impact, the UBSP began to rotate in the soil until the impact-side bolts fractured in tension at approximately 14 ms. The bogie continued to rotate the top section of the UBSP until the non-impact-side bolts fractured at approximately 72 ms, which corresponded to a deflection of approximately 26.0 in. (660 mm).

Damage to the UBSP is shown in Figure 29, and the fractured bolts are shown in Figure 30. Upon post-test examination, all four bolts had fractured in tension. The non-impact side of the bottom post plate was bent downward. The top post plate and lower tube did not experience noticeable deformation.

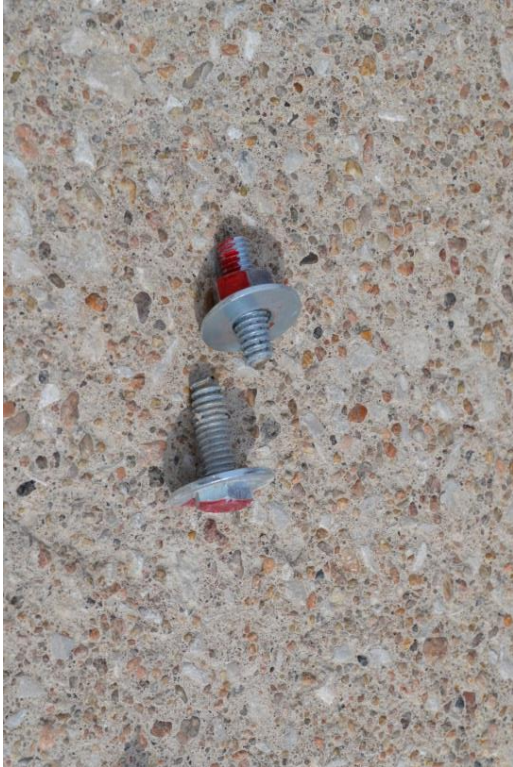
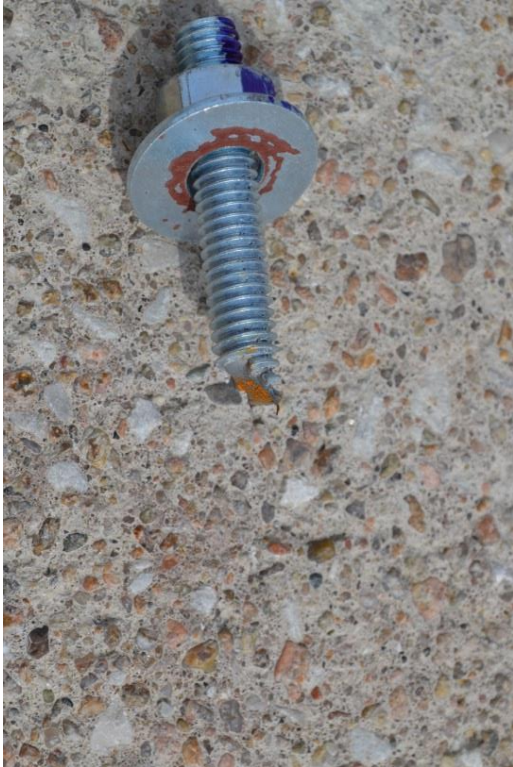
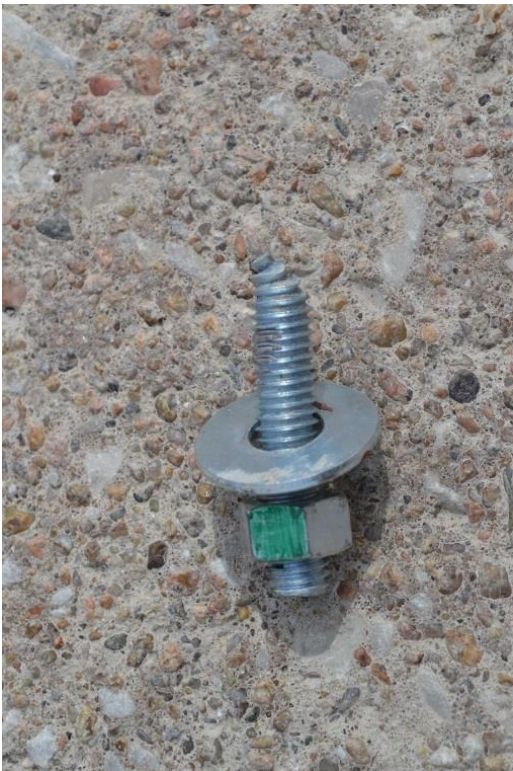
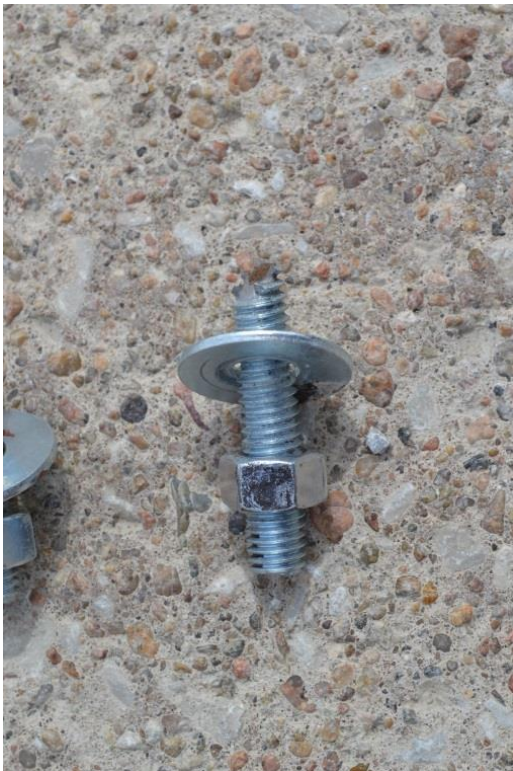
Figure 30. Fractured Bolts, Test No. UBSPB-6

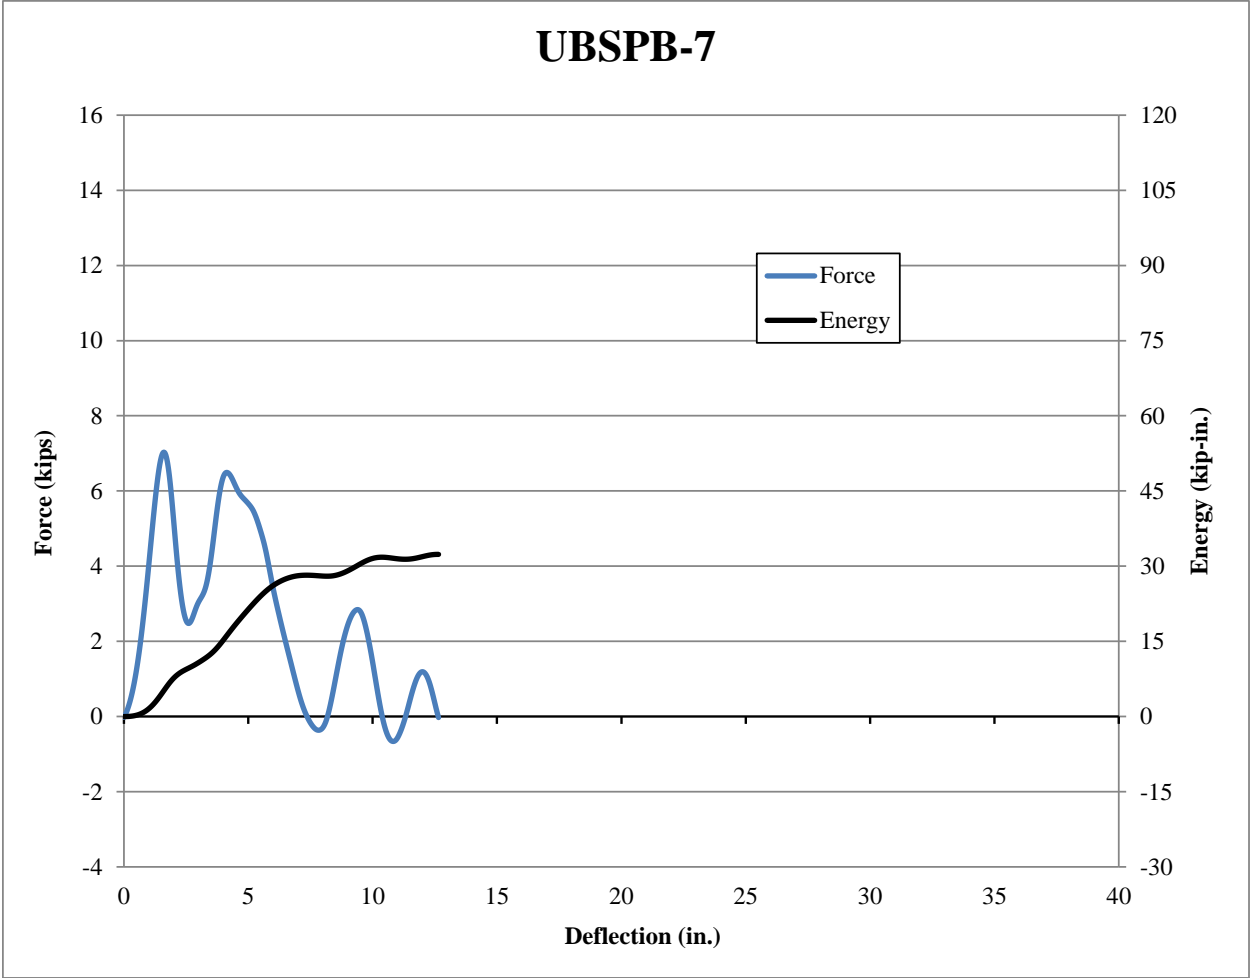
Figure 31. Force vs. Deflection and Energy vs. Deflection, Test No. UBSPB-7

Force vs. deflection and energy vs. deflection curves created from the SLICE accelerometer data are shown in Figure 31. A pre-test photograph is shown in Figure 32. Time-sequential and post-impact photographs are shown in Figure 33. The post reached a peak force of 7.0 kips (31.1 kN) at 1.6 in. (41 mm) of deflection. The force peaked again near 4 in. (102 mm) of deflection, and then began to decrease due to breakaway of the top of the post. At a maximum deflection of 12.7 in. (323 mm), the post absorbed 32.4 kip-in. (3.7 kJ) of energy.

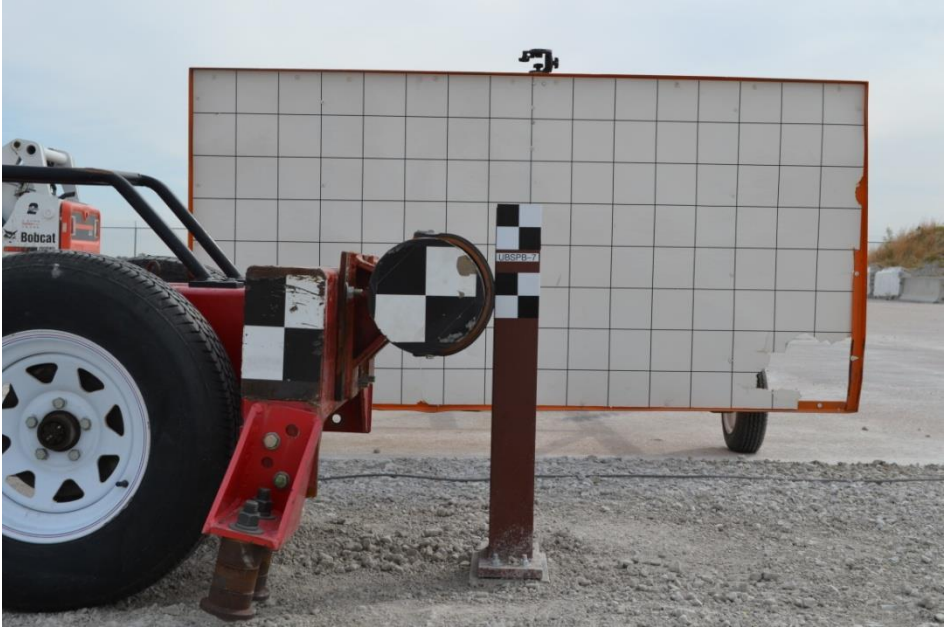
Figure 32. Pre-Test Photograph, Test No. UBSPB-7
