Midwest States' Regional Pooled Fund Research Program

UNIVERSAL BREAKAWAY STEEL POST FOR OTHER APPLICATIONS

MIDWEST ROADSIDE SAFETY FACILITY

MwRSF Research Report No. TRP-03-288-14

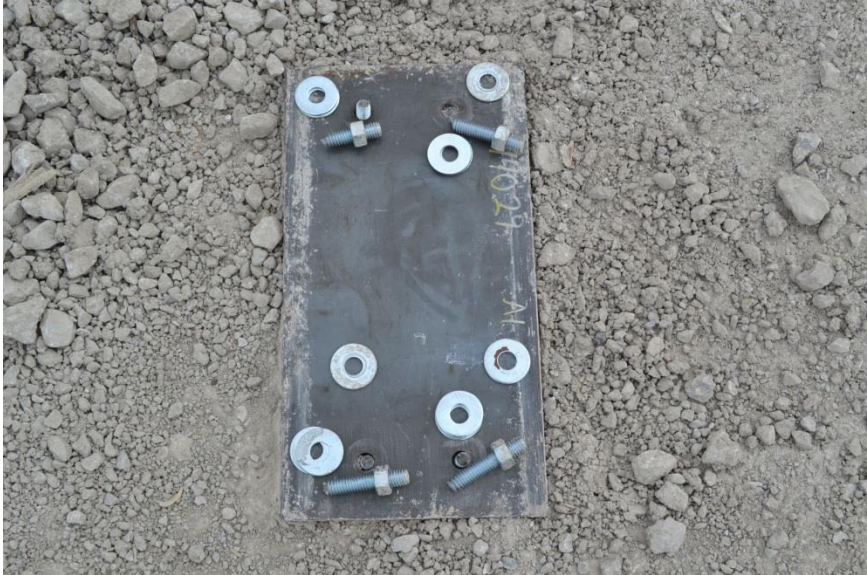
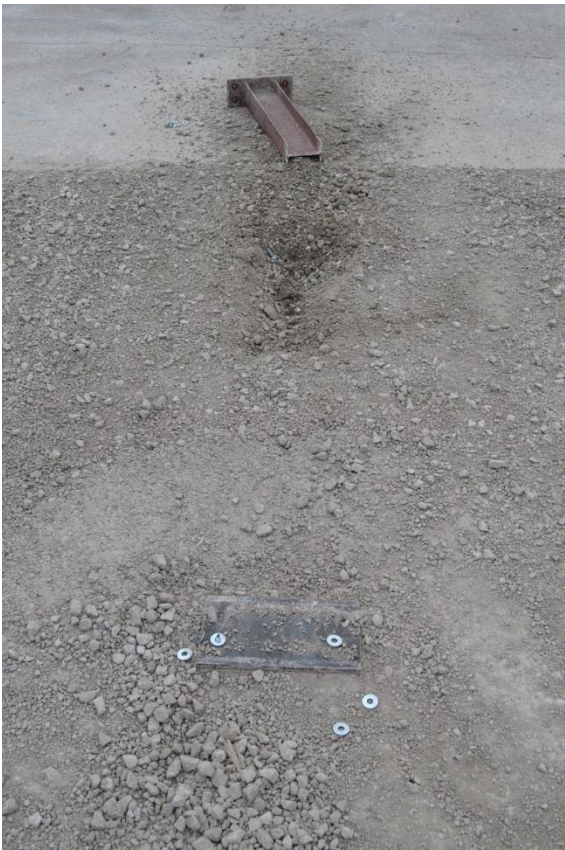
Figure 33. Time-Sequential and Post-Impact Photographs, Test No. UBSPB-7

Force vs. deflection and energy vs. deflection curves created from the SLICE accelerometer data are shown in Figure 31. A pre-test photograph is shown in Figure 32. Time-sequential and post-impact photographs are shown in Figure 33. The post reached a peak force of 7.0 kips (31.1 kN) at 1.6 in. (41 mm) of deflection. The force peaked again near 4 in. (102 mm) of deflection, and then began to decrease due to breakaway of the top of the post. At a maximum deflection of 12.7 in. (323 mm), the post absorbed 32.4 kip-in. (3.7 kJ) of energy.

Fractured bolts are shown in Figure 33. Upon post-test examination, all four bolts had fractured in tension, and the top of the post was bent slightly. The top post plate did not experience noticeable deformation. The lower section of the post was undamaged and displaced very little in the soil. The previous research with the UBSP in the three beam bullnose had noted similar behavior in the full-scale testing [9]. At that time, the researchers noted that if the lower section was undamaged and had displaced less than ½ in. (13 mm), then the bottom section could be reset without removing the post by tamping around the base. In order to further investigate this recommendation, test no. UBSPB-8 was conducted with the same base as UBSPB-7 after re-compacting the soil around the post.

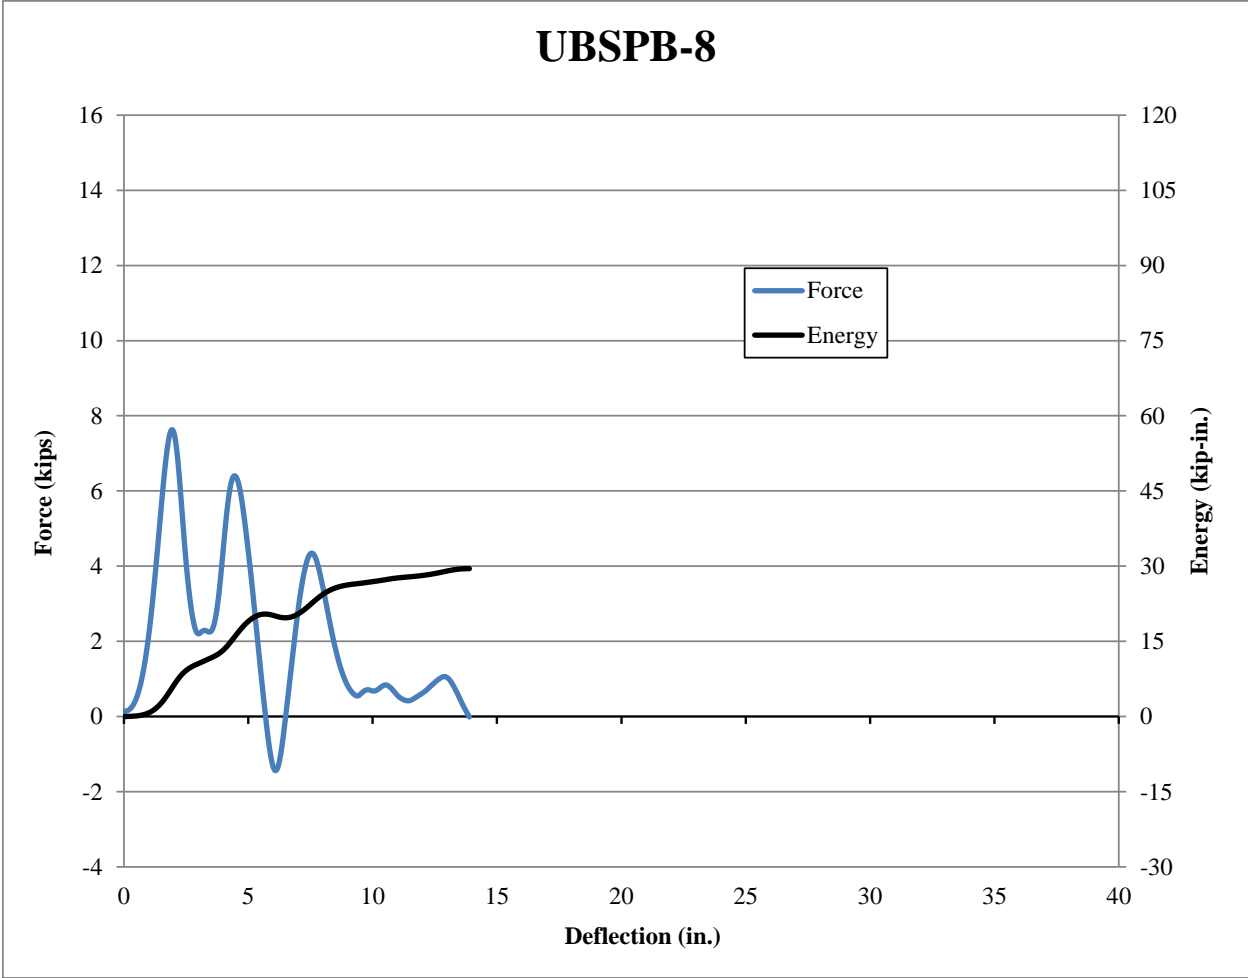
Figure 34. Force vs. Deflection and Energy vs. Deflection, Test No. UBSPB-8

Force vs. deflection and energy vs. deflection curves created from the SLICE accelerometer data are shown in Figure 34. A pre-test photograph is shown in Figure 35. Time-sequential and post-impact photographs are shown in Figure 36. The post reached a peak force of 7.6 kips (33.8 kN) at 1.9 in. (48 mm) of deflection. The force peaked again at 4.5 in. (114 mm) of deflection, and then quickly dropped to zero due to breakaway of the top of the post. At a maximum deflection of 13.9 in. (353 mm), the post absorbed 29.5 kip-in. (3.3 kJ) of energy.

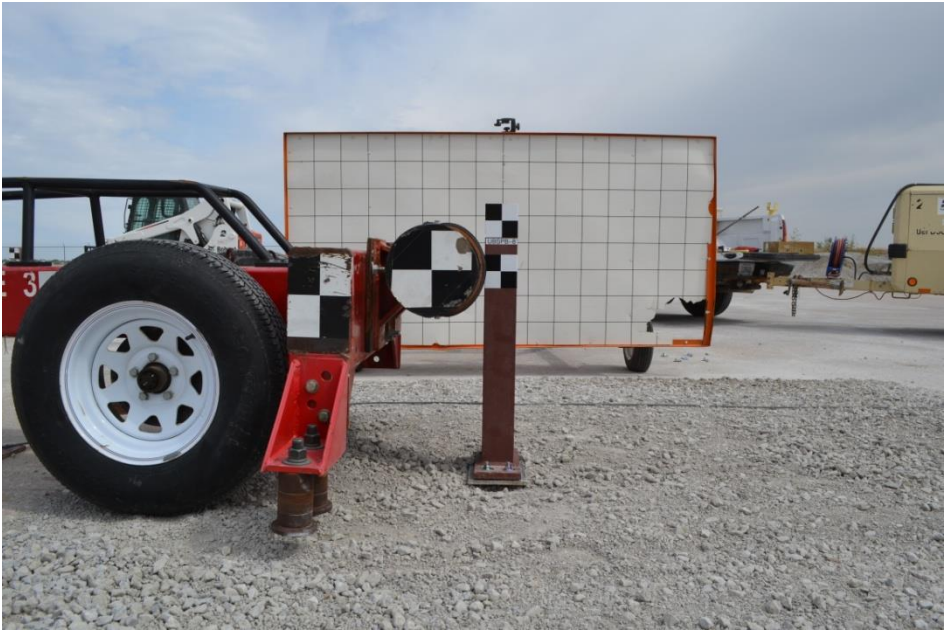
Figure 35. Pre-Test Photograph, Test No. UBSPB-8

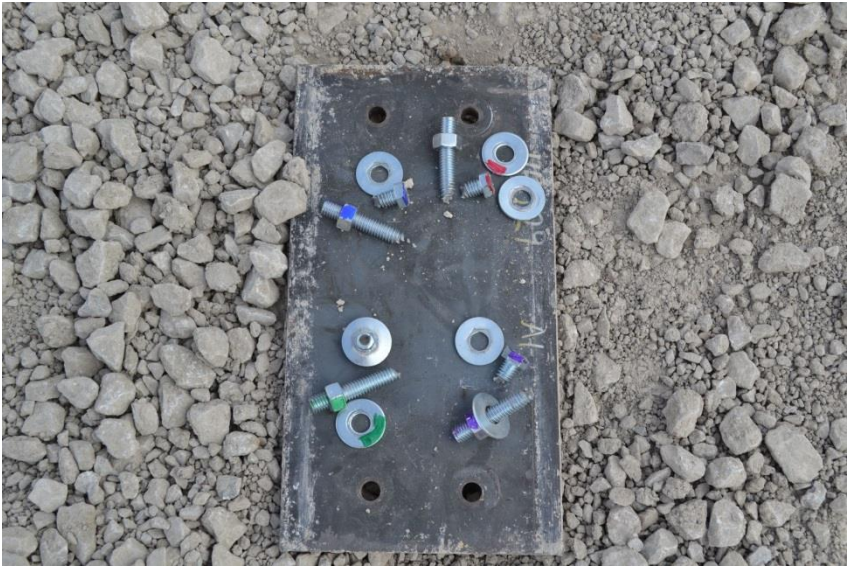
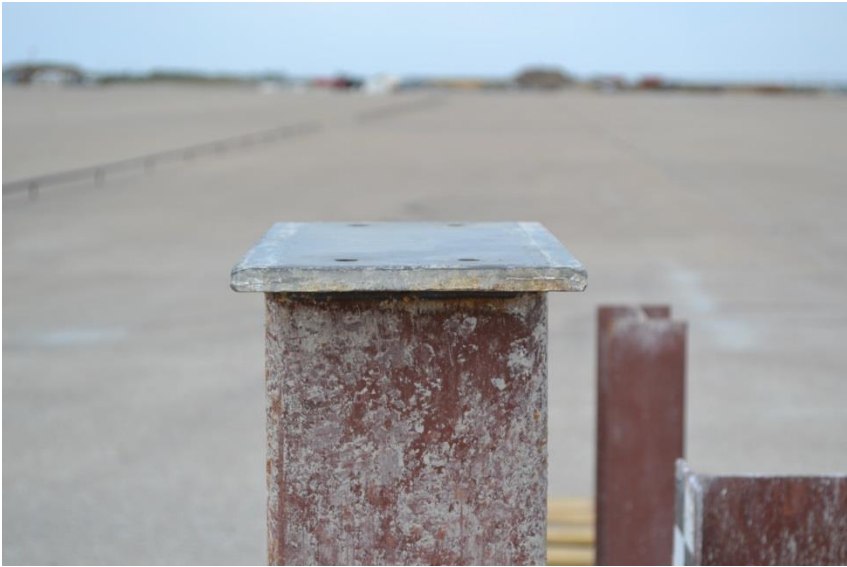
Figure 36. Time-Sequential and Post-Impact Photographs, Test No. UBSPB-8

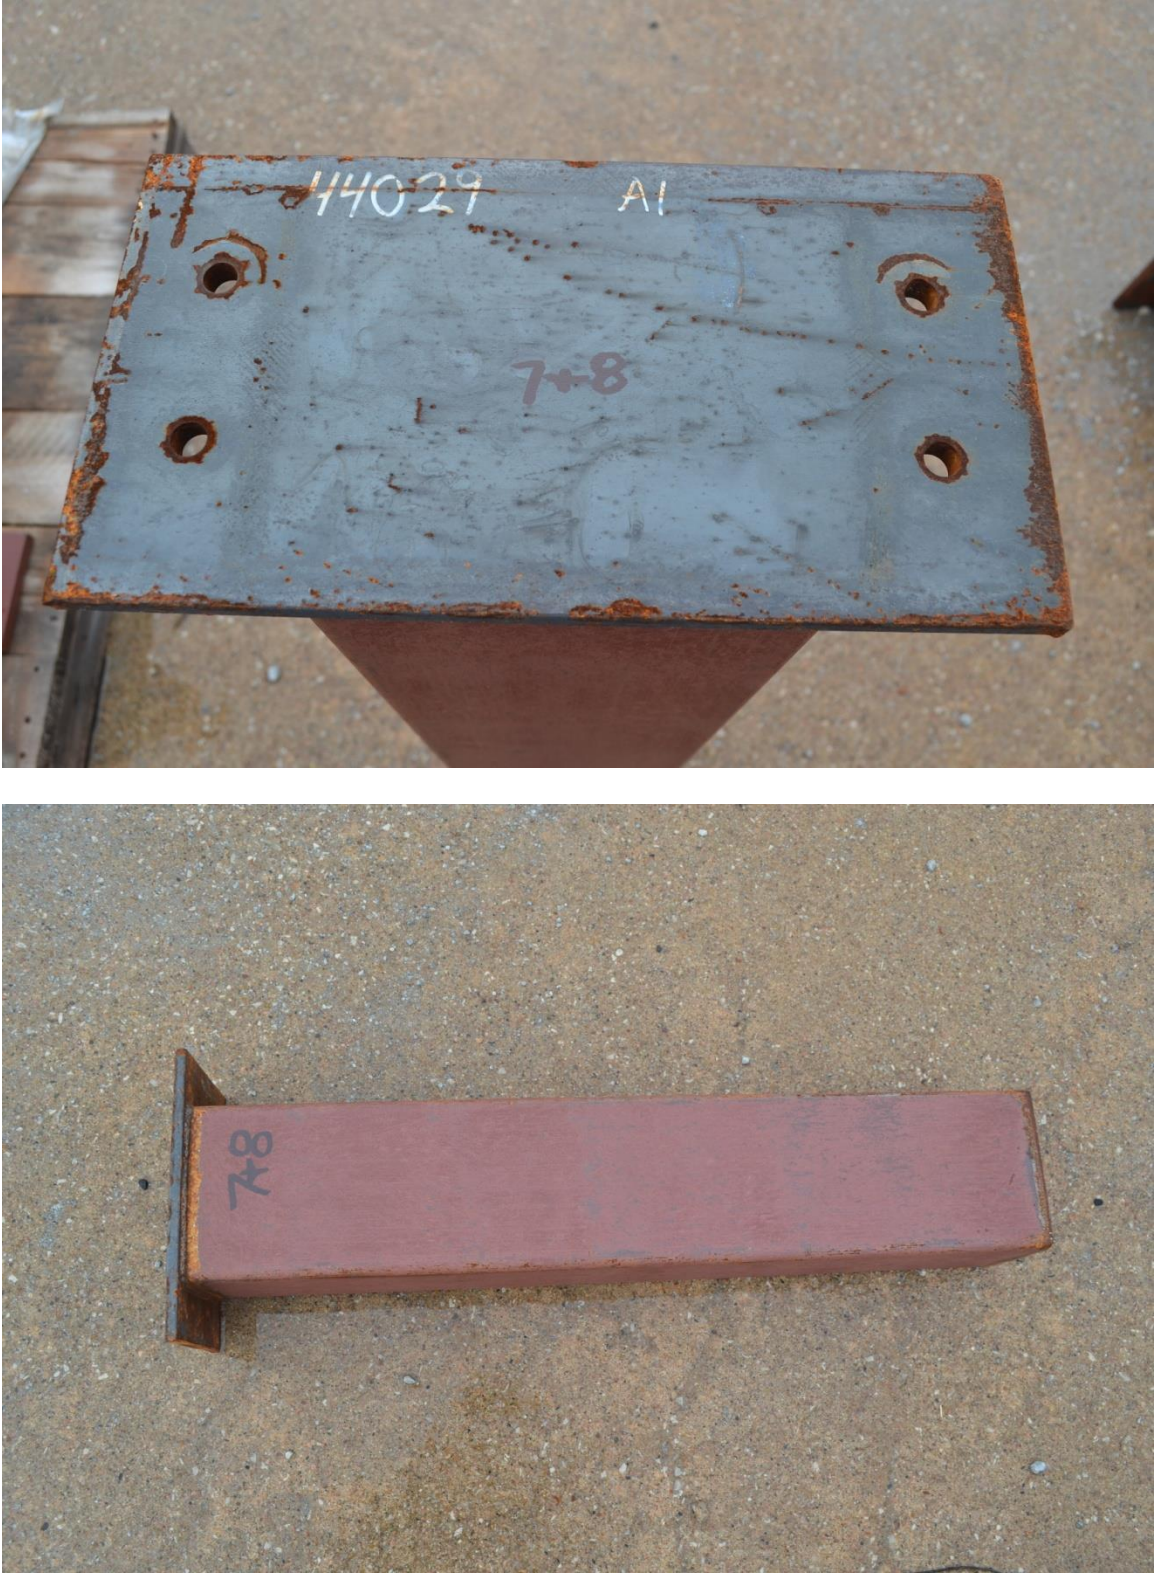
Figure 37. Lower Section and Base Plate, Test No. UBSPB-8

Damage to the UBSP is shown in Figures 37 and 38. Upon post-test examination, it was found that all four bolts had fractured in tension. The top of the post and bottom of the post did not experience noticeable deformation.

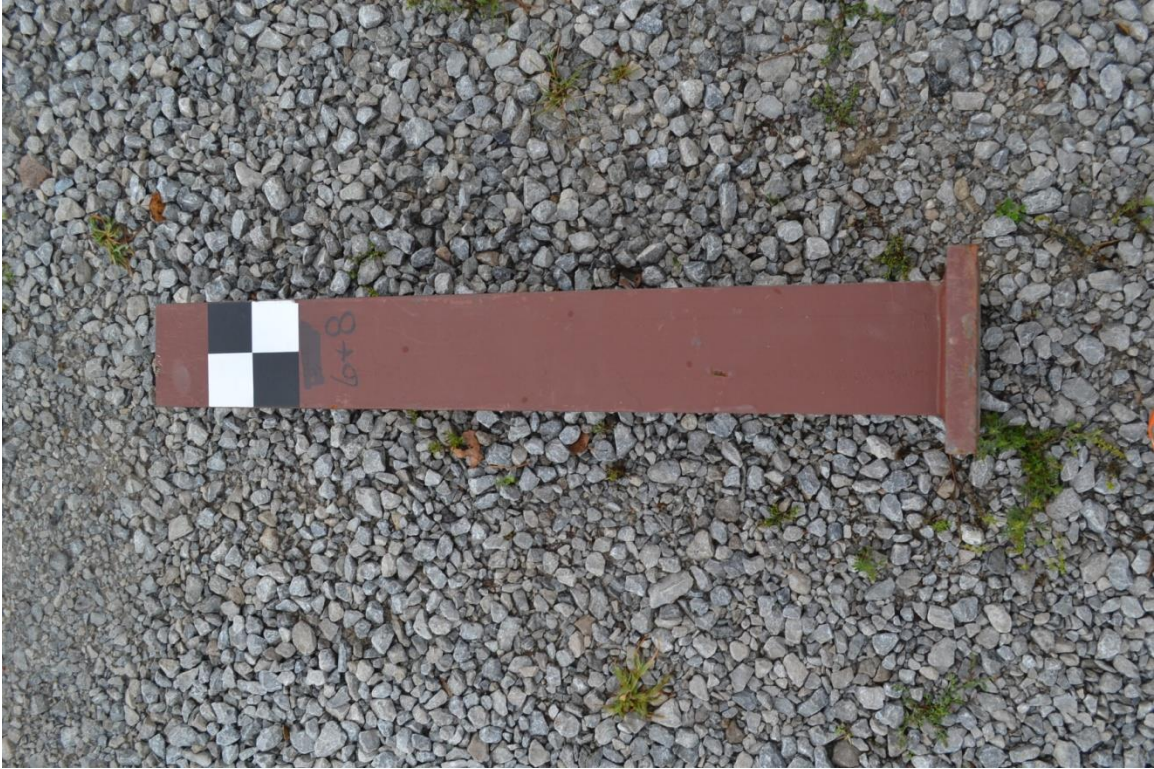
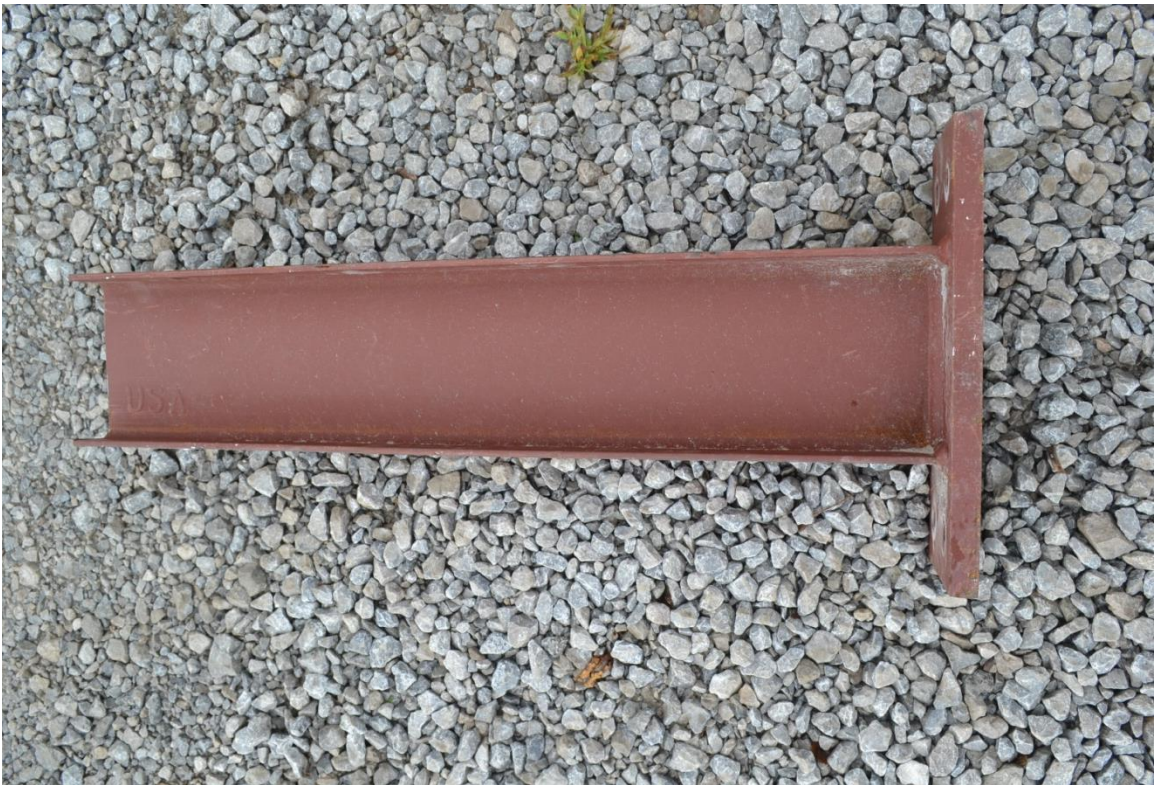
Figure 38. Top Section, Test No. UBSPB-8

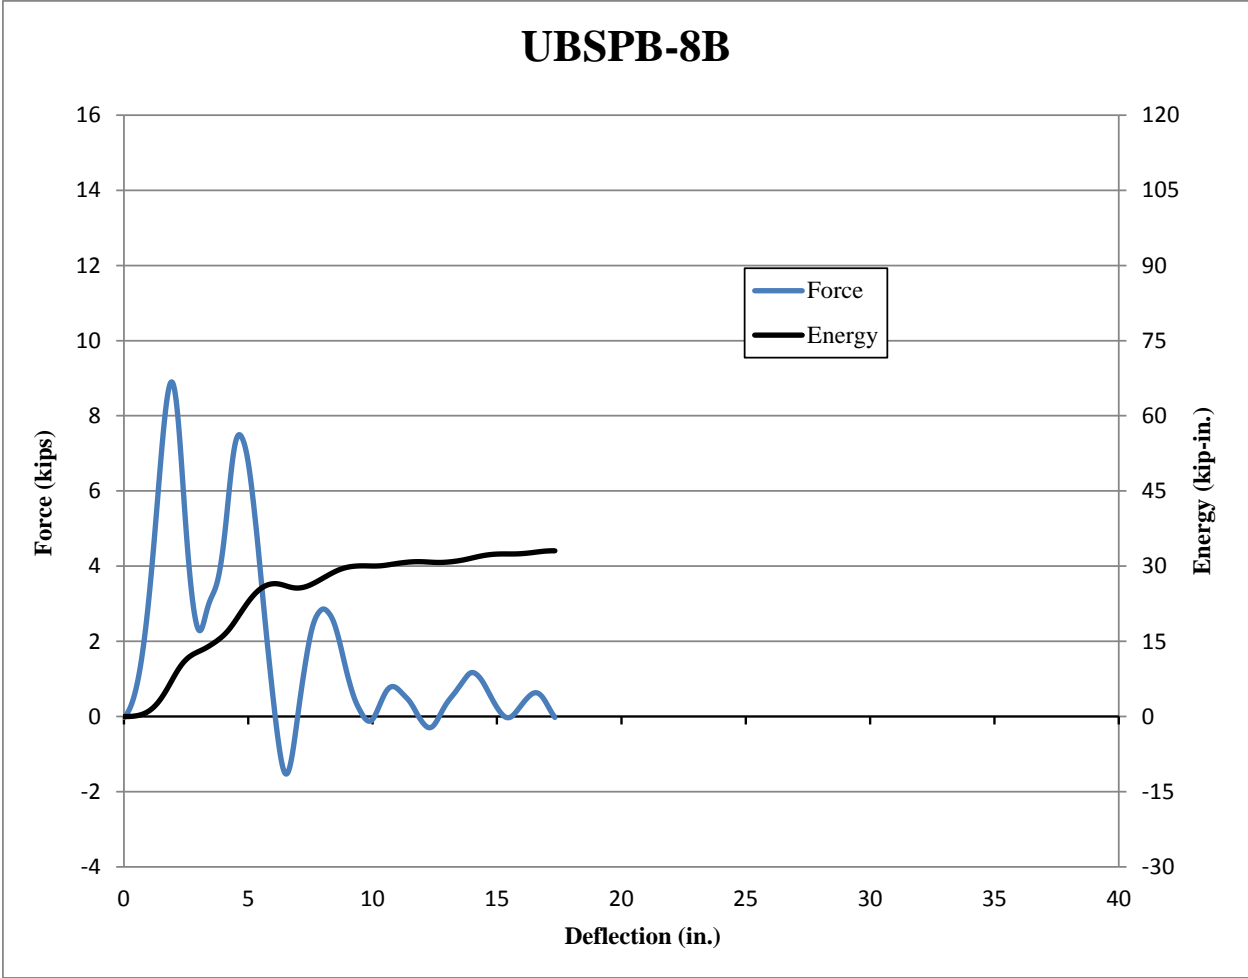
Figure 39. Force vs. Deflection and Energy vs. Deflection, Test No. UBSPB-8B

Force vs. deflection and energy vs. deflection curves created from the SLICE accelerometer data are shown in Figure 39. A pre-test photograph is shown in Figure 40. Time-sequential and post-impact photographs are shown in Figure 41. The post reached a peak force of 8.9 kips (39.6 kN) at 1.9 in. (48 mm) of deflection. The force peaked again around 4.5 in. (114 mm) of deflection, and then quickly dropped to zero. At a maximum deflection of 17.3 in. (439 mm), the post absorbed 33.1 kip-in. (3.7 kJ) of energy.

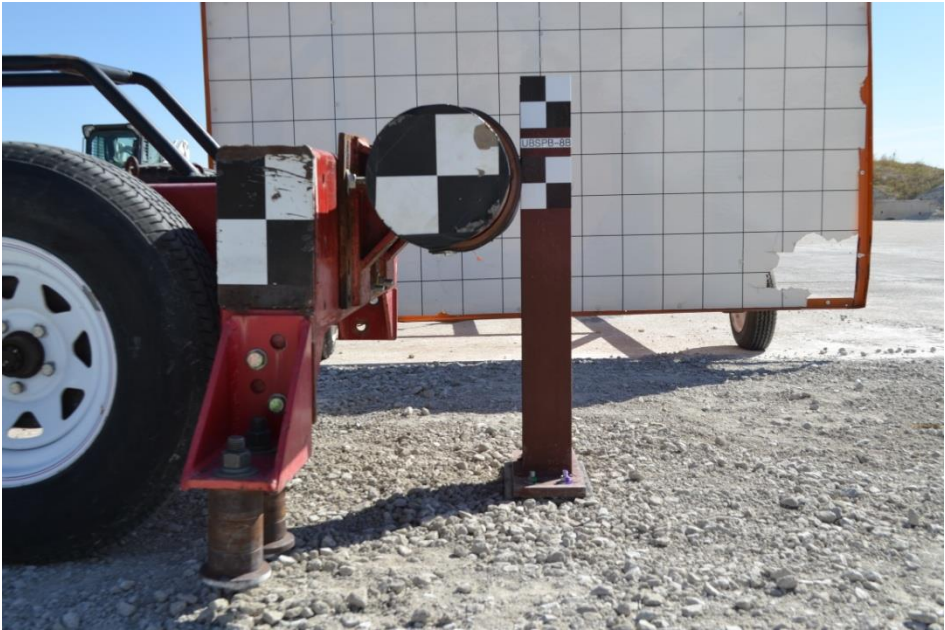
Figure 40. Pre-Test Photograph, Test No. UBSPB-8B

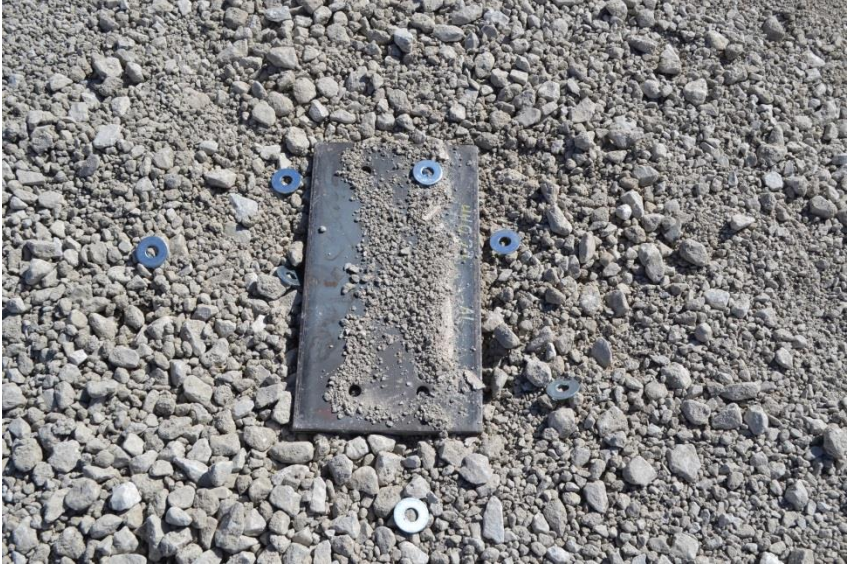
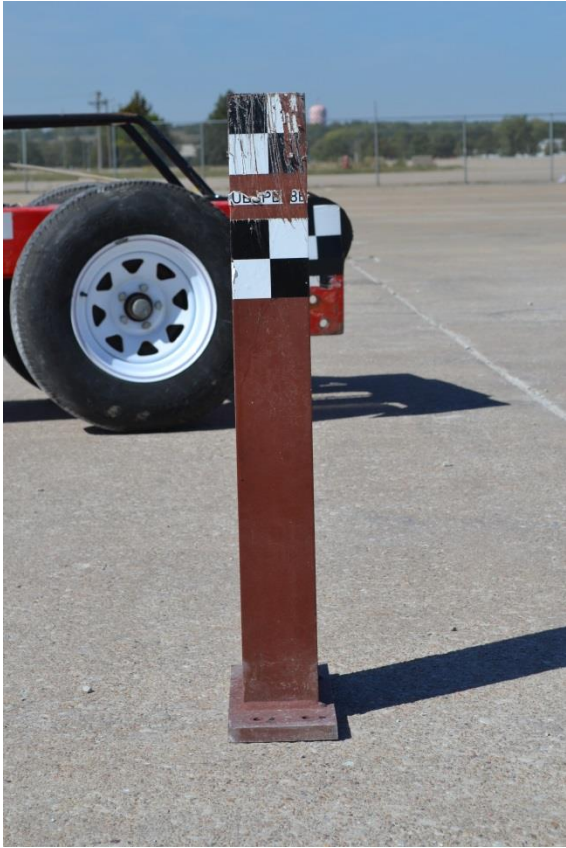
Figure 41. Time-Sequential and Post-Impact Photographs, Test No. UBSPB-8B

Upon post-test examination, all four bolts had fractured in tension. The top of the post and bottom of the post did not experience noticeable deformation.

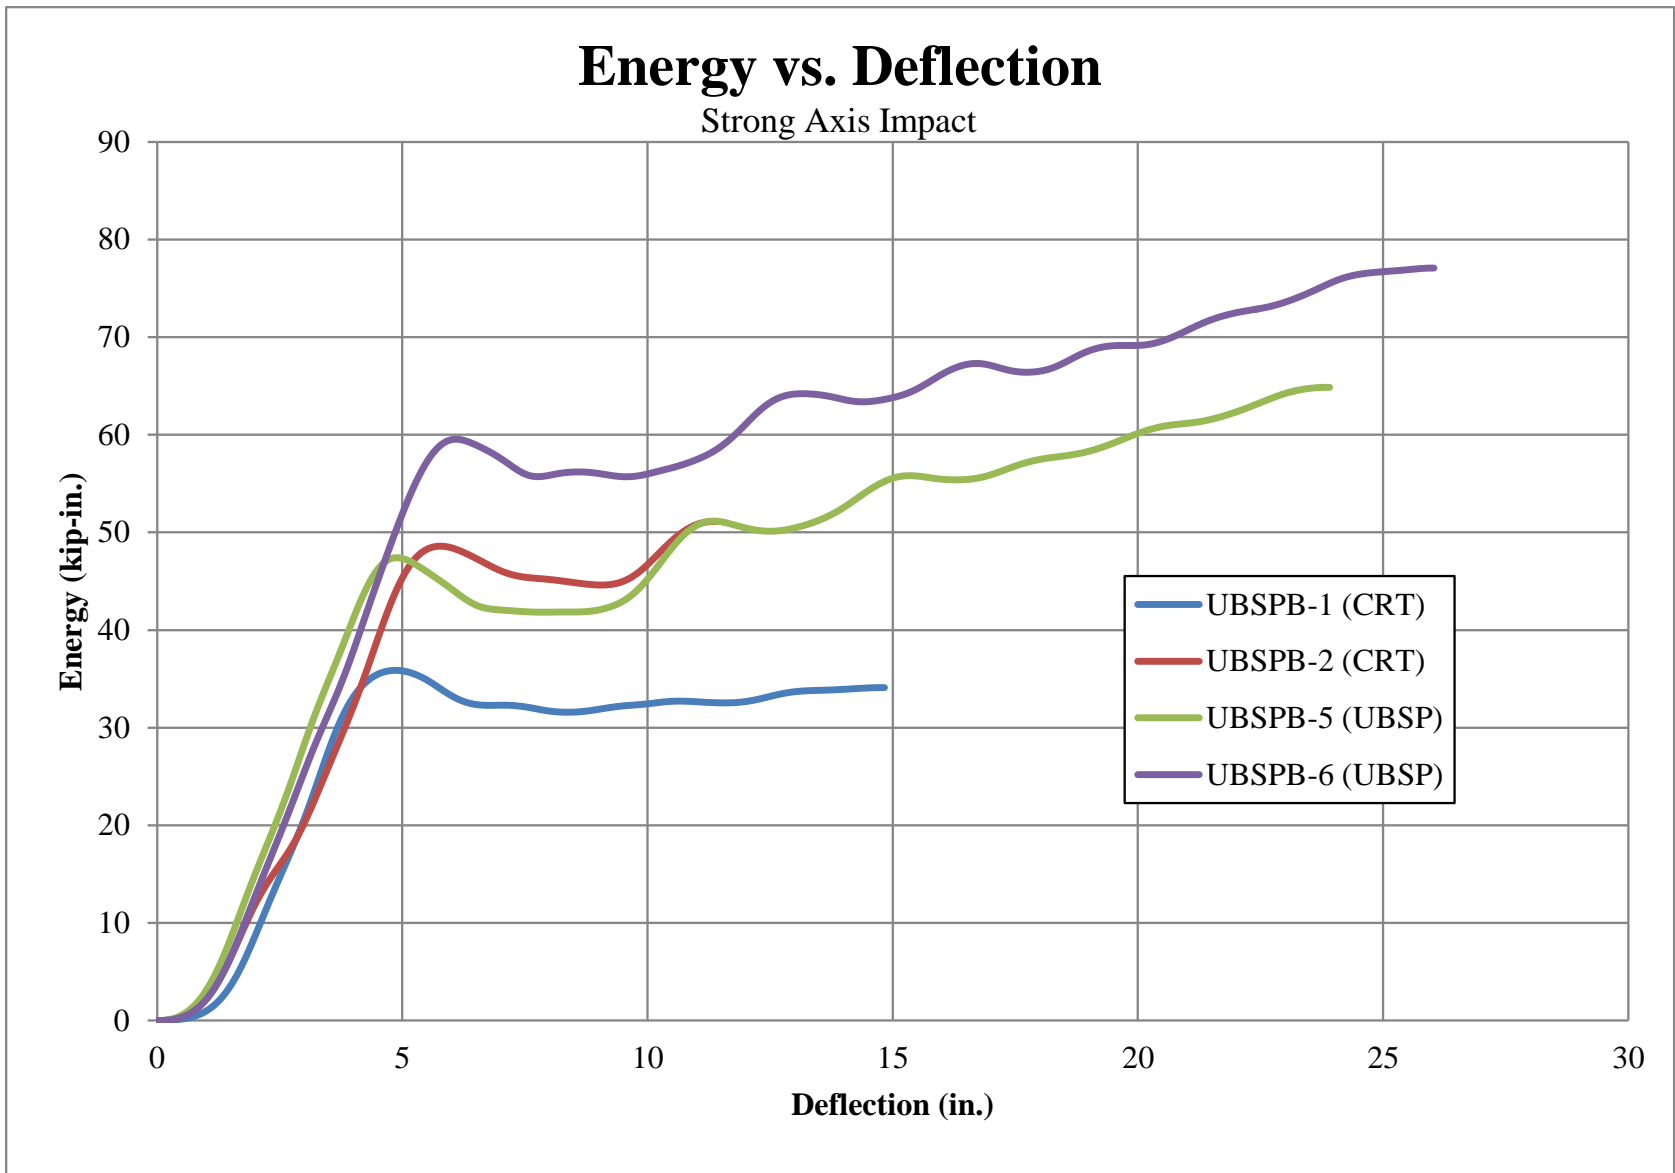
Figure 43. Energy vs. Deflection Comparison Plot, Strong-Axis Tests

Test nos. UBSPB-1, UBSPB-2, UBSPB-5, and UBSPB-6 were conducted with the bogie impacting along the strong axis of the posts. Test results are summarized in Table 3 and shown graphically in Figure 42 and Figure 43. The forces developed by the UBSPs and CRT posts appeared to be similar and suggested that the UBSP correlated well with the CRT posts. All four tests displayed very similar peak loads ranging from 14.4 kips (64.1 kN) to 14.6 kips (64.9 kN) during the first 3½ in. (89 mm) to 4 in. (102 mm) of post deflection. Average post forces through 5 in. (127 mm) and 10 in. (254 mm) of post deflection were slightly higher for the UBSP. The UBSPs displayed average forces at 5 in. (127 mm) and 10 in. (254 mm) of deflection that were 21.8 percent and 28.0 percent higher than the CRT posts, respectively. The difference in average forces was believed largely due to two factors. First, small differences in the fracture force and time between the posts caused the average forces to vary during the first 5 in. (127 mm) of deflection. However, this level of discrepancy in the average forces was not unexpected due to variability in post material properties and soil-resistive forces from test to test. In general, the

A comparison of energy dissipated by the UBSPs and CRT posts when impacted along the strong axis displayed similar results. Total energy for the UBSP was slightly higher than that of the CRT post, but this finding was attributed to the CRT post disengaging in a more brittle fashion, while the UBSP required more deflection prior to disengaging the back side connection bolts. When compared to typical posts used in W-beam guardrails, the energy for all tests on the UBSP and CRT posts was considerably lower than typically observed in tests on the strong axis of standard, strong post guardrail posts.
