DEVELOPMENT OF A STAND-ALONE CONCRETE BRIDGE PIER PROTECTION SYSTEM

MwRSF Research Report No. TRP-03-190-08

April 18, 2008

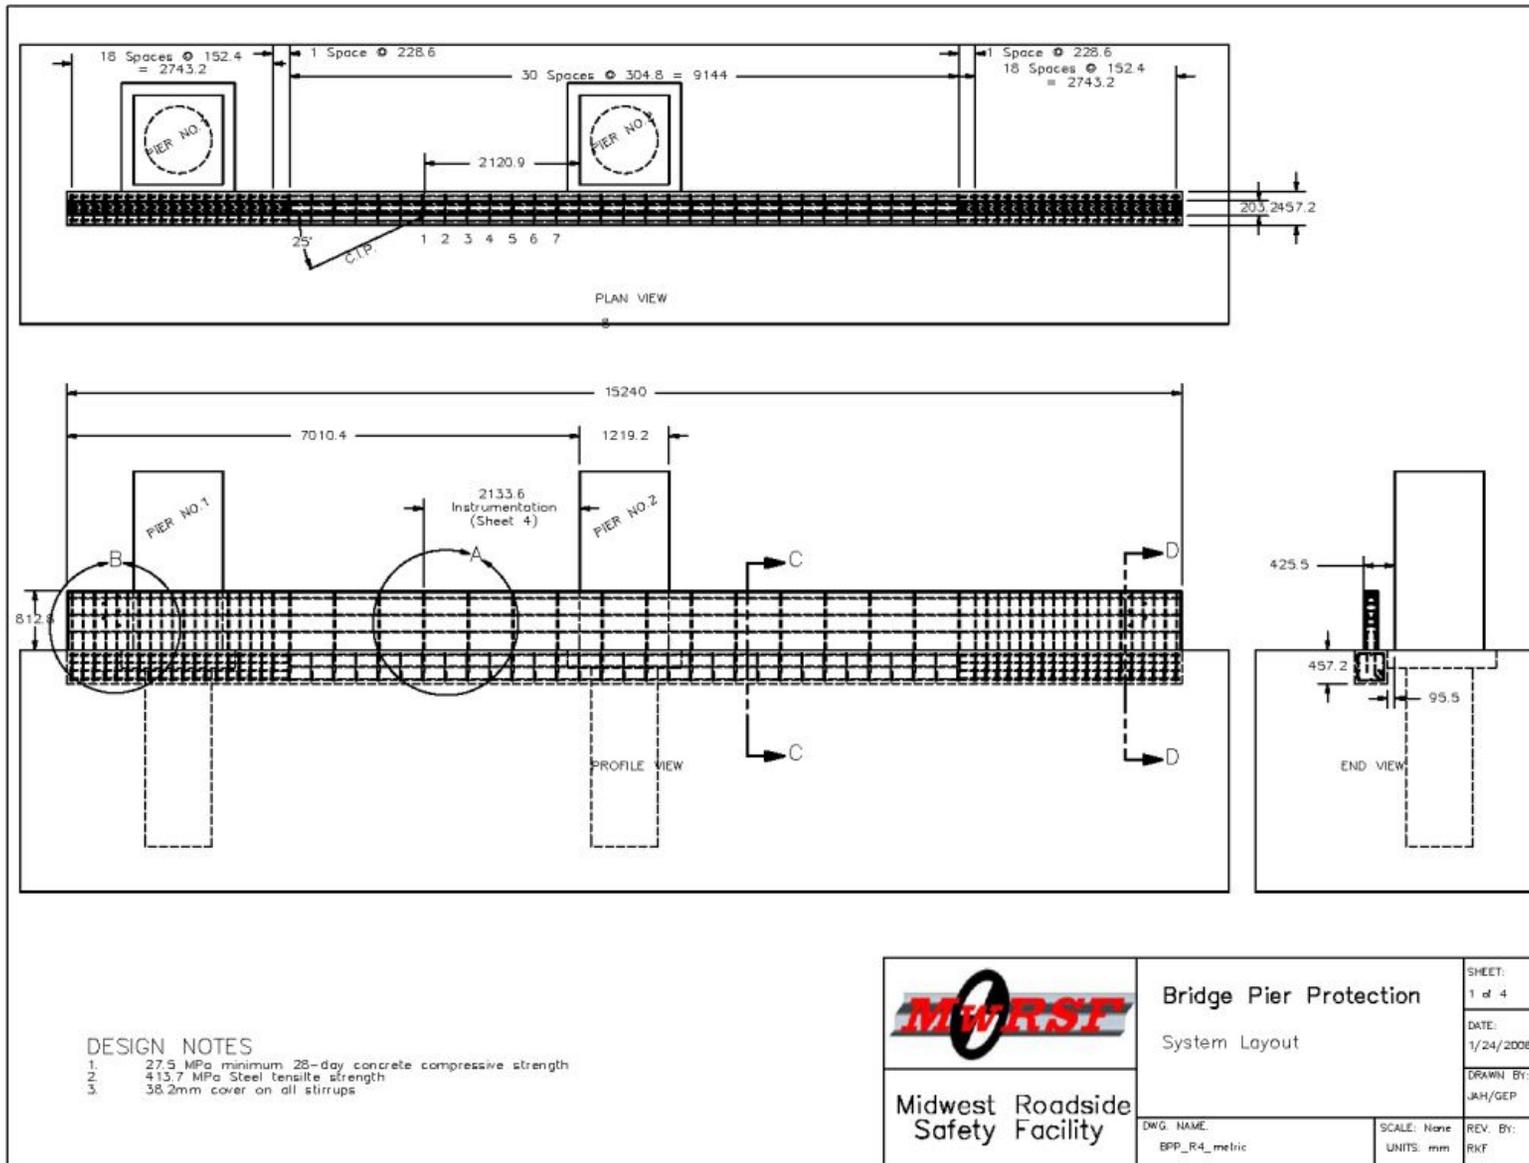
Figure 1. Test Installation Layout, Test CBPP-1

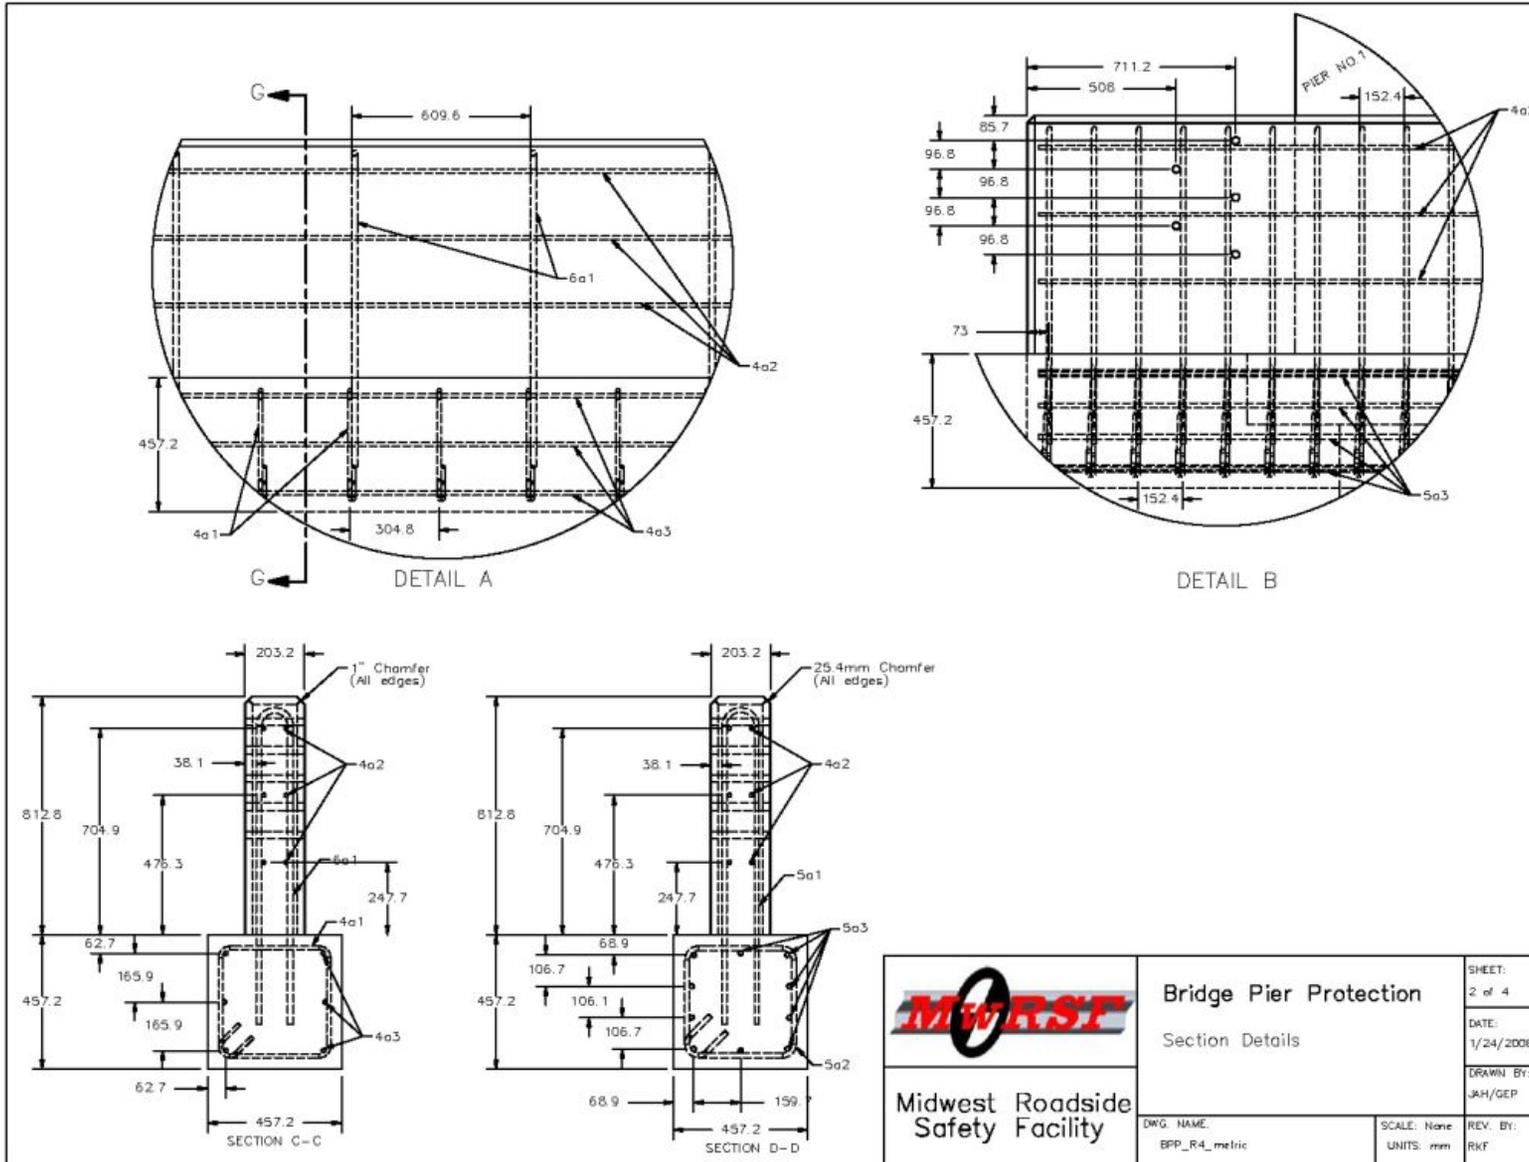
Figure 2. Design Details and Reinforcement Placement, Test CBPP-1

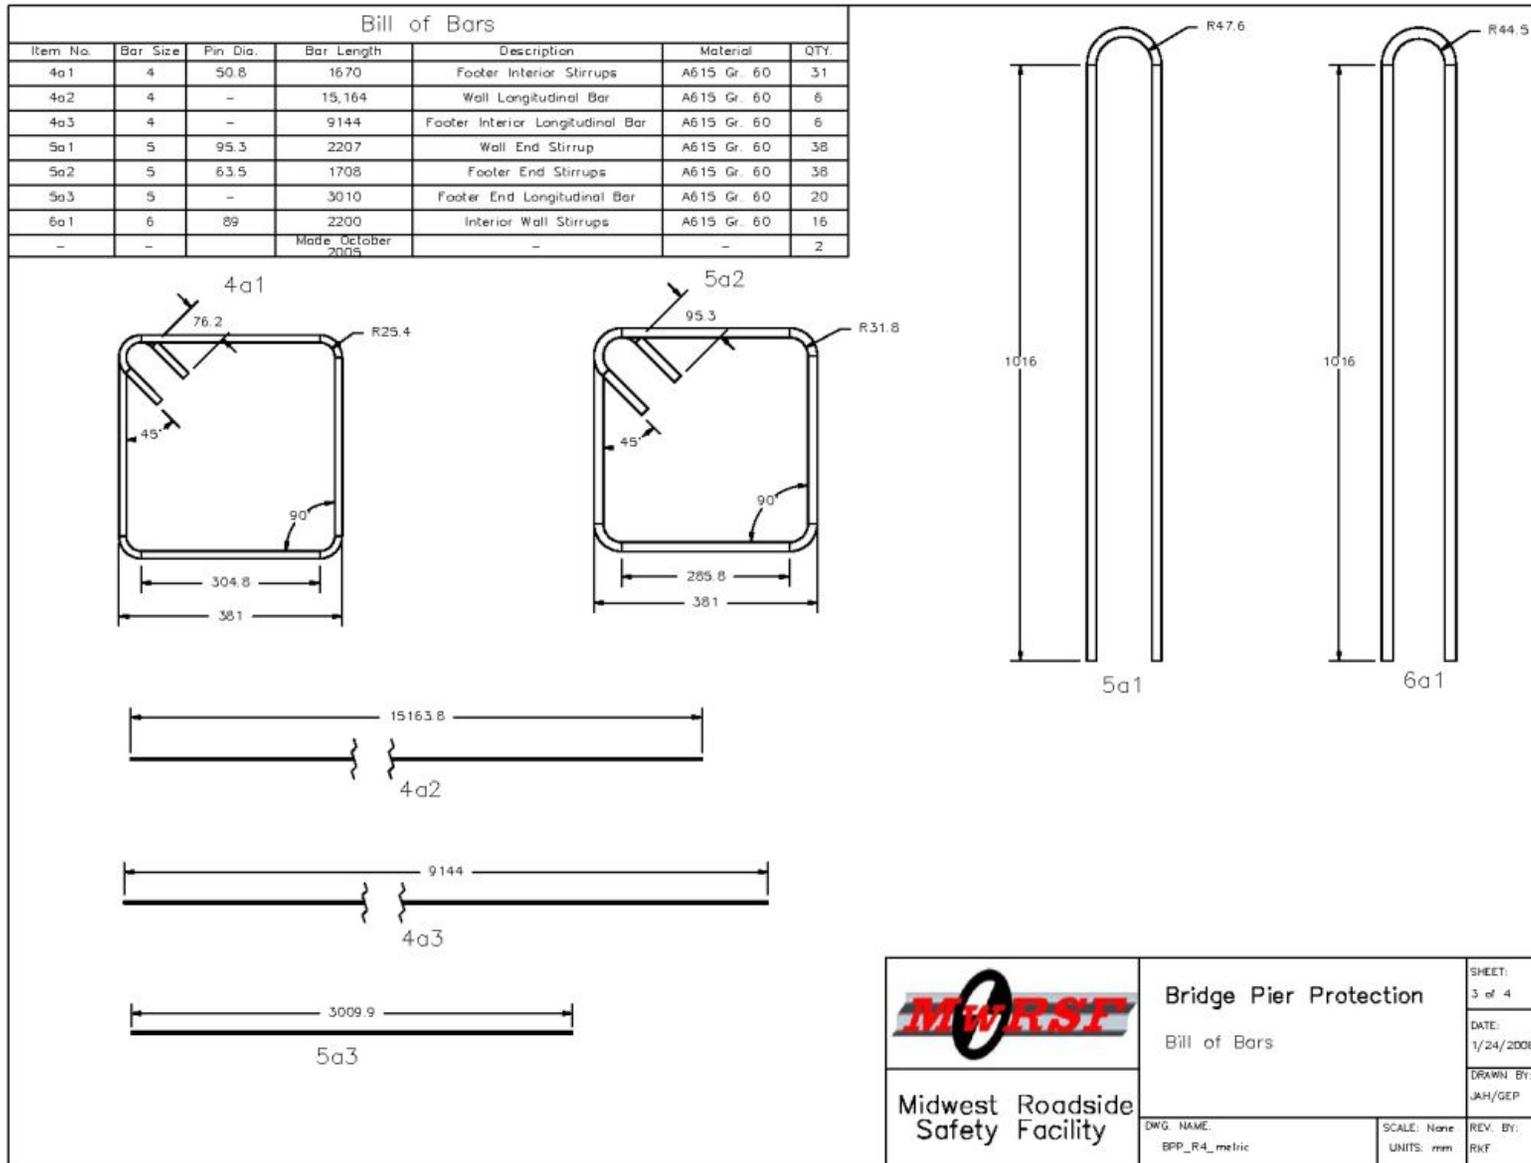
Figure 3. Internal Steel Reinforcement Dimensions, Test CBPP-1

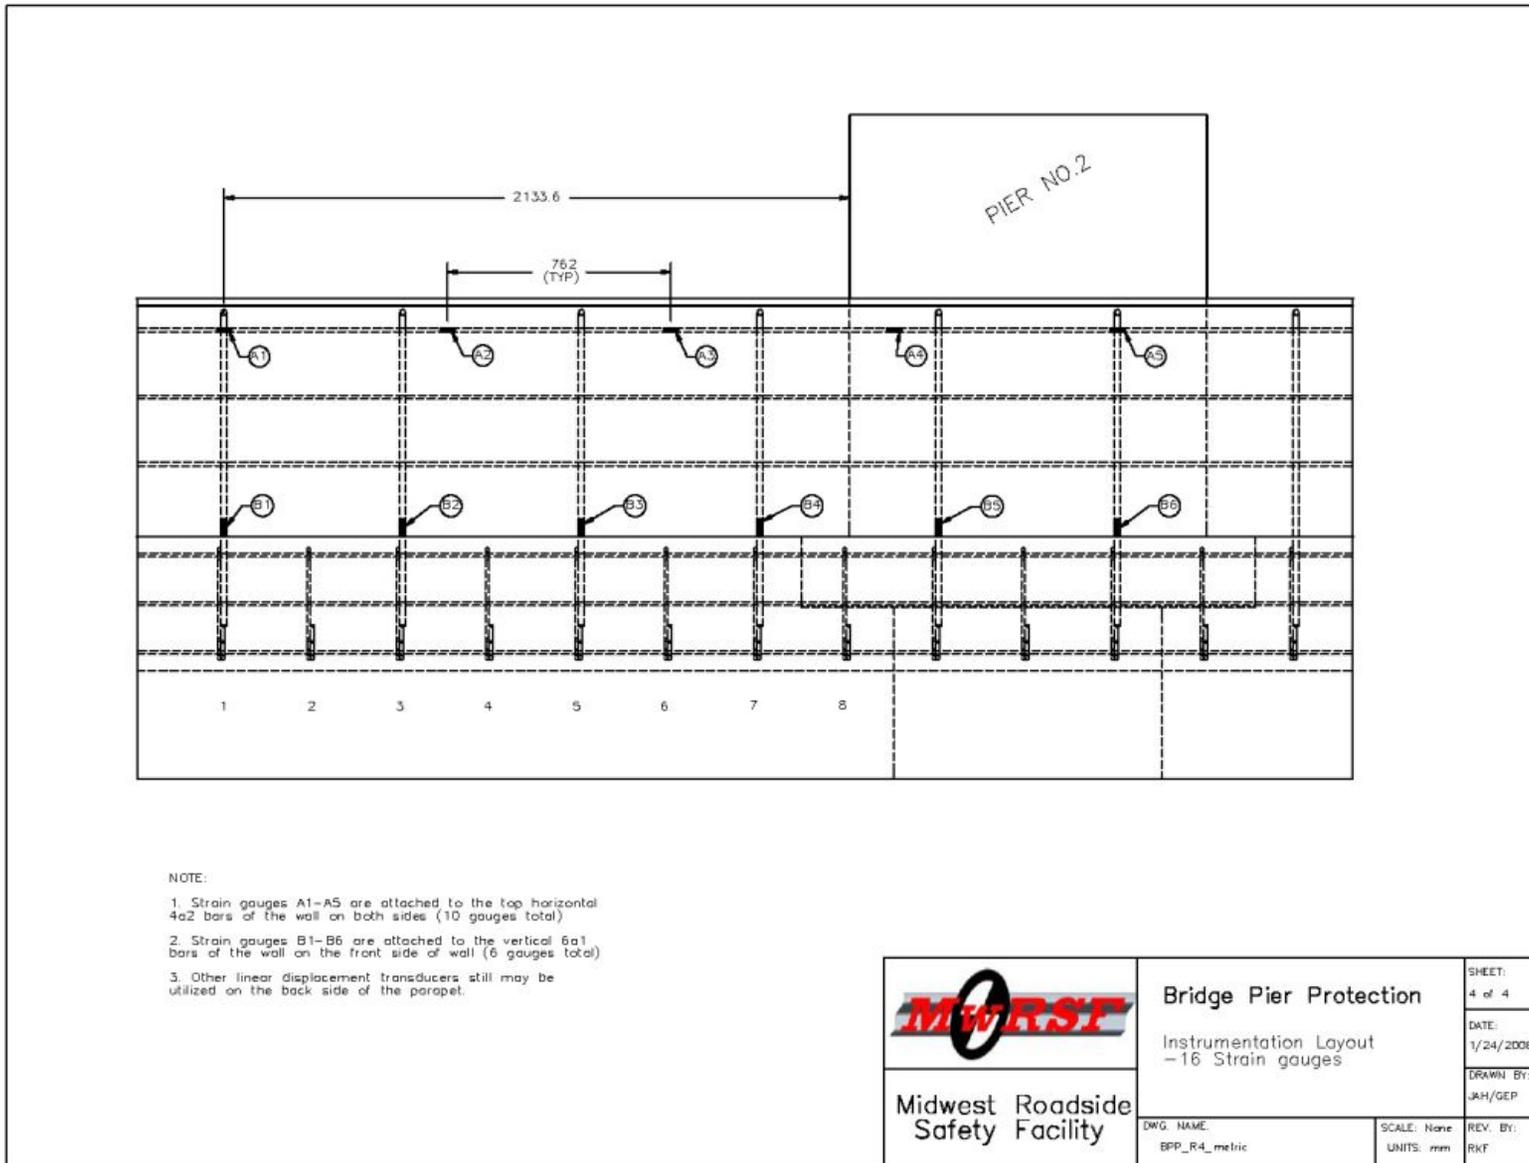
Figure 4. Location of Strain Gauges, Test CBPP-1

In preparation for crash test CBPP-1, a total of sixteen strain gauges were installed on the steel reinforcement within the concrete barrier. However, during the test, technical difficulties were encountered, thus resulting in no discernable data being collected from the strain gauges located on the longitudinal reinforcement. Data was collected and analyzed from the remaining six gauges which were located on the front legs of the vertical stirrups in the barrier and throughout the impact region, as noted in Figure 4 of Chapter 4. This data is shown graphically in Figure 31 and each strain gauge is shown independently in Appendix G.

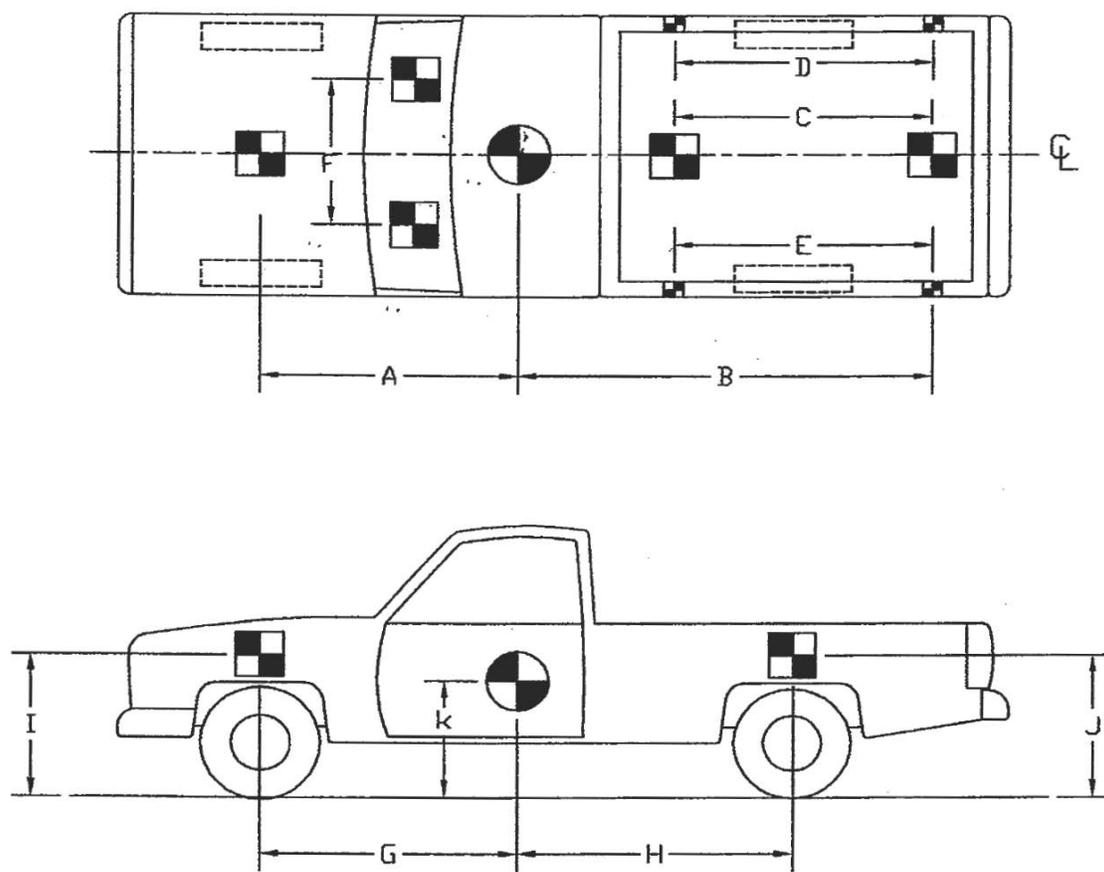
TEST #: CBPP-1
 TARGET GEOMETRY-- mm (in.)

A	<u>1600</u>	<u>(63.0)</u>	E	<u>2153</u>	<u>(84.75)</u>	I	<u>1003</u>	<u>(39.5)</u>
B	<u>2496</u>	<u>(98.25)</u>	F	<u>1003</u>	<u>(39.5)</u>	J	<u>1048</u>	<u>(41.25)</u>
C	<u>1410</u>	<u>(55.5)</u>	G	<u>1439</u>	<u>(56.66)</u>	K	<u>667</u>	<u>(26.25)</u>
D	<u>2153</u>	<u>(84.75)</u>	H	<u>1946</u>	<u>(76.6)</u>

Square black and white-checkered targets were placed on the vehicle to aid in the analysis of the high-speed VITcam videos, as shown in Figure 9. Round, checkered targets were placed on the center of gravity, on the left-side door, on the right-side door, and on the roof of the vehicle. The remaining targets were located for references so that they could be viewed from the high-speed cameras for video analysis.

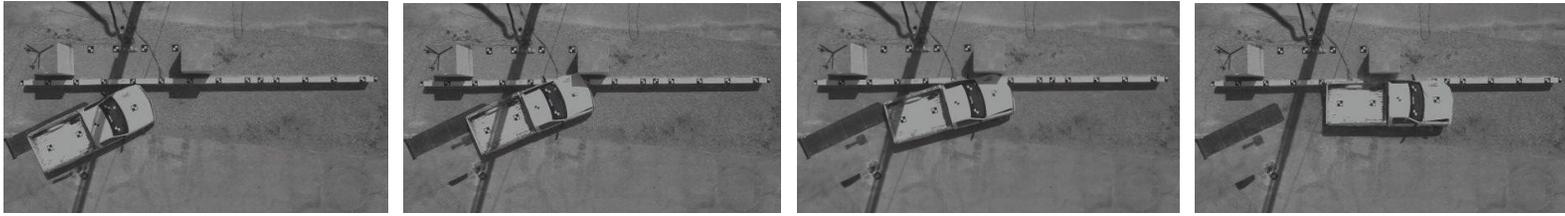
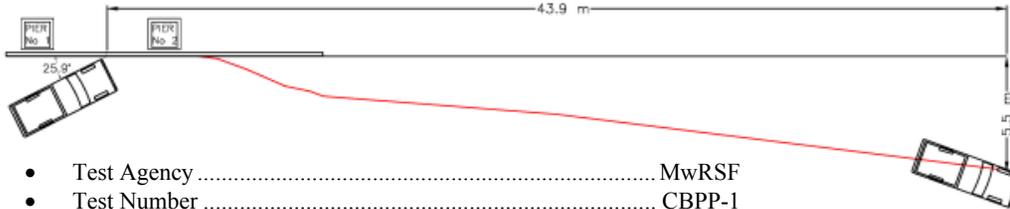
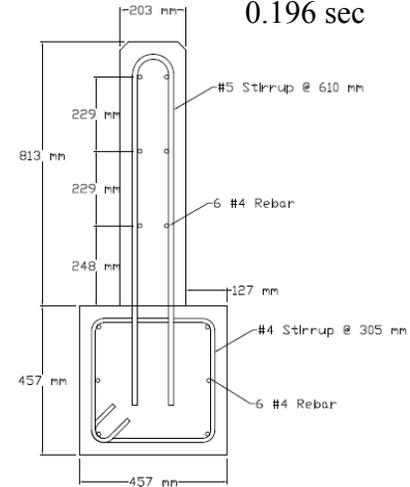
- Test Agency MwRSF
- Test Number CBPP-1
- Date 7/3/07
- NCHRP Report 350 Test Designation..... 3-11
- Test Article Concrete Pier Protection Barrier
- Concrete Material..... Nebraska L4000 mix
- Reinforcing Steel Material..... Grade 60 Rebar
- Concrete Barrier
 - Length 15.24 m
 - Width 203 mm
 - Height..... 813 mm
- Concrete Footing
 - Length 15.24 m
 - Width..... 457 mm
 - Depth..... 457 mm
- Vehicle Make and Model.....1999 Chevrolet C2500 Pickup
 - Curb.....2,098 kg
 - Test Inertial2,015 kg
 - Gross Static2,015 kg
- Impact Conditions
 - Speed 104.3 km/h
 - Angle25.9 deg
 - Impact Location..... 4.9 m from Upstream End
- Exit Conditions
 - Speed 79.9 km/h
 - Angle6.6 deg

- Vehicle Stability Satisfactory
- Occupant Ridedown Deceleration (10 msec avg.)
 - Longitudinal..... 6.97 g's
 - Lateral 9.66 g's
- Occupant Impact Velocity
 - Longitudinal..... 6.52 m/s
 - Lateral 7.74 m/s
- Vehicle DamageModerate
 - VDS^[16] 11-FL-5 and 11-RD-4
 - CDC^[17] 11-FLEN3 and 11-LDES2
- Vehicle Stopping Distance..... 44 m DS of impact, 5.5 m Laterally
- Test Article Damage Minimal
- Test Article Deflections
 - Permanent Set NA
 - Dynamic26 mm
 - Working Width.....504 mm

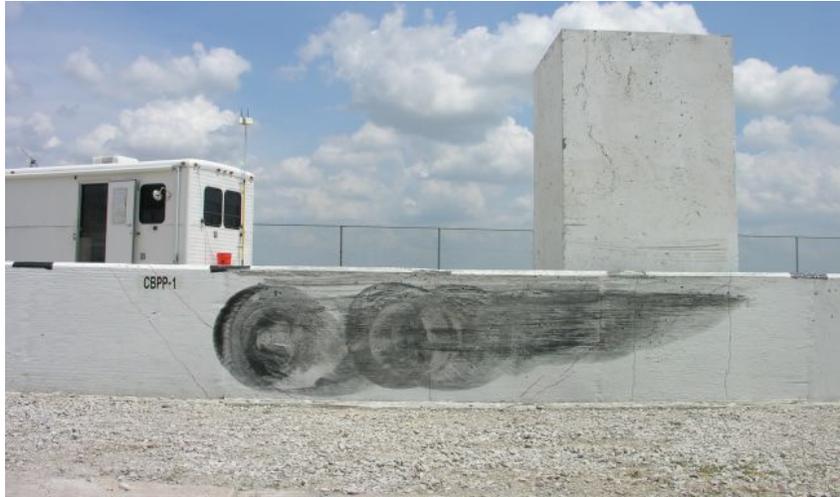
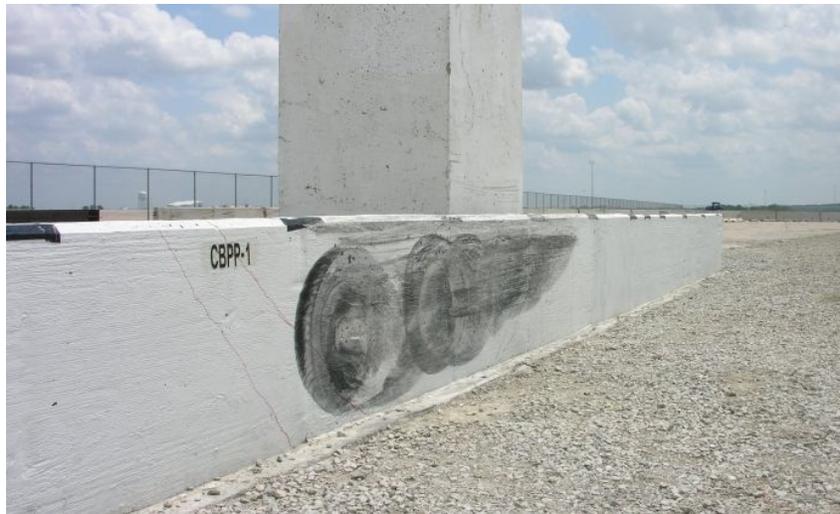
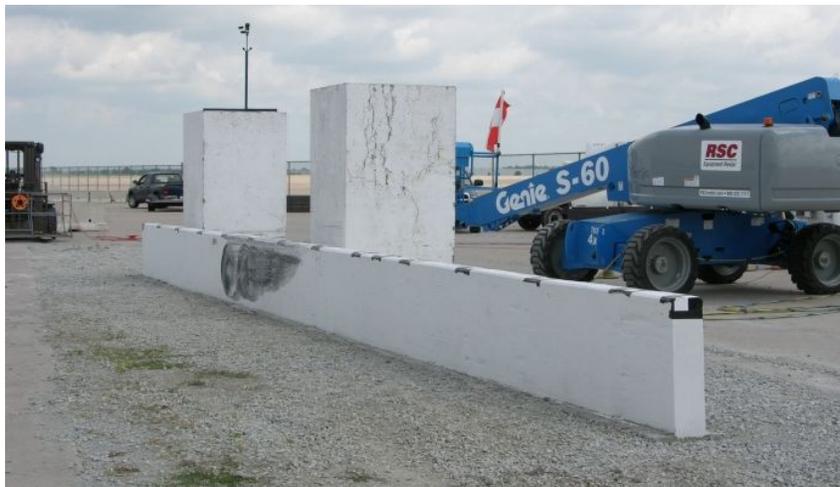
Figure 18. System Damage, Test CBPP-1

Damage to the barrier was minimal, as shown in Figures 18 through 22. The damage consisted of concrete cracks, spalling and gouging, and contact marks. All of the cracks found on the barrier were no wider than 2 mm (1/16 in.). Cracks on the front face of the barrier were diagonal and resembled the predicted yield line failure shape used for the structural analysis described in Chapter 3. The distance between the upstream cracks and the downstream cracks was 4,039 mm (159 in.) on the top of the barrier and 1,956 mm (77 in.) near the base of the barrier. The cracks on the back side of the barrier were nearly vertical and were located between the diagonal cracks on the front side of the barrier. All barrier cracks shown in Figures 20 and 21 were colored red to make them more visible. Any black lines represented cracks formed in the barrier during curing.

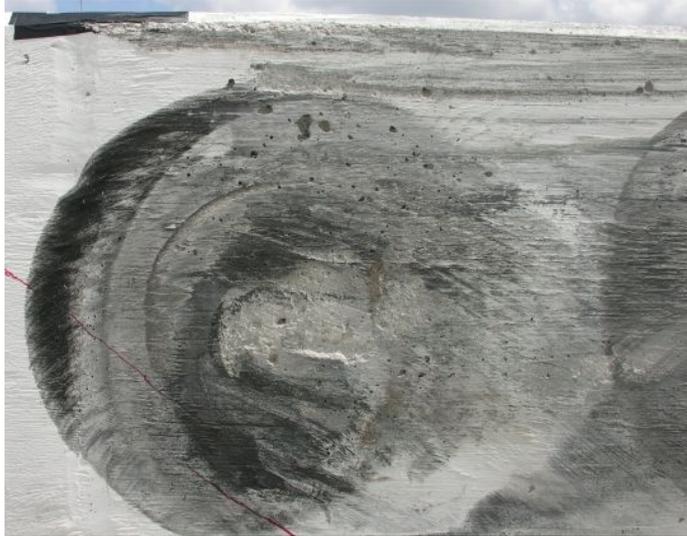
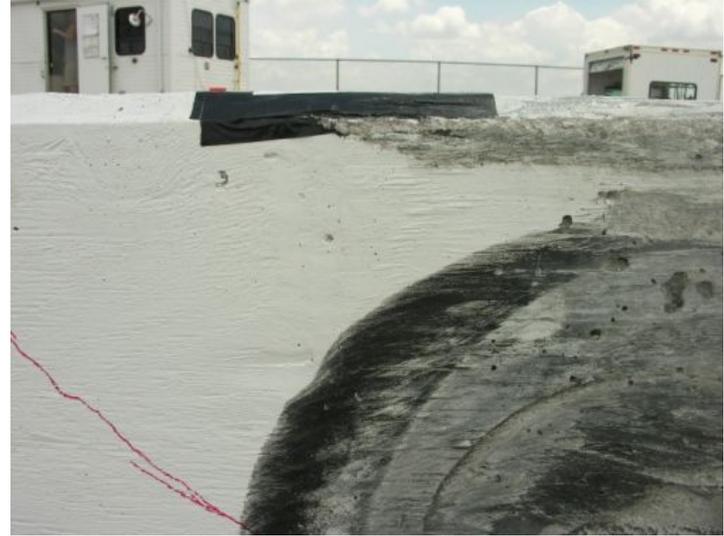
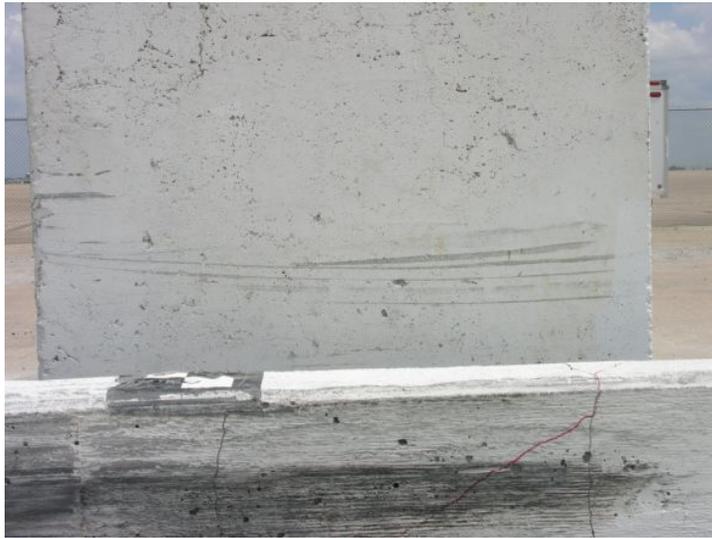
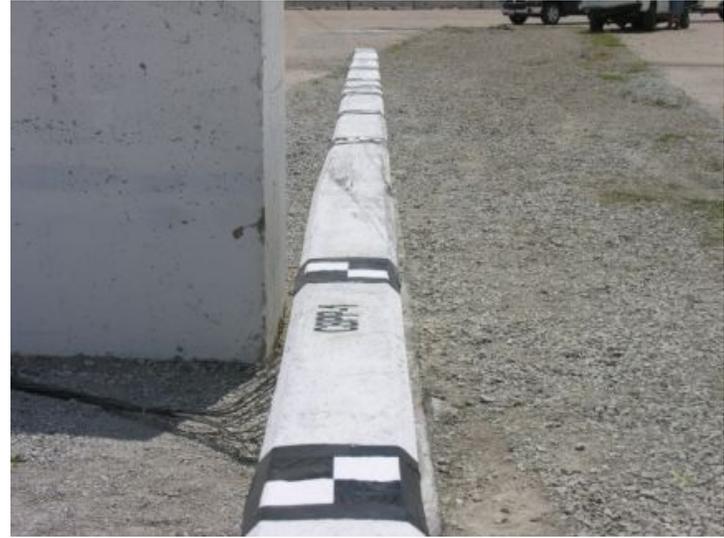
Figure 19. System Damage, Contact Marks and Gouging, Test CBPP-1

Contact marks were found on the barrier's front face, beginning 25 mm (1 in.) downstream of the initial targeted impact point and extending 3,378 mm (133 in.) downstream. Contact marks were also found on the front face of the bridge pier. Minor spalling was found along the front-top corner of the barrier, beginning 216 mm (8.5 in.) downstream of impact and extending 2,083 mm (82 in.) downstream. Also, a 216-mm (8.5-in.) long gouge mark was found

halfway up the barrier face 203 mm (8 in.) downstream of impact. These contact marks and instances of spalling and gouging are shown in Figure 19.

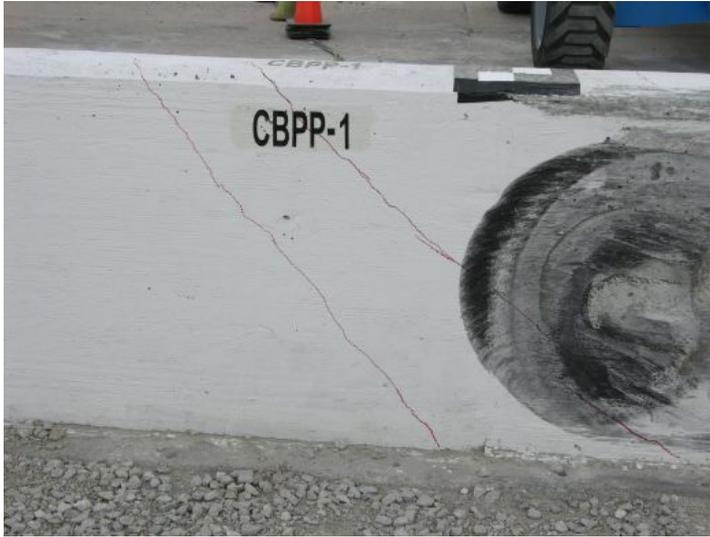
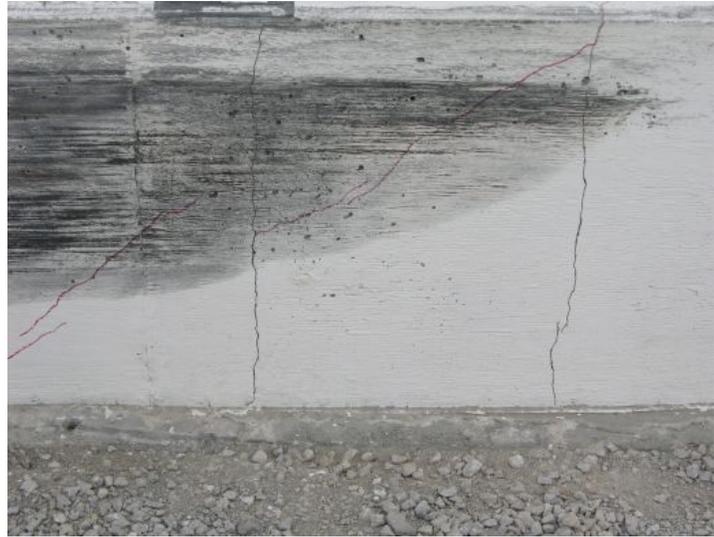
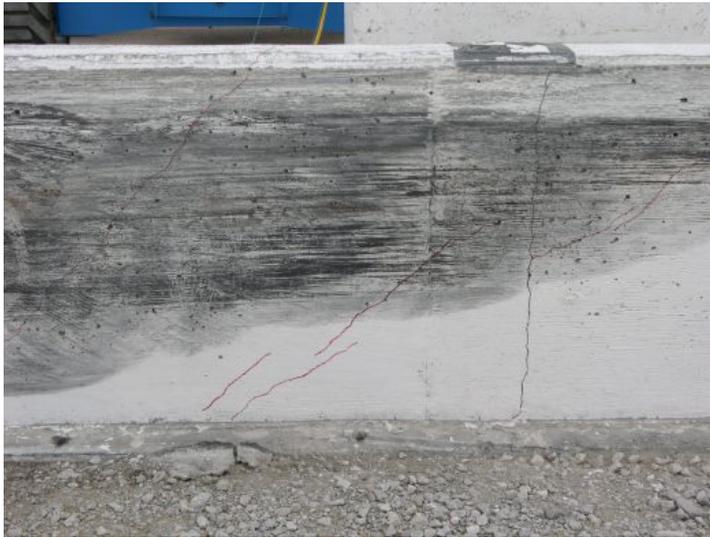
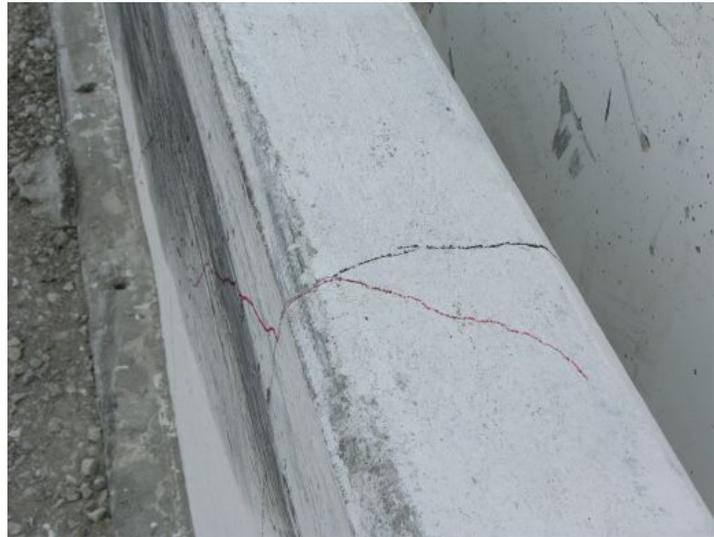
Figure 20. System Damage, Front Side Concrete Cracks, Test CBPP-1

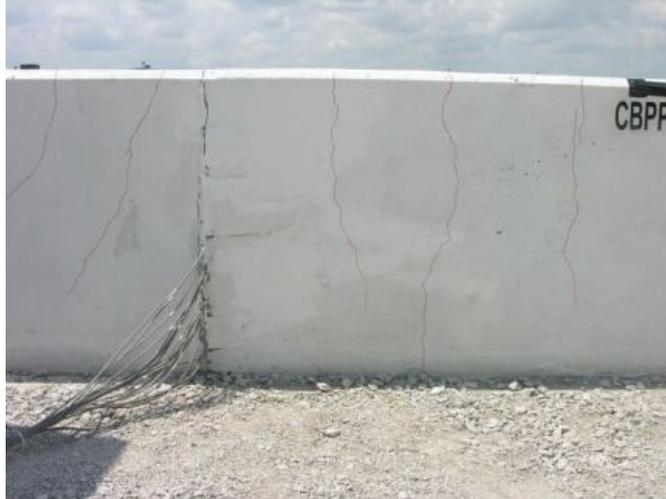
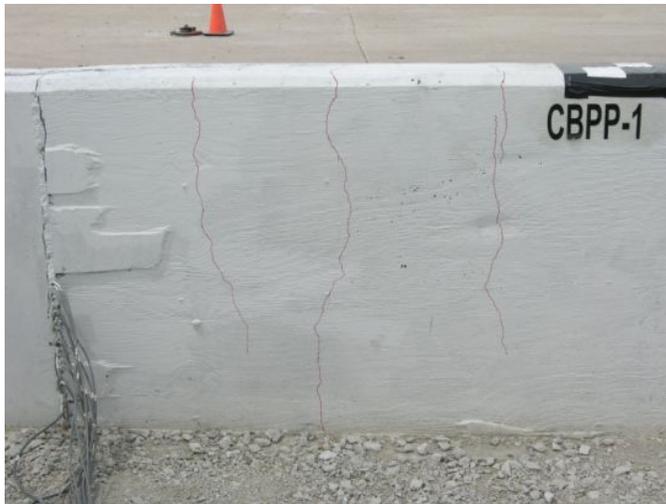
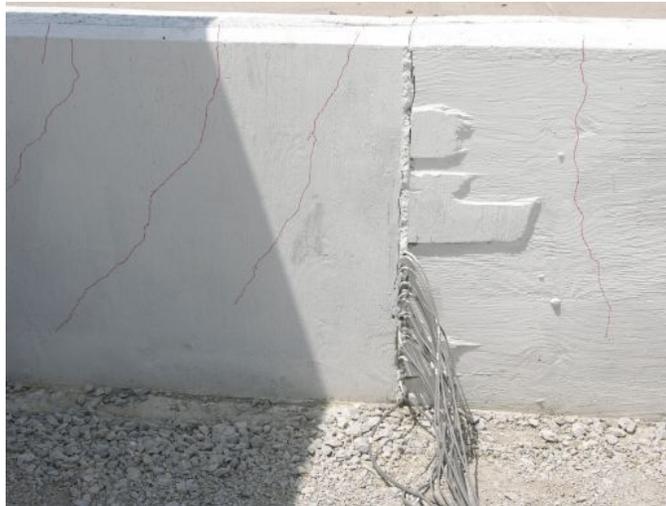
Figure 21. System Damage, Back Side Concrete Cracks, Test CBPP-1

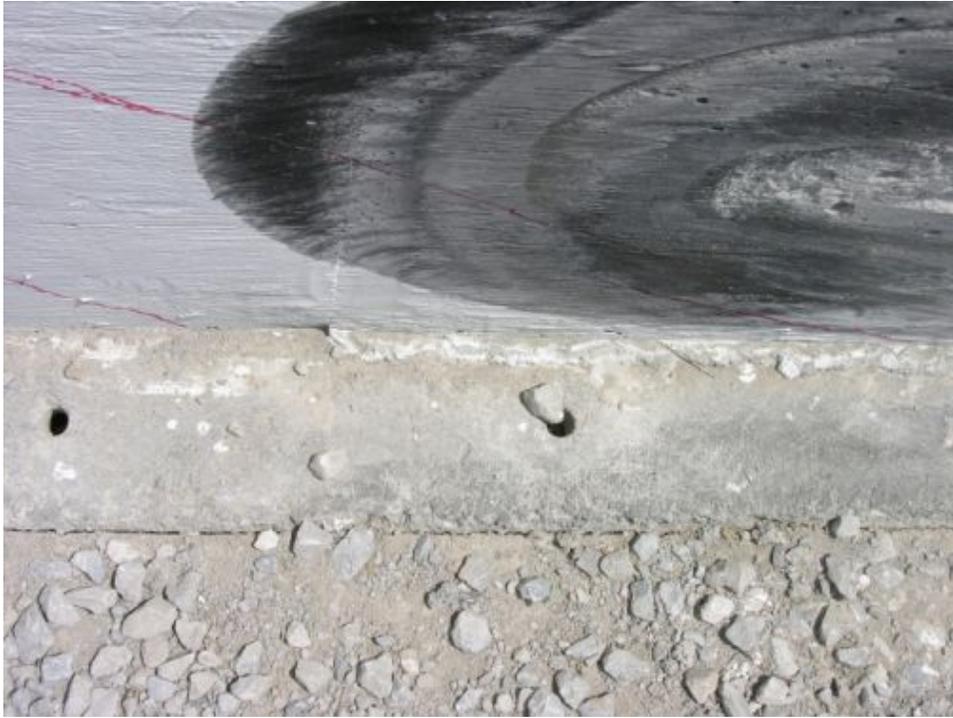
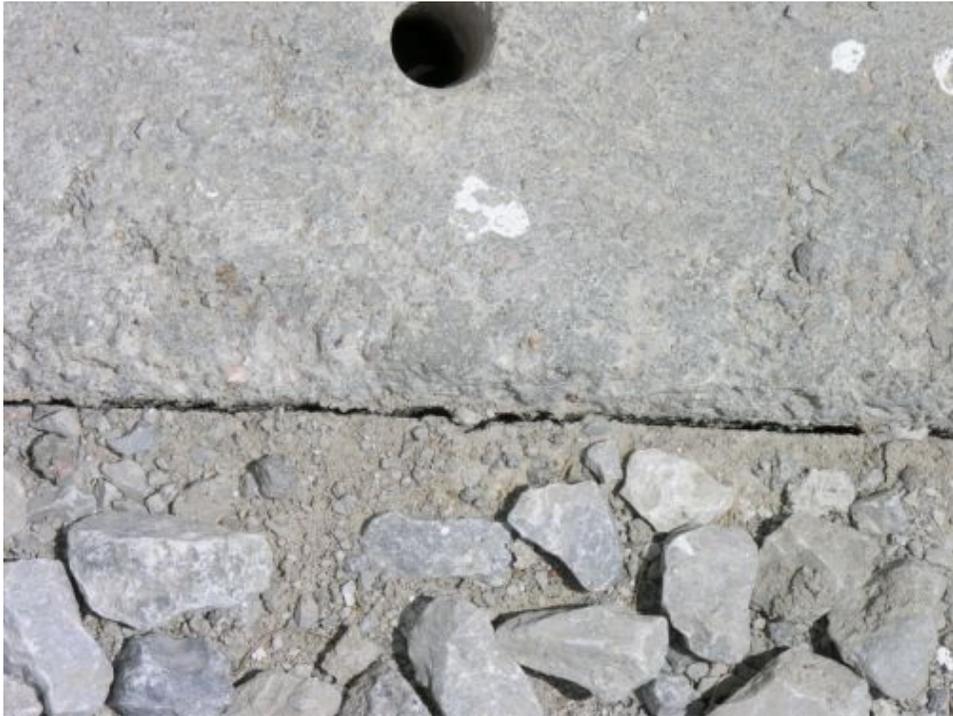
Figure 22. System Damage, Soil Gap, Test CBPP-1

Finally, a minor soil gap was found along the base of the barrier on the front side. The gap measured approximately 3 mm (0.125 in.) wide and extended through the area of impact. This gap is shown in Figure 22. The maximum dynamic deflection was 26 mm (1 in.) and the permanent set was negligible. The working width was found to be 504 mm (19.8 in.)

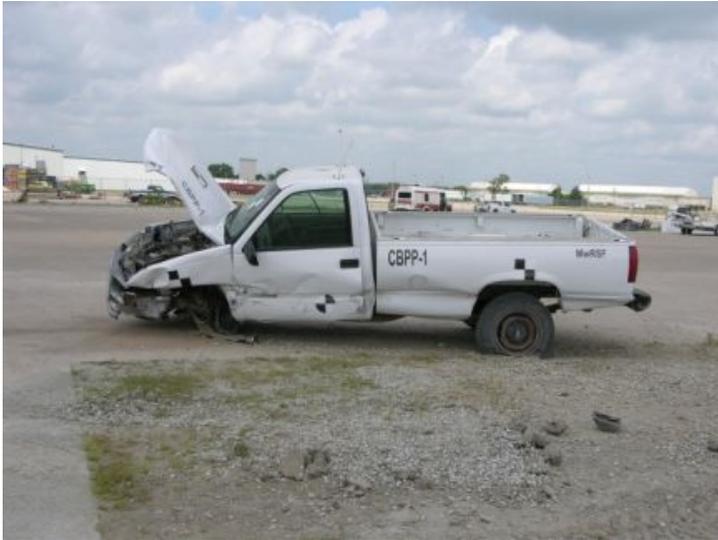
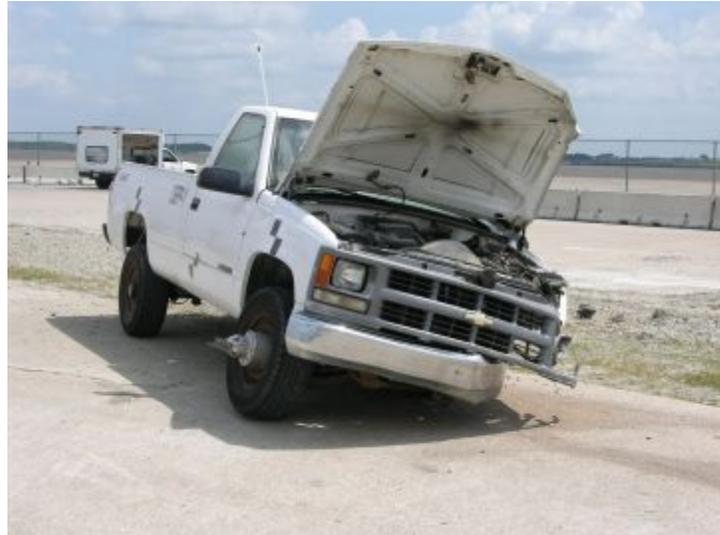
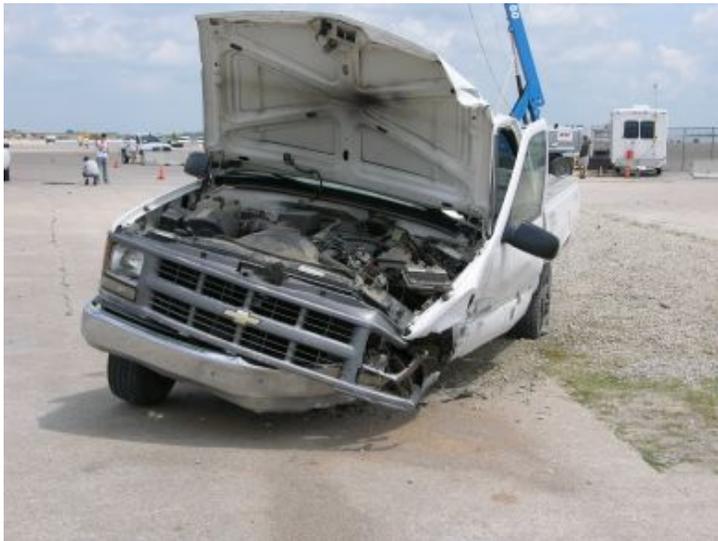
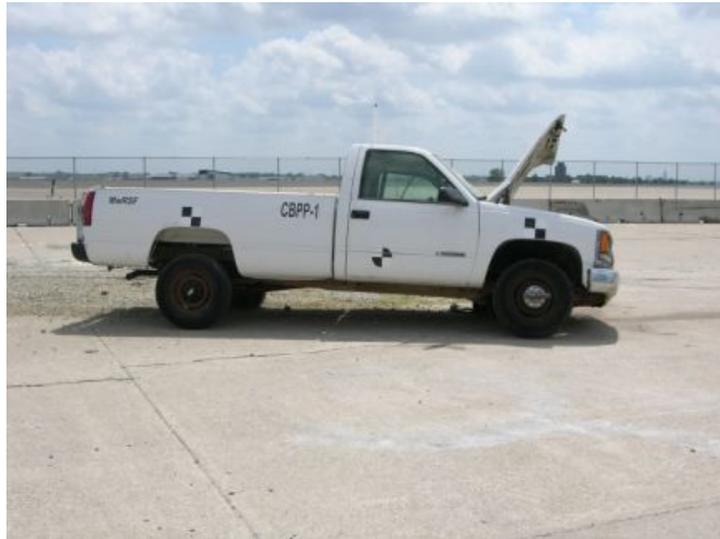
Figure 23. Vehicle Damage, Test CBPP-1

The damage to the vehicle was moderate, as shown in Figures 23 through 29. The most severe damage was located at the left-front region of the vehicle, as shown in Figure 24. The left-front corner of the vehicle was crushed inward toward the engine with the bumper buckling near the center. The left-front headlight disengaged, and the left-front tire was disengaged from the rim. Both the lower control arm and the anti-roll bar were also disengaged from the left-front wheel assembly.

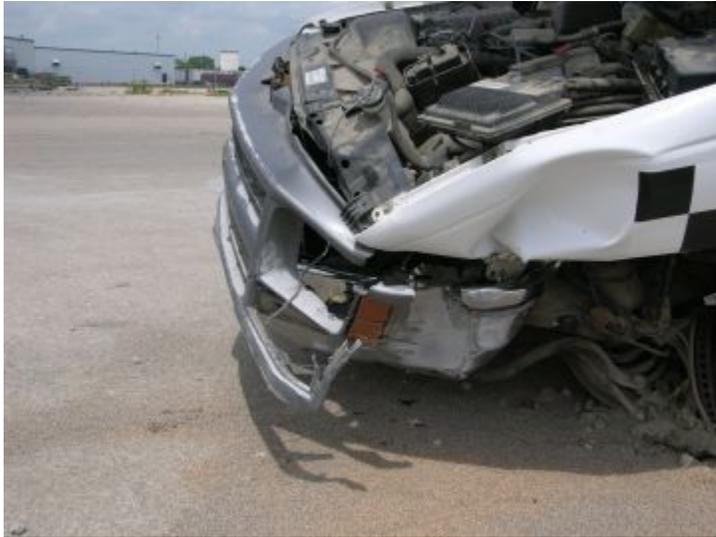
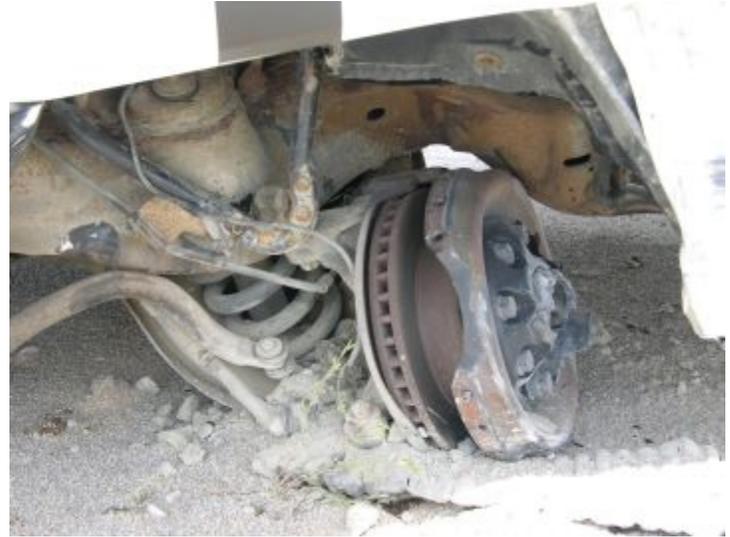
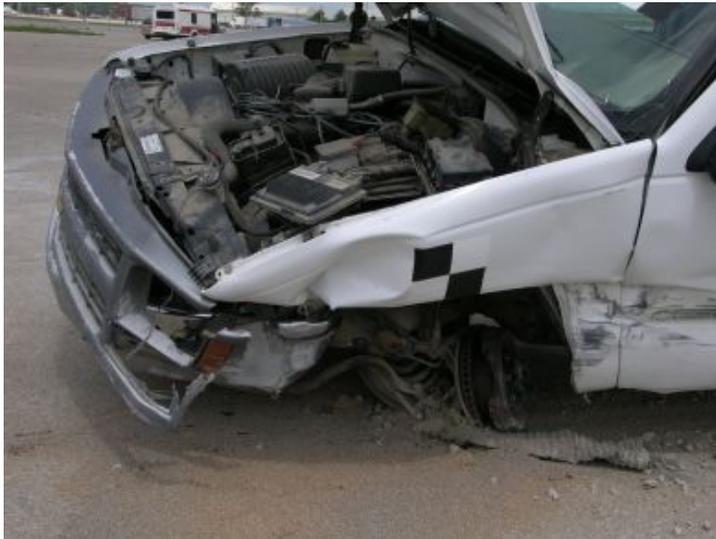
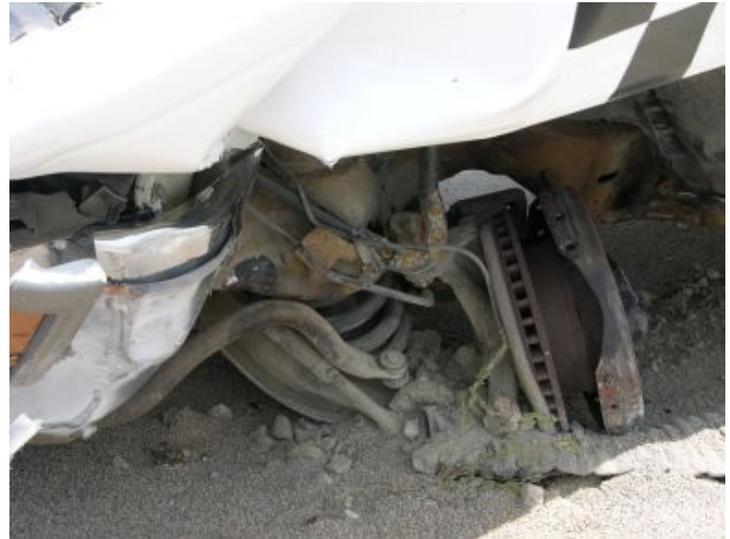
Figure 24. Vehicle Damage, Left-Front Wheel, Test CBPP-1

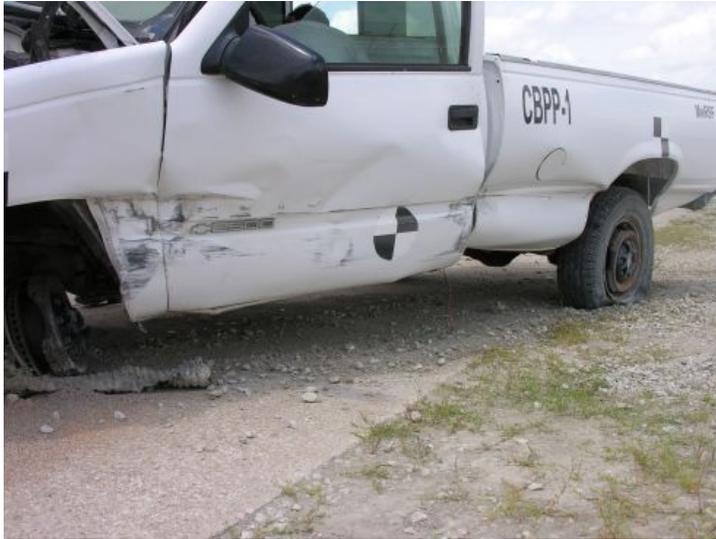
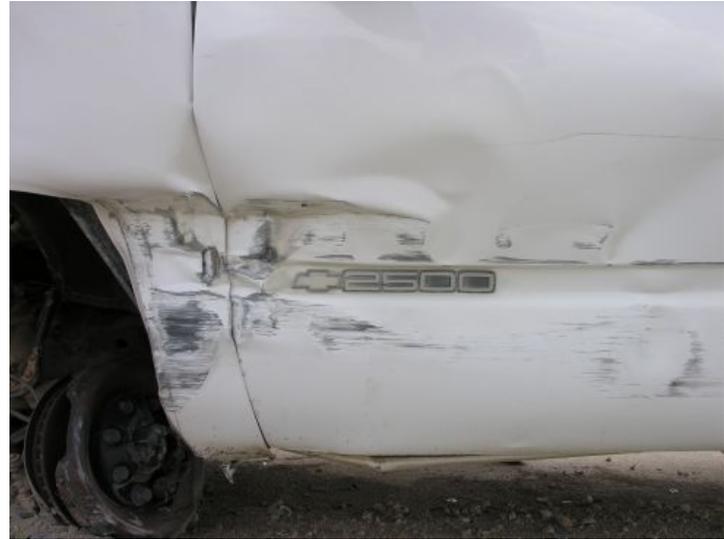
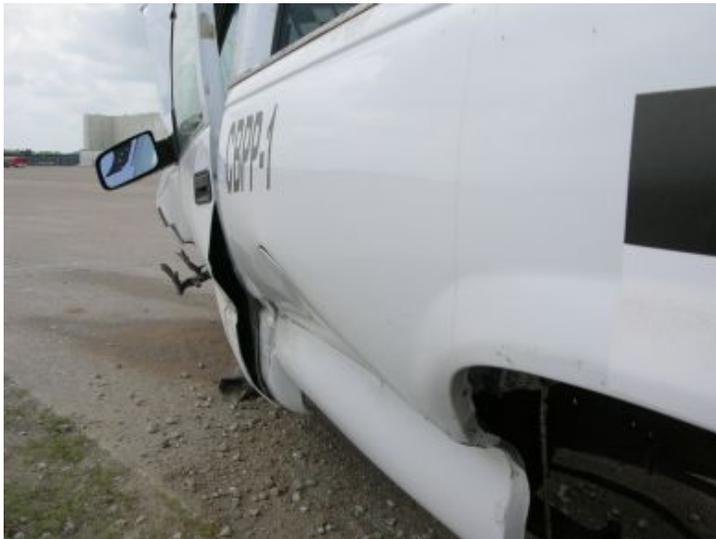
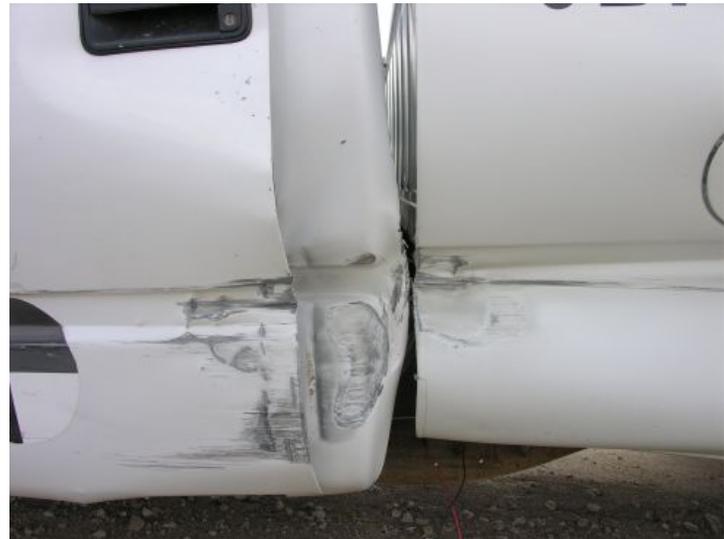
Figure 25. Vehicle Damage, Left Side, Test CBPP-1

Gouges, indentations, and scratches were found along the entire left side of the vehicle, as shown in Figure 25. Two gouges were found on the lower portion of the left-side door, each measuring about 25 mm (1 in.) wide. A major indentation, measuring 102 mm (4 in.) deep, was found directly in front of the left-rear wheel well. The top of the left-side door was separated from the rest of the cab, as shown in Figure 26, and the left-rear tire was deflated.
