DEVELOPMENT OF A STAND-ALONE CONCRETE BRIDGE PIER PROTECTION SYSTEM

MwRSF Research Report No. TRP-03-190-08

April 18, 2008

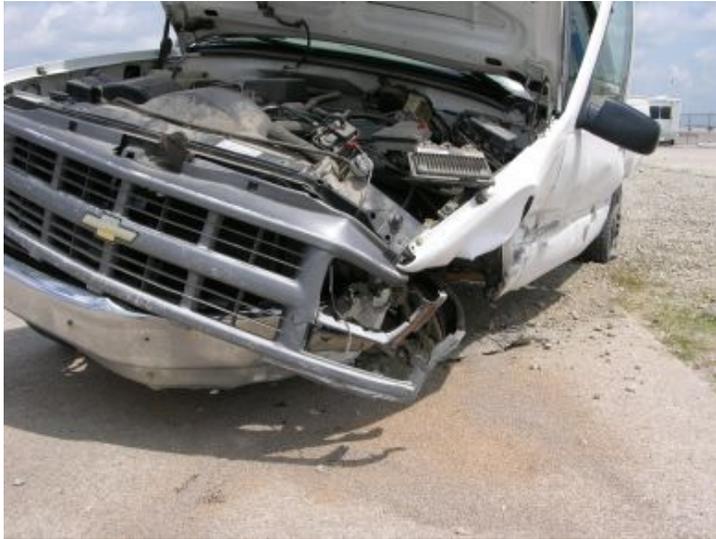
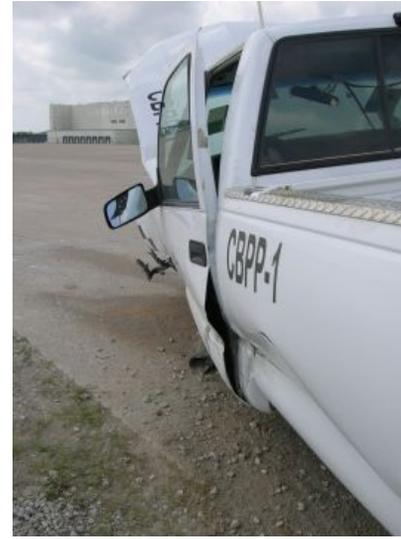
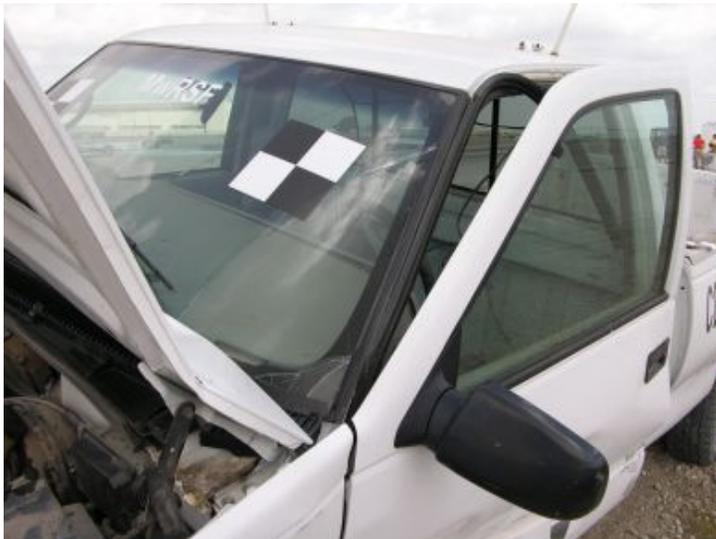
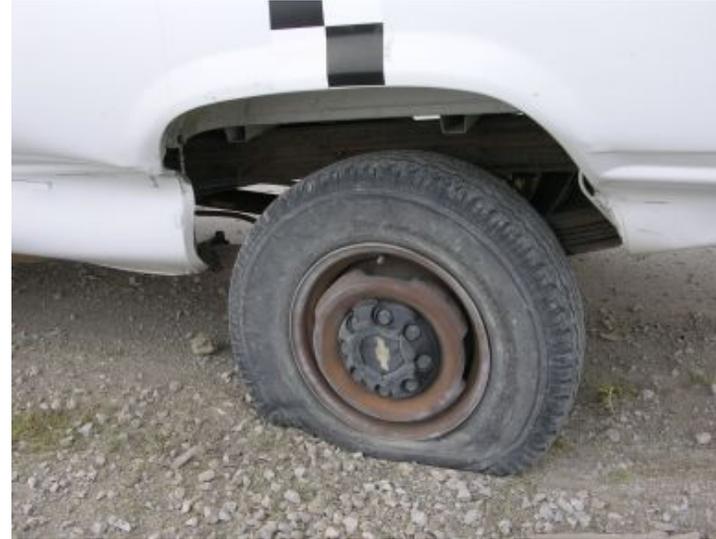
Figure 26. Vehicle Damage, Left Side, Test CBPP-1

Gouges, indentations, and scratches were found along the entire left side of the vehicle, as shown in Figure 25. Two gouges were found on the lower portion of the left-side door, each measuring about 25 mm (1 in.) wide. A major indentation, measuring 102 mm (4 in.) deep, was found directly in front of the left-rear wheel well. The top of the left-side door was separated from the rest of the cab, as shown in Figure 26, and the left-rear tire was deflated.

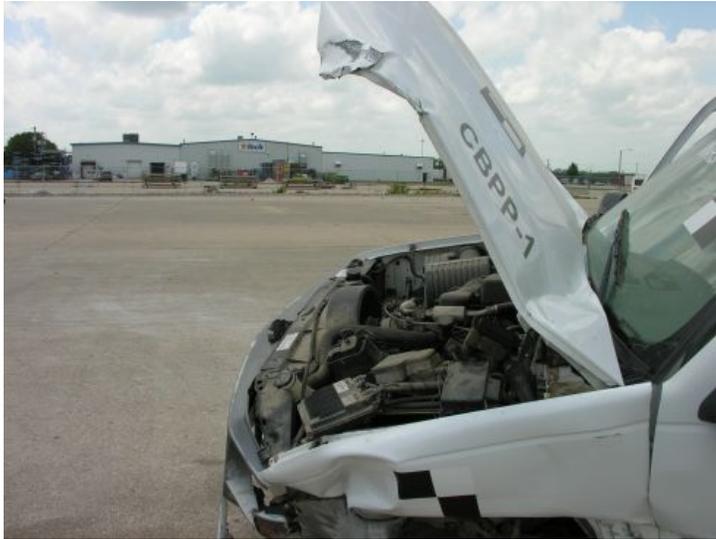
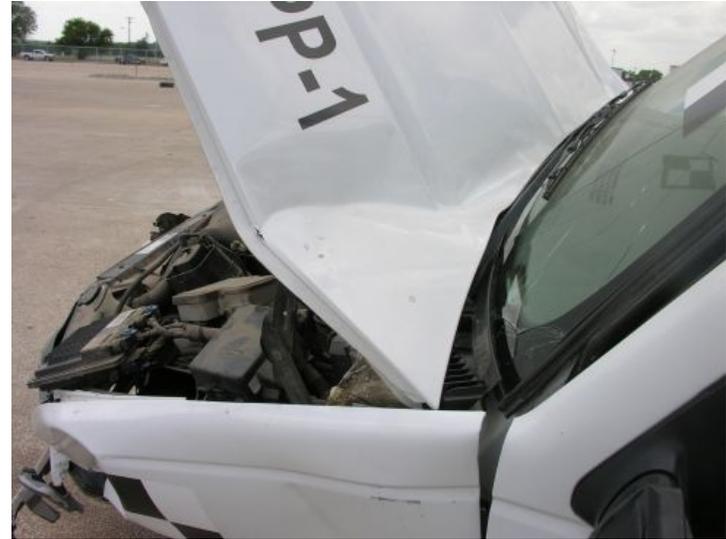
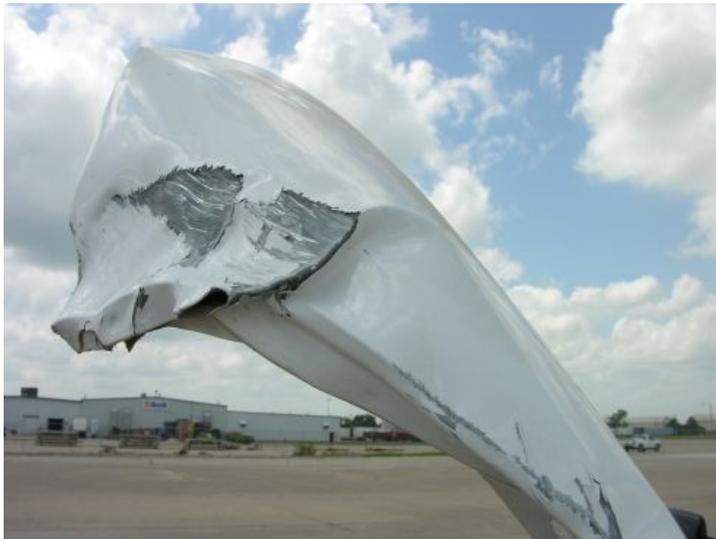
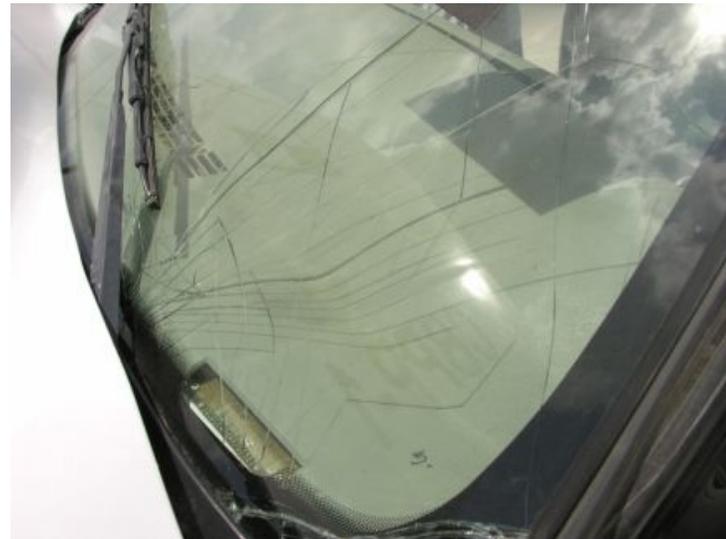
Figure 27. Vehicle Damage, Hood and Windshield, Test CBPP-1

As shown in Figure 27, the engine hood was dented and buckled. Localized damage in the form of folding and scrapes was found on the left-front corner of the hood from contact between the hood and the pier. The front of the hood was disengaged from the vehicle, and the hood was buckled near the windshield. Cracks were found in the windshield spreading from the left-lower corner to the top and middle.

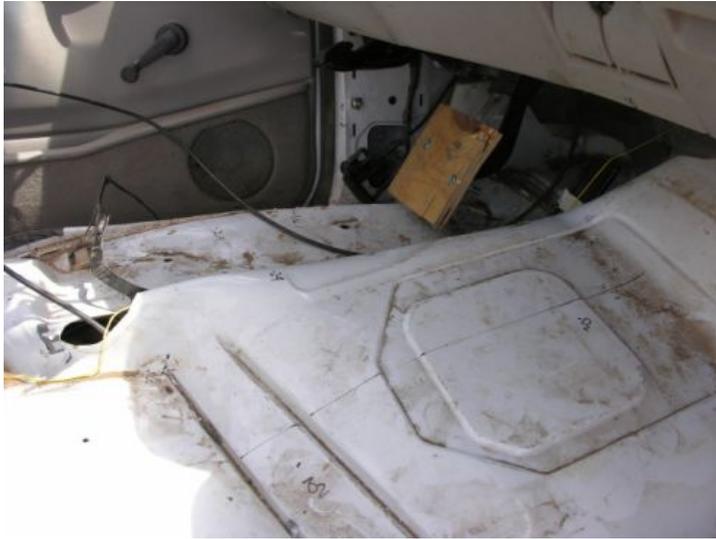
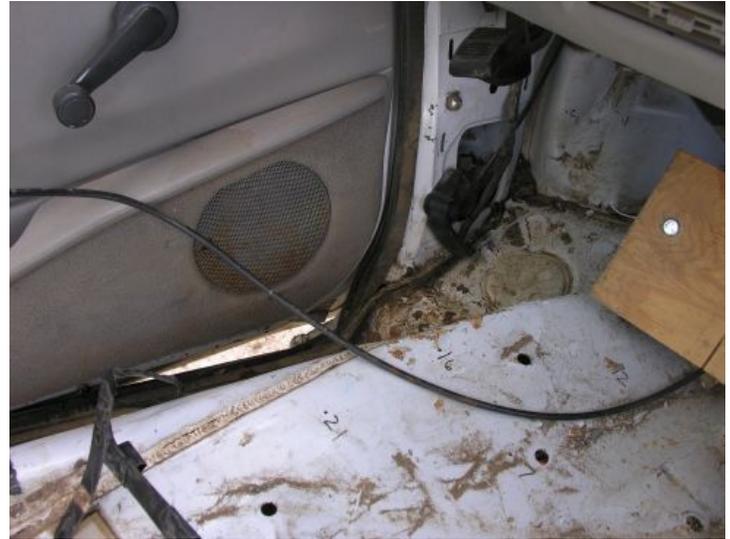
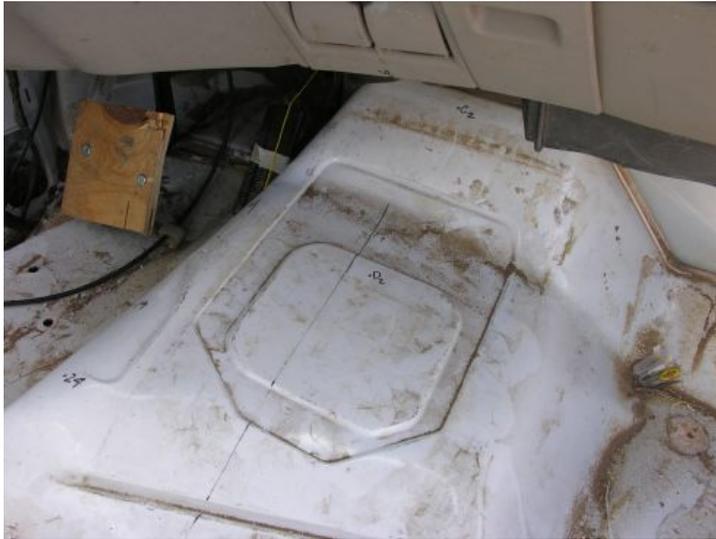
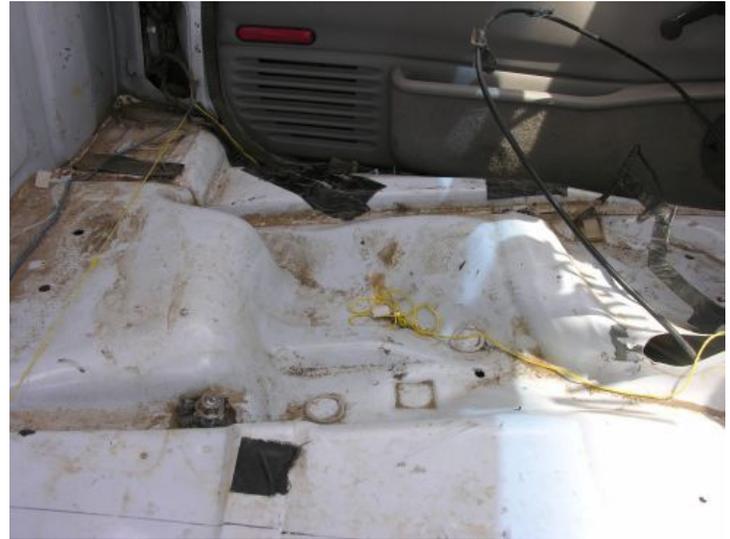
Figure 28. Vehicle Damage, Occupant Compartment, Test CBPP-1

Occupant compartment deformations to the left side and center of the floorboard, as shown in Figure 28, were judged insufficient to cause serious injury to the vehicle occupants. A maximum longitudinal deformation of 83 mm (3.25 in.) was located near the left-front side of the floorboard. A maximum lateral deflection of 133 mm (5.25 in.) was located along the left side of the floorboard. A maximum vertical deflection of 89 mm (3.5 in.) was located near the center of the floorboard. Deformations were recorded from two separate reference points before and after the test. Complete occupant compartment deformations and the corresponding locations are provided in Appendix E.

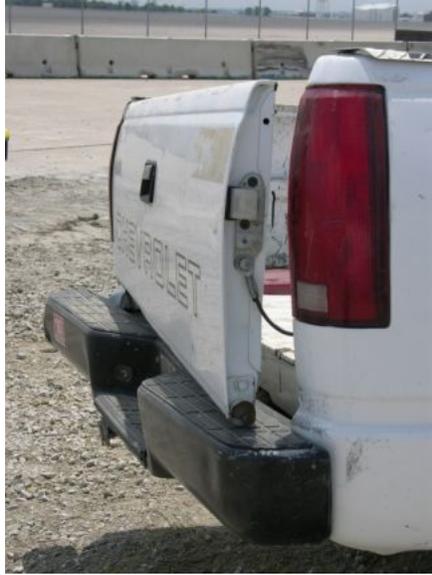
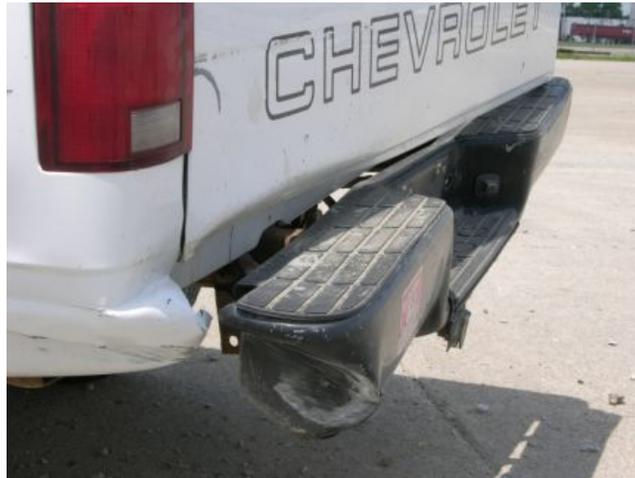
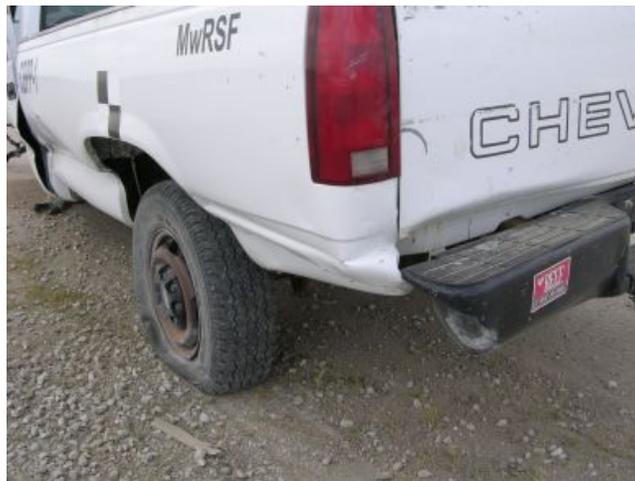
Figure 29. Vehicle Damage, Rear of Vehicle, Test CBPP-1

The rear of the vehicle received minimal exterior damage. As shown in Figure 29, the tailgate became detached from the right side of the pickup truck bed. The left-side face of the rear bumper had a 76 mm (3 in.) indentation, and the entire left side of the rear bumper was detached from the truck. Finally, the entire pickup truck bed was shifted 25 mm (1 in.) toward the left side of the cab.

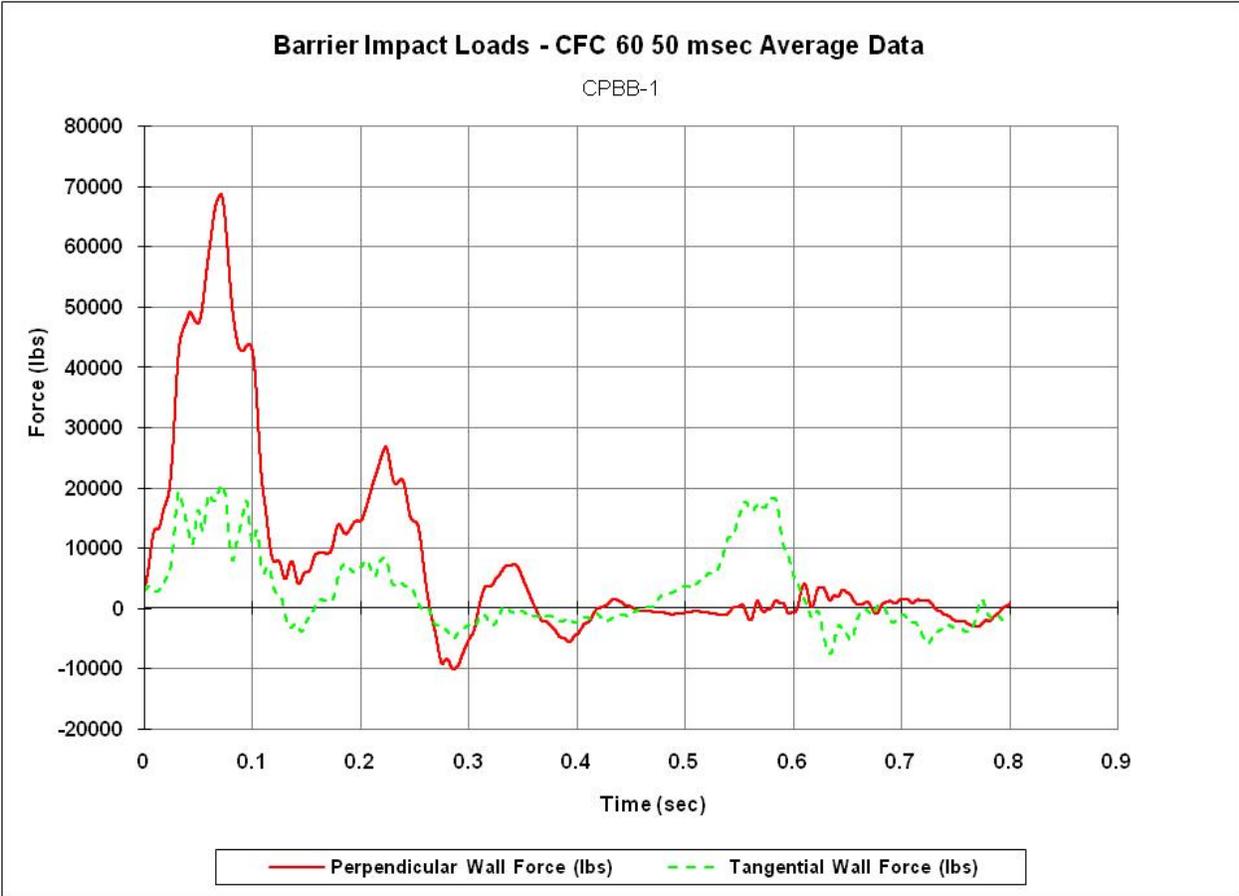
Figure 30. Lateral and Longitudinal Impact Forces vs. Time, Test CBPP-1

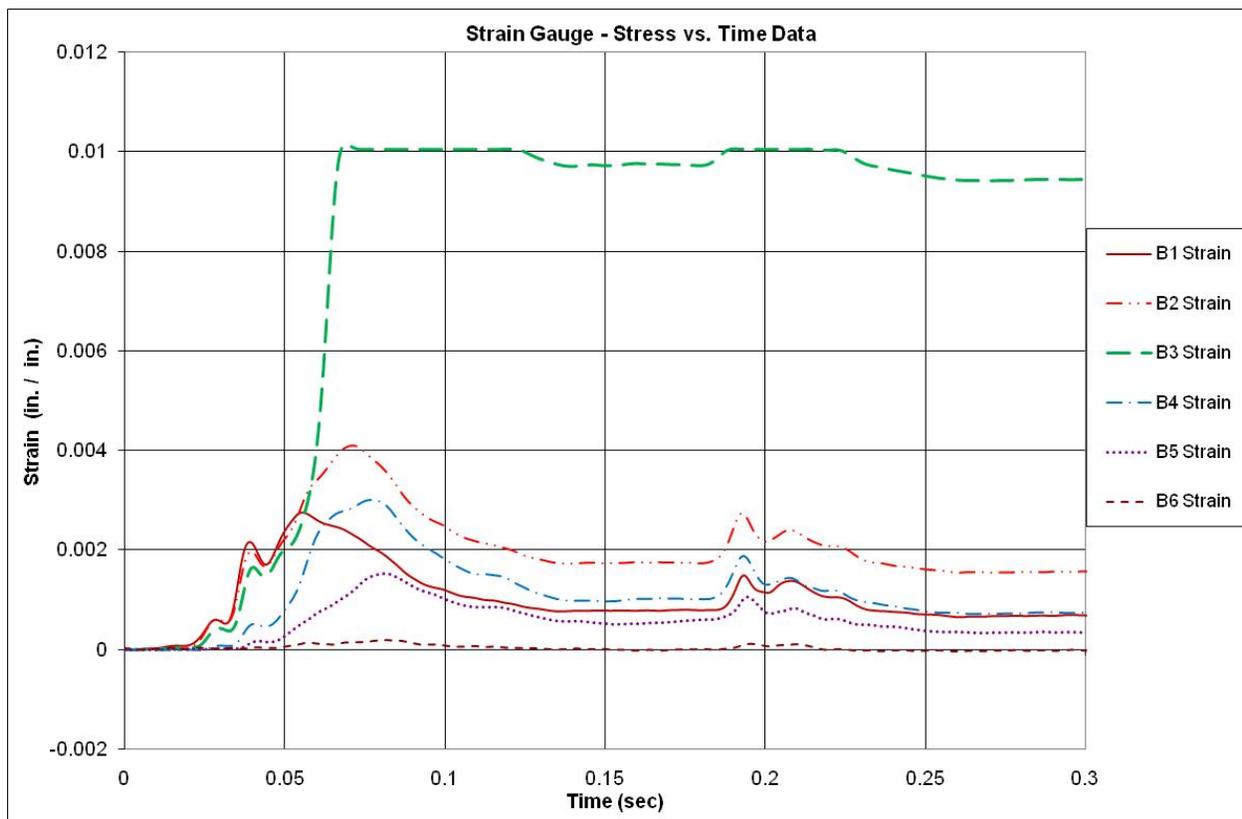
Figure 31. Strain vs. Time Data From Strain Gauge Results

In preparation for crash test CBPP-1, a total of sixteen strain gauges were installed on the steel reinforcement within the concrete barrier. However, during the test, technical difficulties were encountered, thus resulting in no discernable data being collected from the strain gauges located on the longitudinal reinforcement. Data was collected and analyzed from the remaining six gauges which were located on the front legs of the vertical stirrups in the barrier and throughout the impact region, as noted in Figure 4 of Chapter 4. This data is shown graphically in Figure 31 and each strain gauge is shown independently in Appendix G.

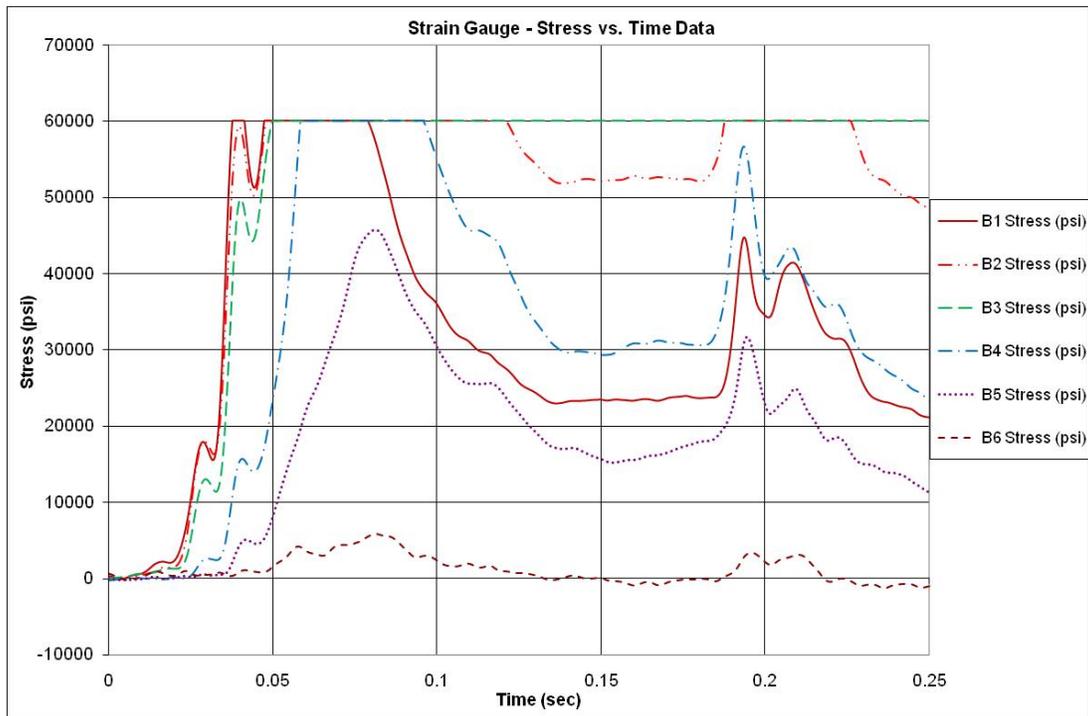
Figure 32. Stress vs. Time Data From Strain Gauge Results

The calculated stresses were limited to 414 MPa (60 ksi), at which point the rebar would hypothetically have begun to yield and where the linear-elastic relation between stress and strain no longer applied. Solving the more complex, plastic relation between stress and strain was

considered unnecessary since all of the design calculations were based on the yield-line capacity of barrier using minimum yield strength. With the absence of data from the longitudinal rebars, a more complete analysis of the load imparted to the barrier could not be performed. The resulting stress levels in the vertical bars are shown in Figure 32.

Strain gauge B3, which was located in the middle of the impact region, recorded the most deformation as it was the only gauge to bottom out. Thus, the stirrup at this location observed the highest strain. The recorded strains from the rest of the gauges decreased with an increased distance away from gauge B3. This fact was evident in Figure 32 by observing strains in gauges B2 and B4, which observed the next highest strains, followed by readings at gauges B1, B5, and finally B6. The time that the peak loading was observed from the strain gauge data, approximately 0.050 sec after impact, matched the time corresponding to the peak lateral impact

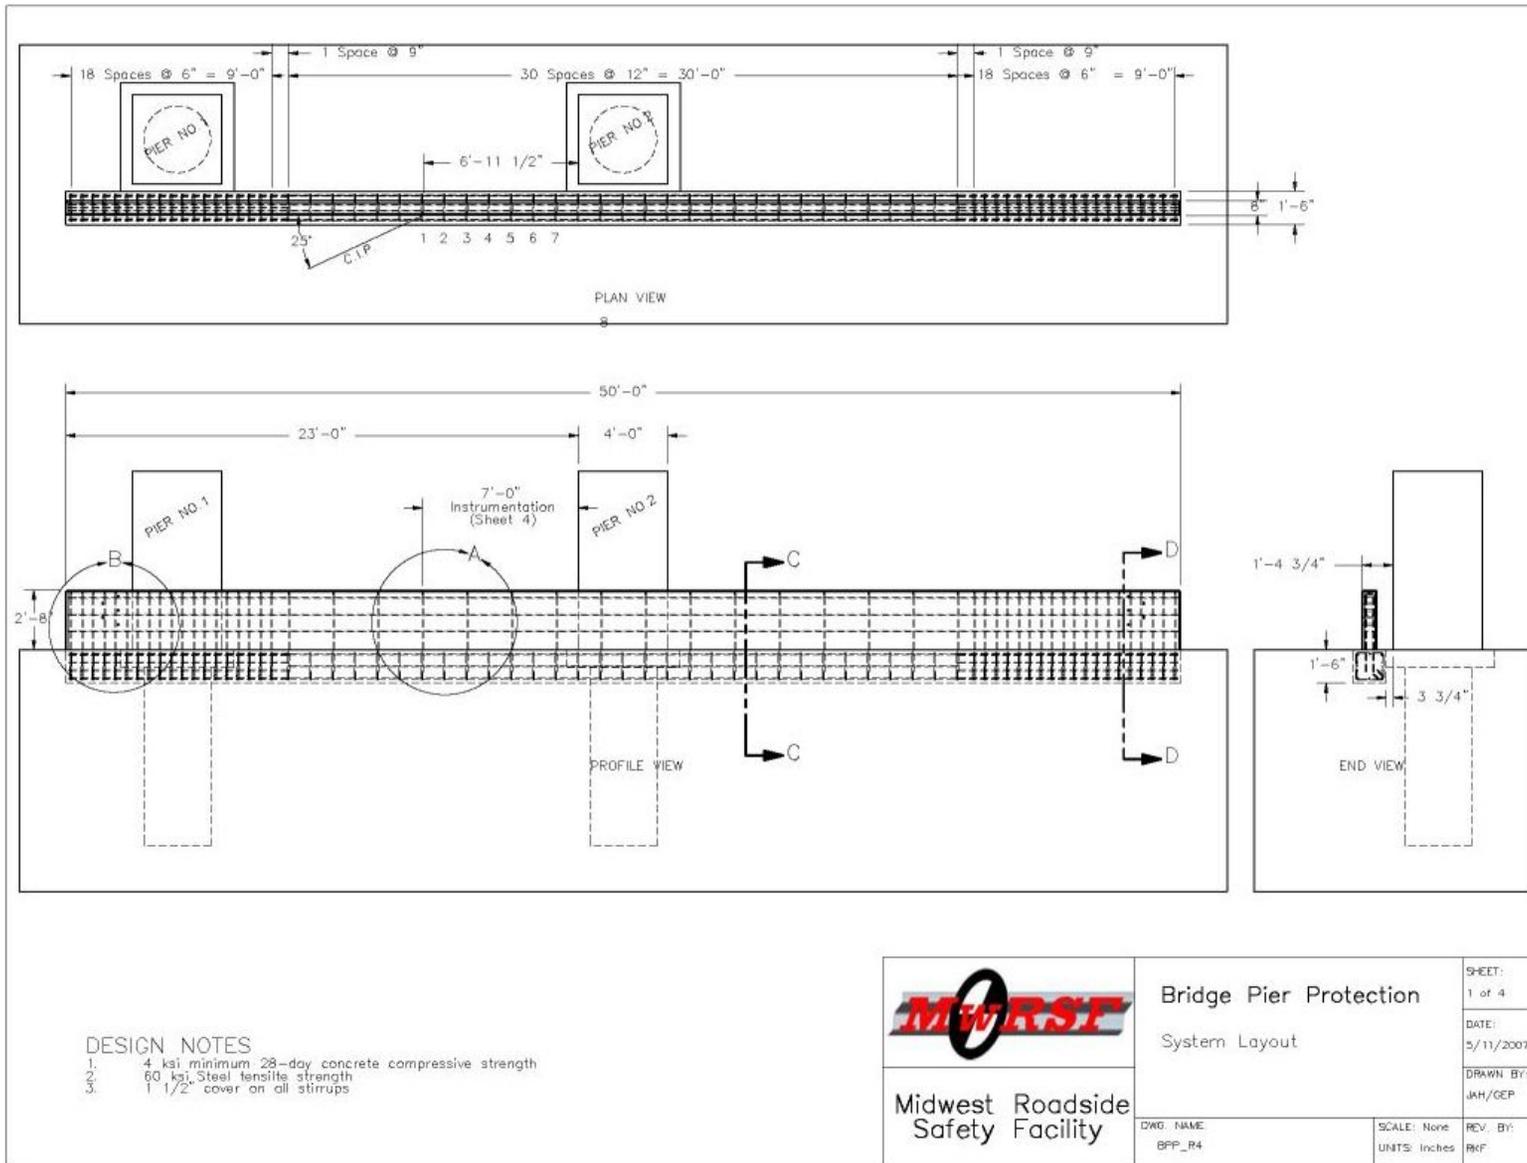
Figure C-1. Test Installation Layout, Test CBPP-1

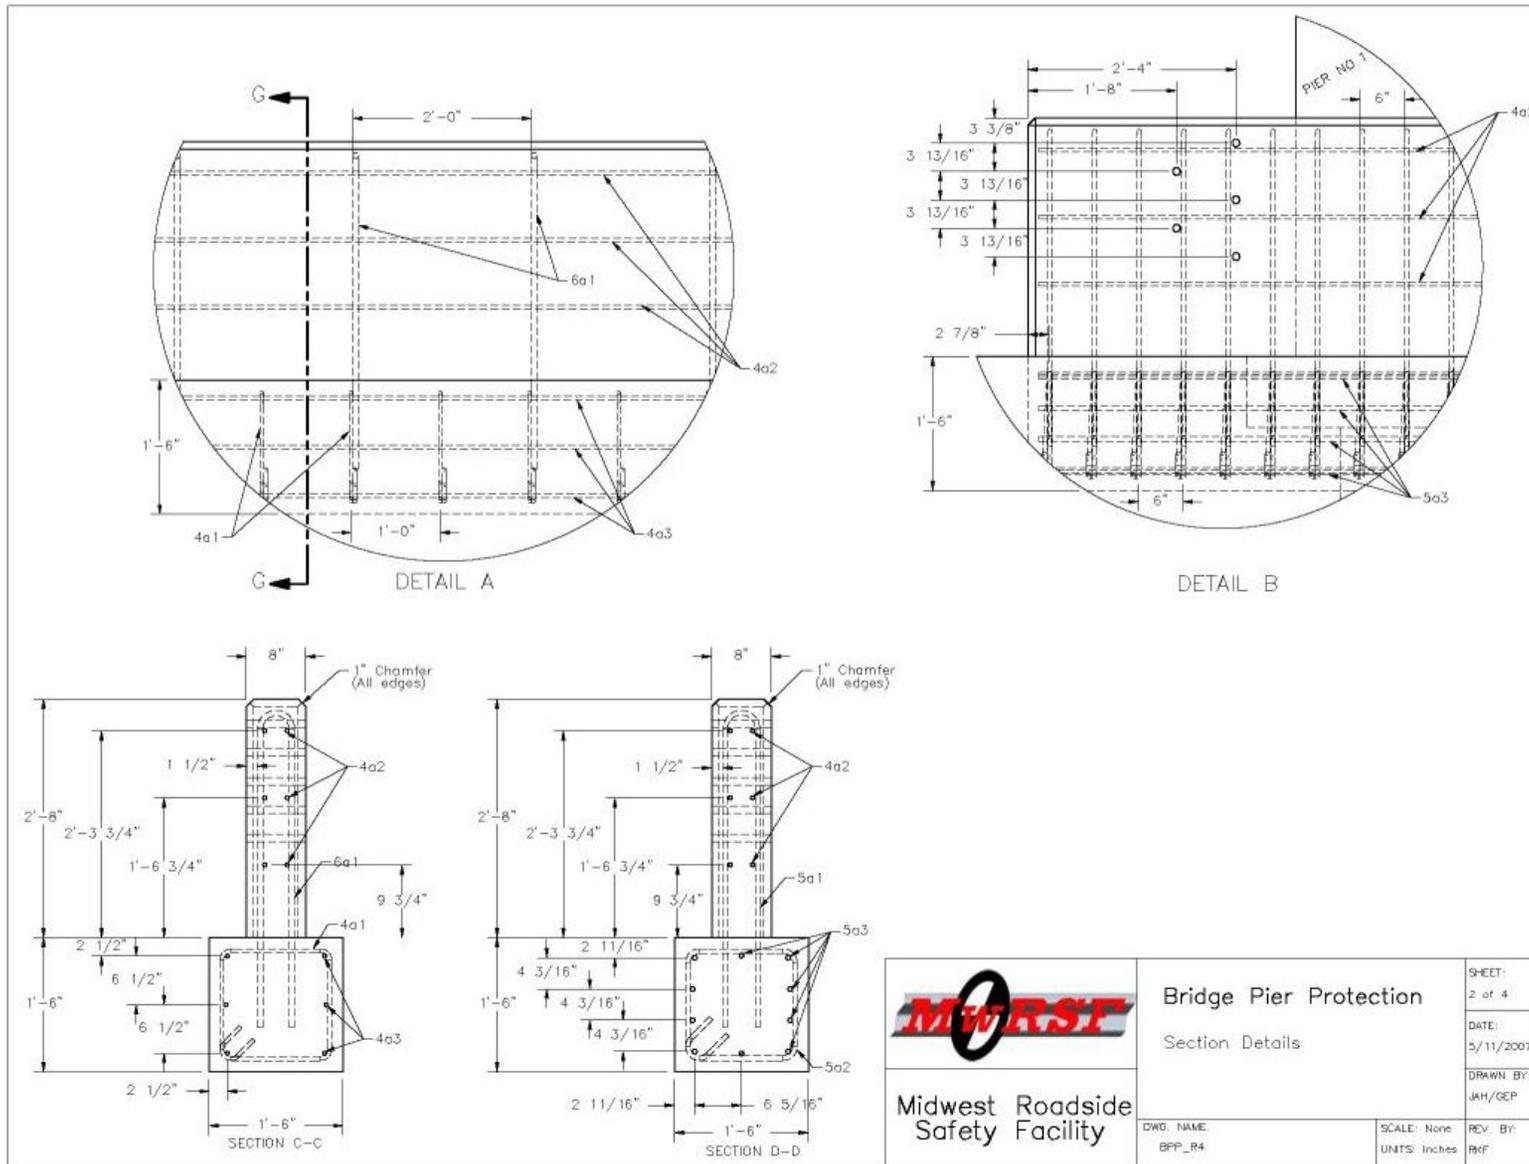
Figure C-2. Design Details and Reinforcement Placement, Test CBPP-1

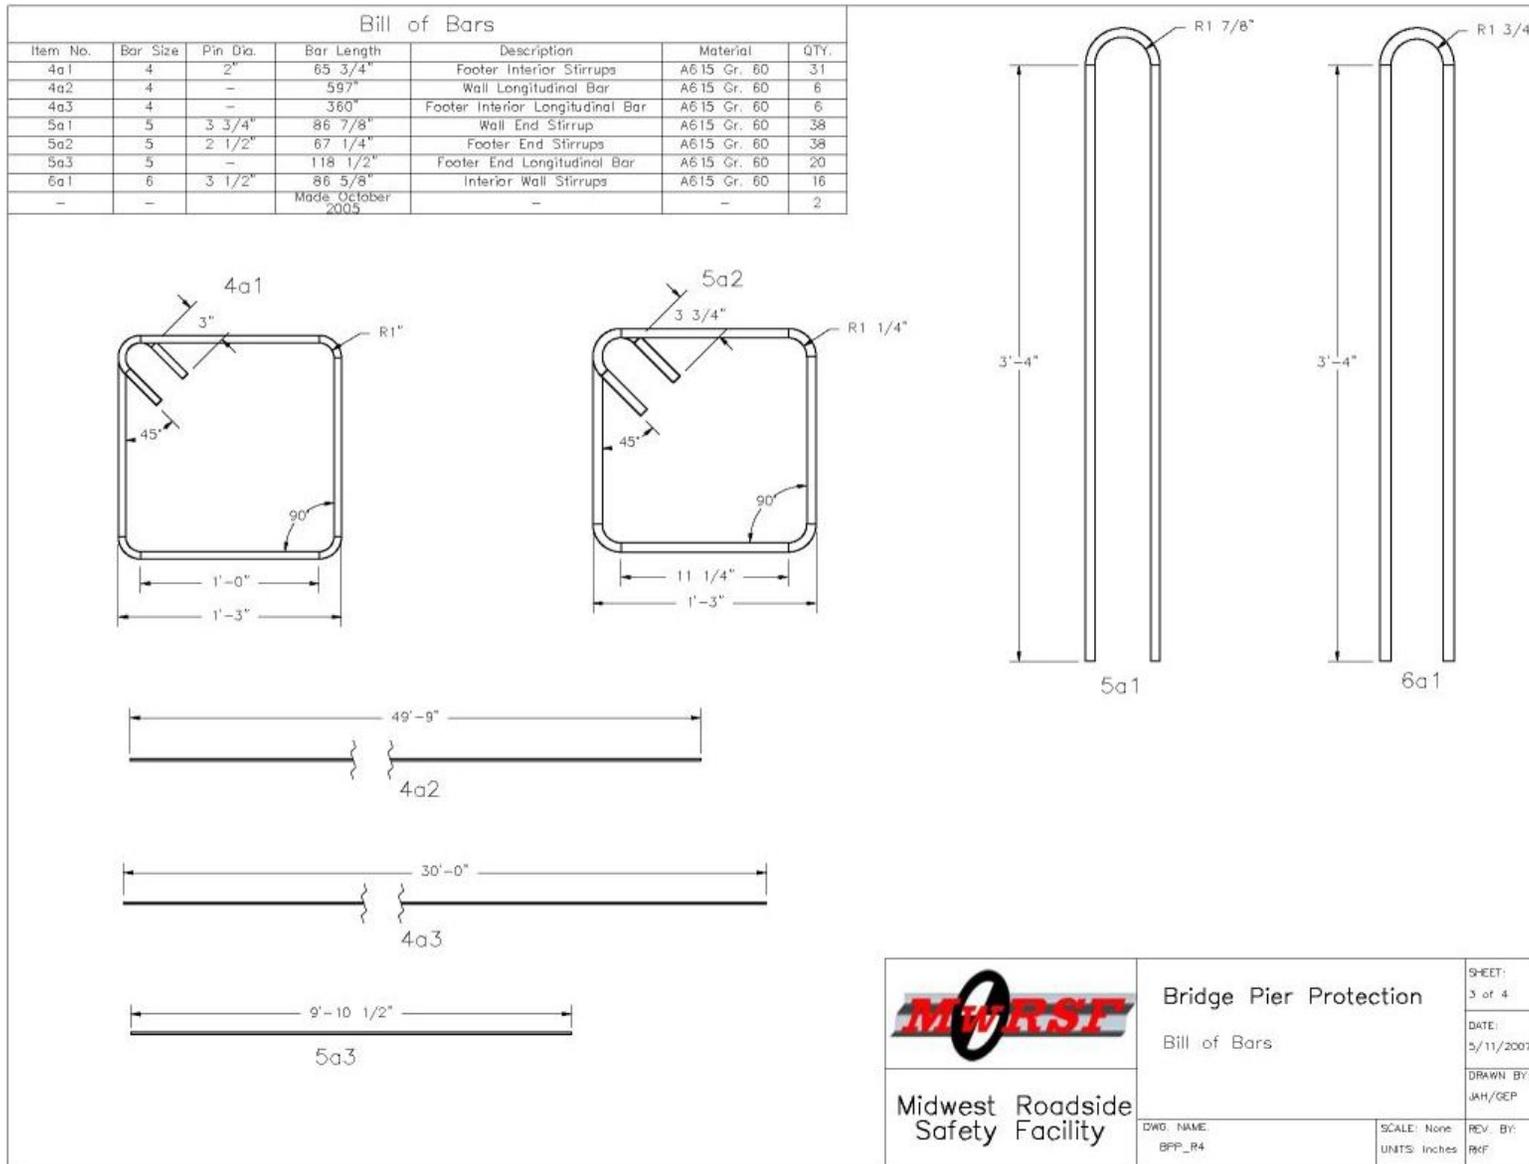
Figure C-3. Internal Steel Reinforcement Dimensions, Test CBPP-1

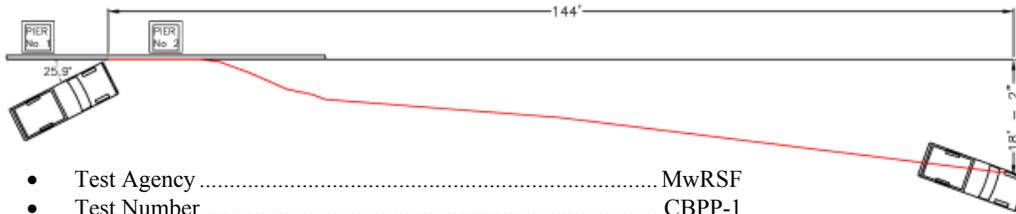
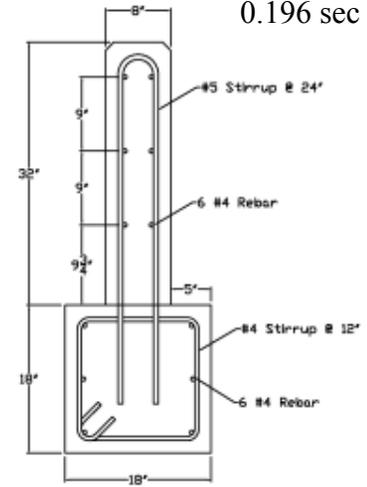
- Test Agency MwRSF
- Test Number CBPP-1
- Date 7/3/07
- NCHRP Report 350 Test Designation..... 3-11
- Test Article Concrete Pier Protection Barrier
- Concrete Material..... Nebraska L4000 mix
- Reinforcing Steel Material..... Grade 60 Rebar
- Concrete Barrier
 - Length 50 ft
 - Width..... 8 in.
 - Height..... 32 in.
- Concrete Footing
 - Length 50 ft
 - Width..... 18 in.
 - Depth..... 18 in.
- Vehicle Make and Model1999 Chevrolet C2500 Pickup
 - Curb..... 4,625 lbs
 - Test Inertial4,442 lbs
 - Gross Static4,442 lbs
- Impact Conditions
 - Speed 64.8 mph
 - Angle..... 25.9 deg
 - Impact Location..... 16 ft from Upstream End
- Exit Conditions
 - Speed 49.6 mph
 - Angle..... 6.6 deg

- Vehicle Stability Satisfactory
- Occupant Ridedown Deceleration (10 msec avg.)
 - Longitudinal..... 6.97 g's
 - Lateral 9.66 g's
- Occupant Impact Velocity
 - Longitudinal..... 21.40 ft/s
 - Lateral 25.40 ft/s
- Vehicle DamageModerate
 - VDS^[16] 11-FL-5 and 11-RD-4
 - CDC^[17] 11-FLEN3 and 11-LDES2
- Vehicle Stopping Distance..... 144 ft DS of impact, 16 ft Laterally
- Test Article Damage Minimal
- Test Article Deflections
 - Permanent Set NA
 - Dynamic..... 1 in.
 - Working Width..... 19.875 in.

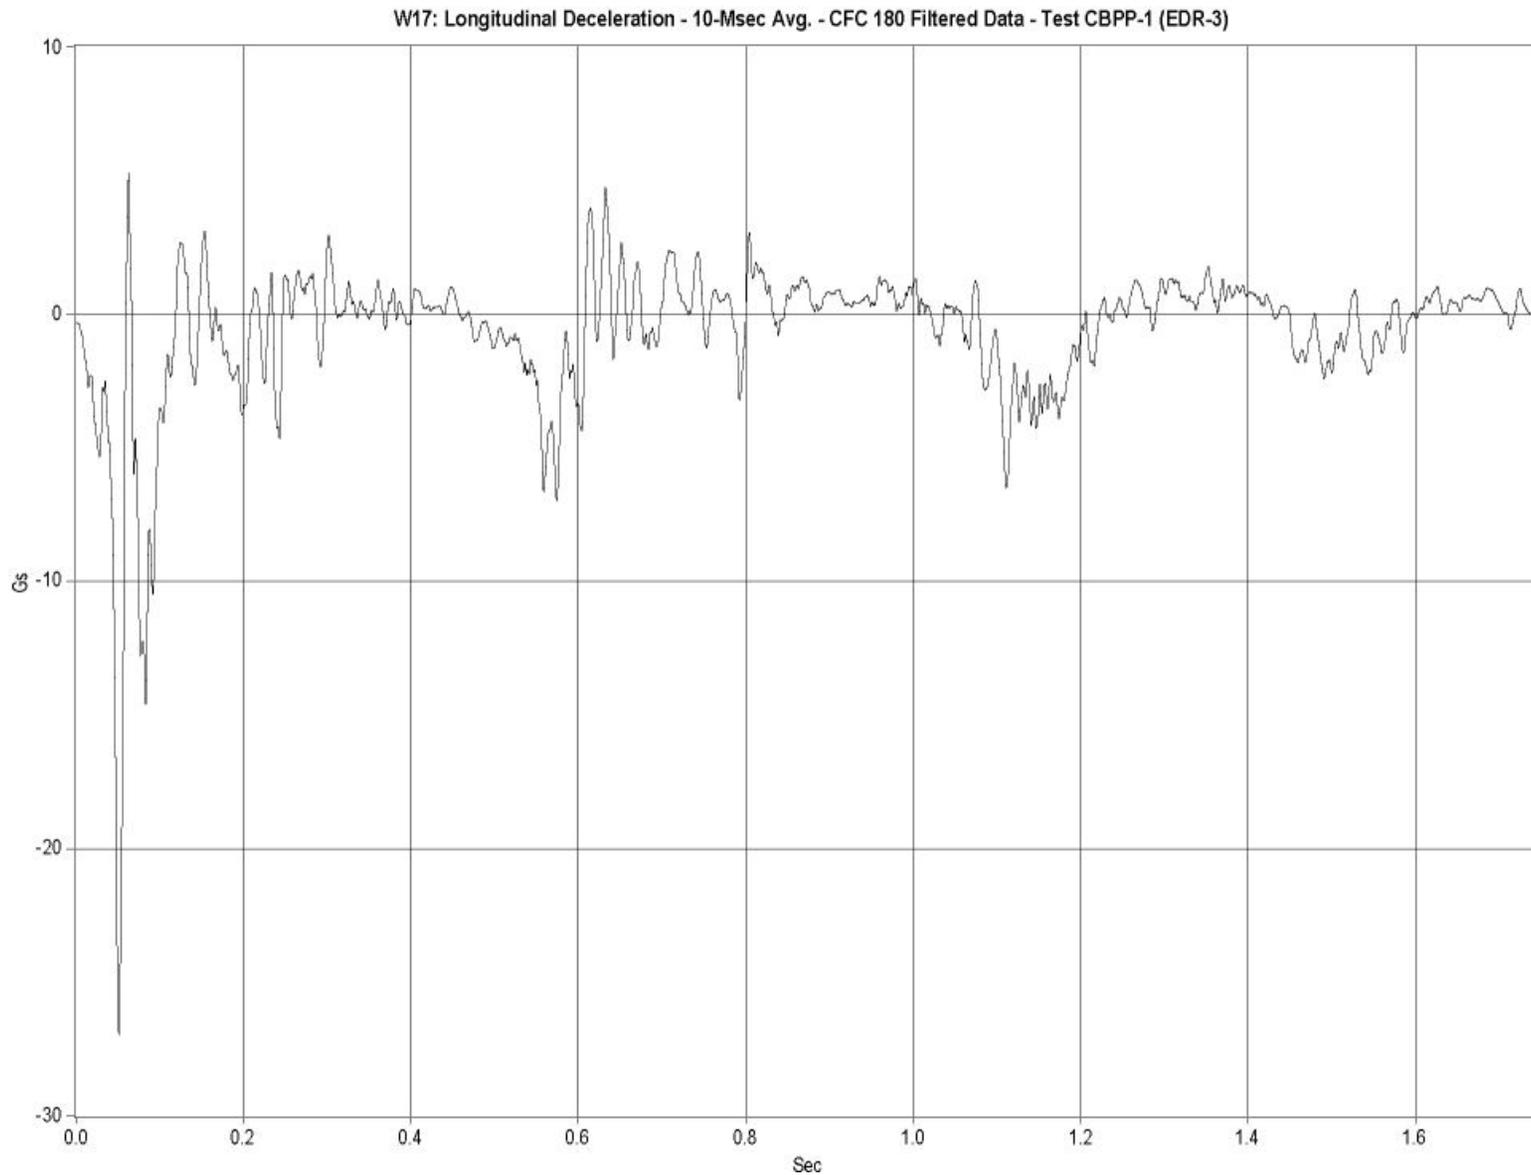
Figure F-1. Graph of 10-ms Average Longitudinal Deceleration, Test CBPP-1

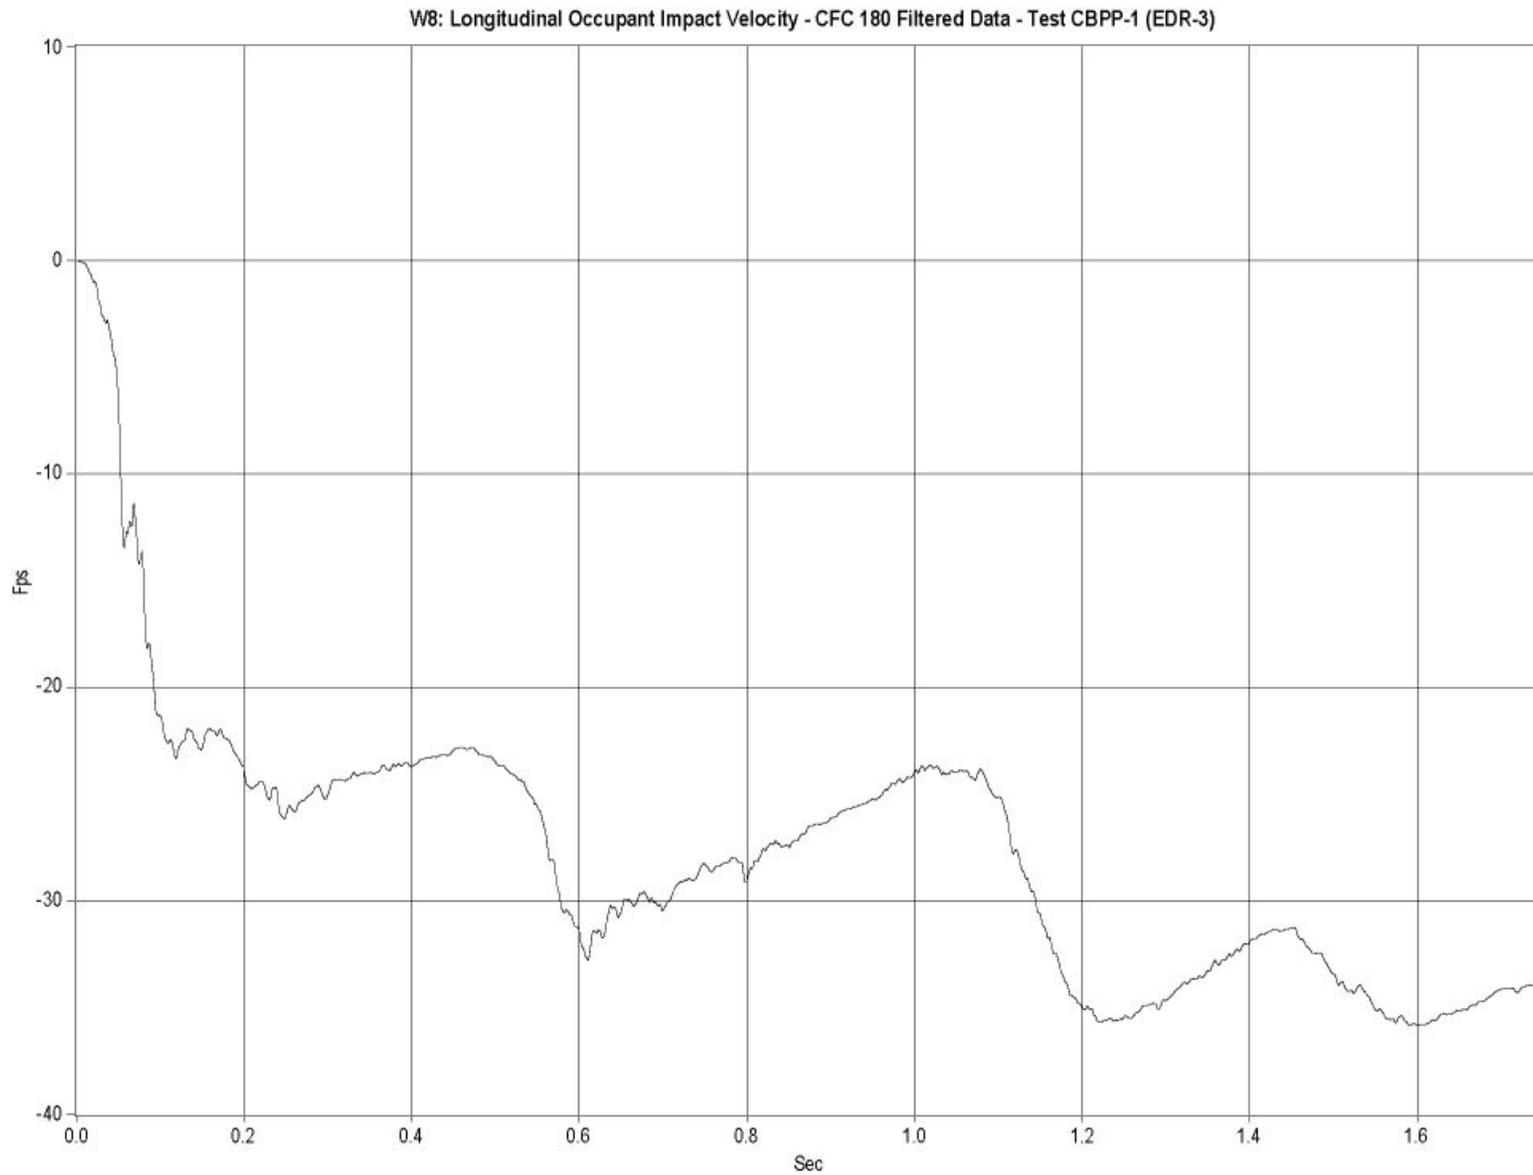
Figure F-2. Graph of Longitudinal Occupant Impact Velocity, Test CBPP-1

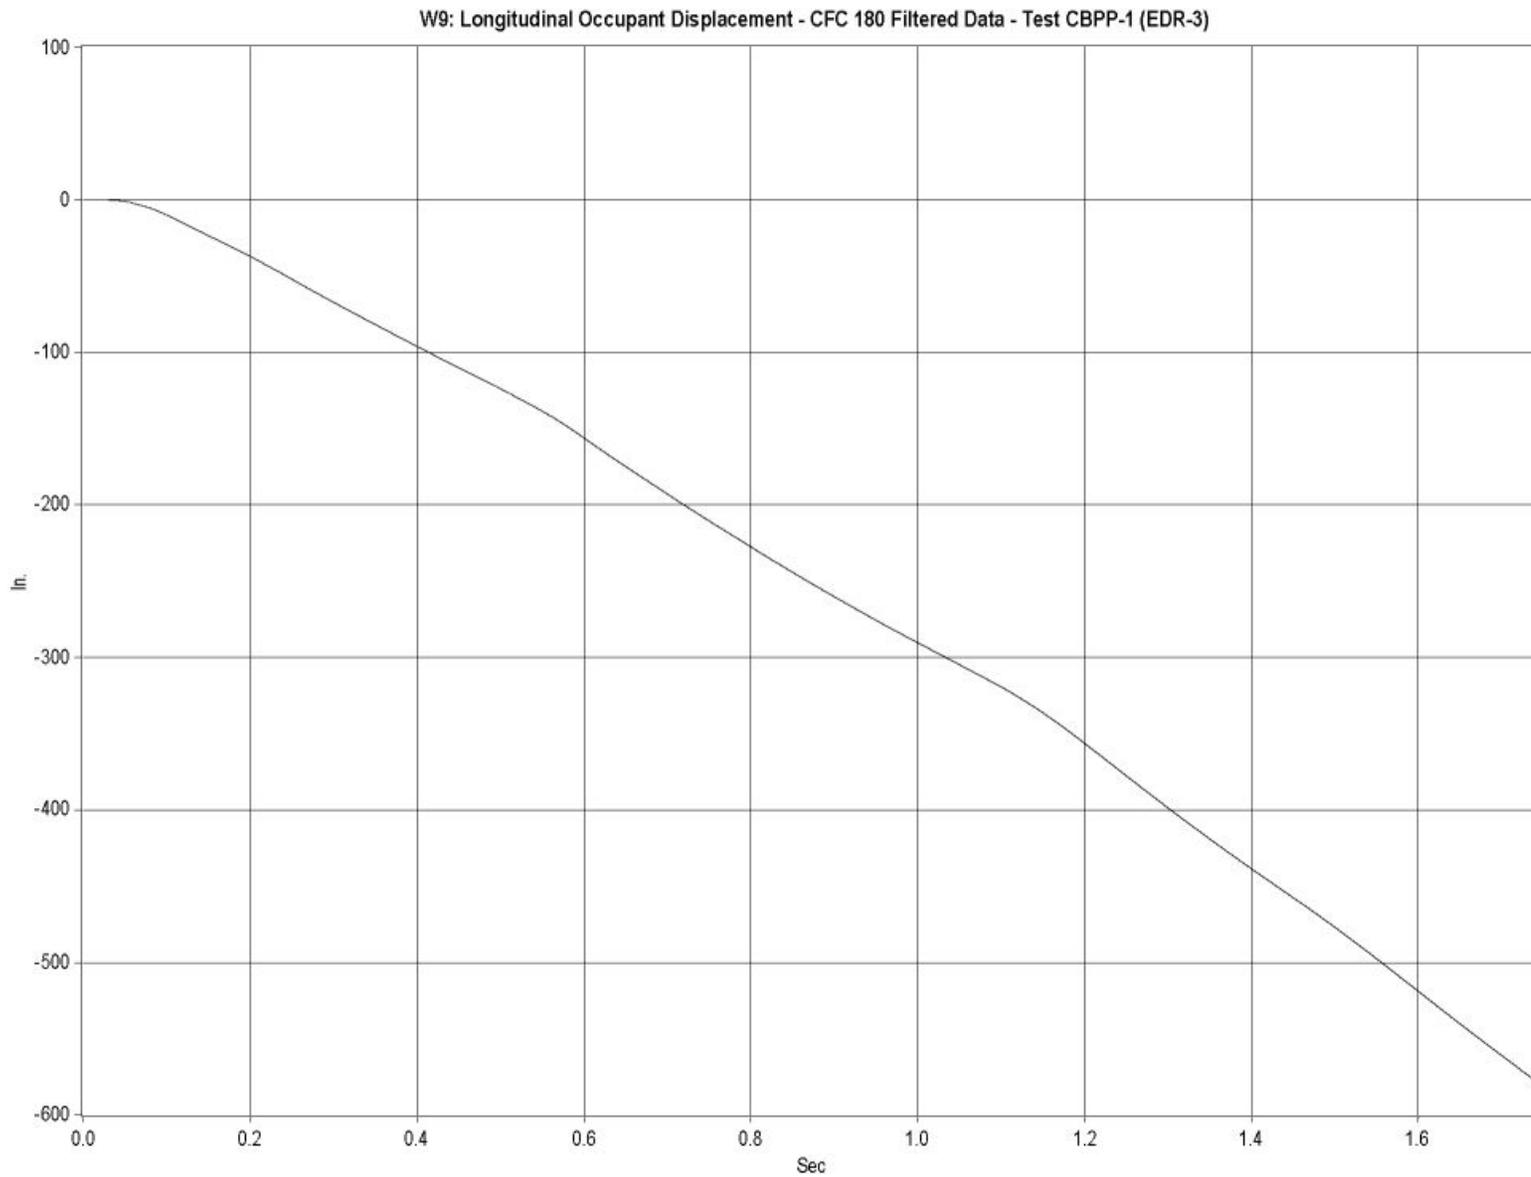
Figure F-3. Graph of Longitudinal Occupant Displacement, Test CBPP-1

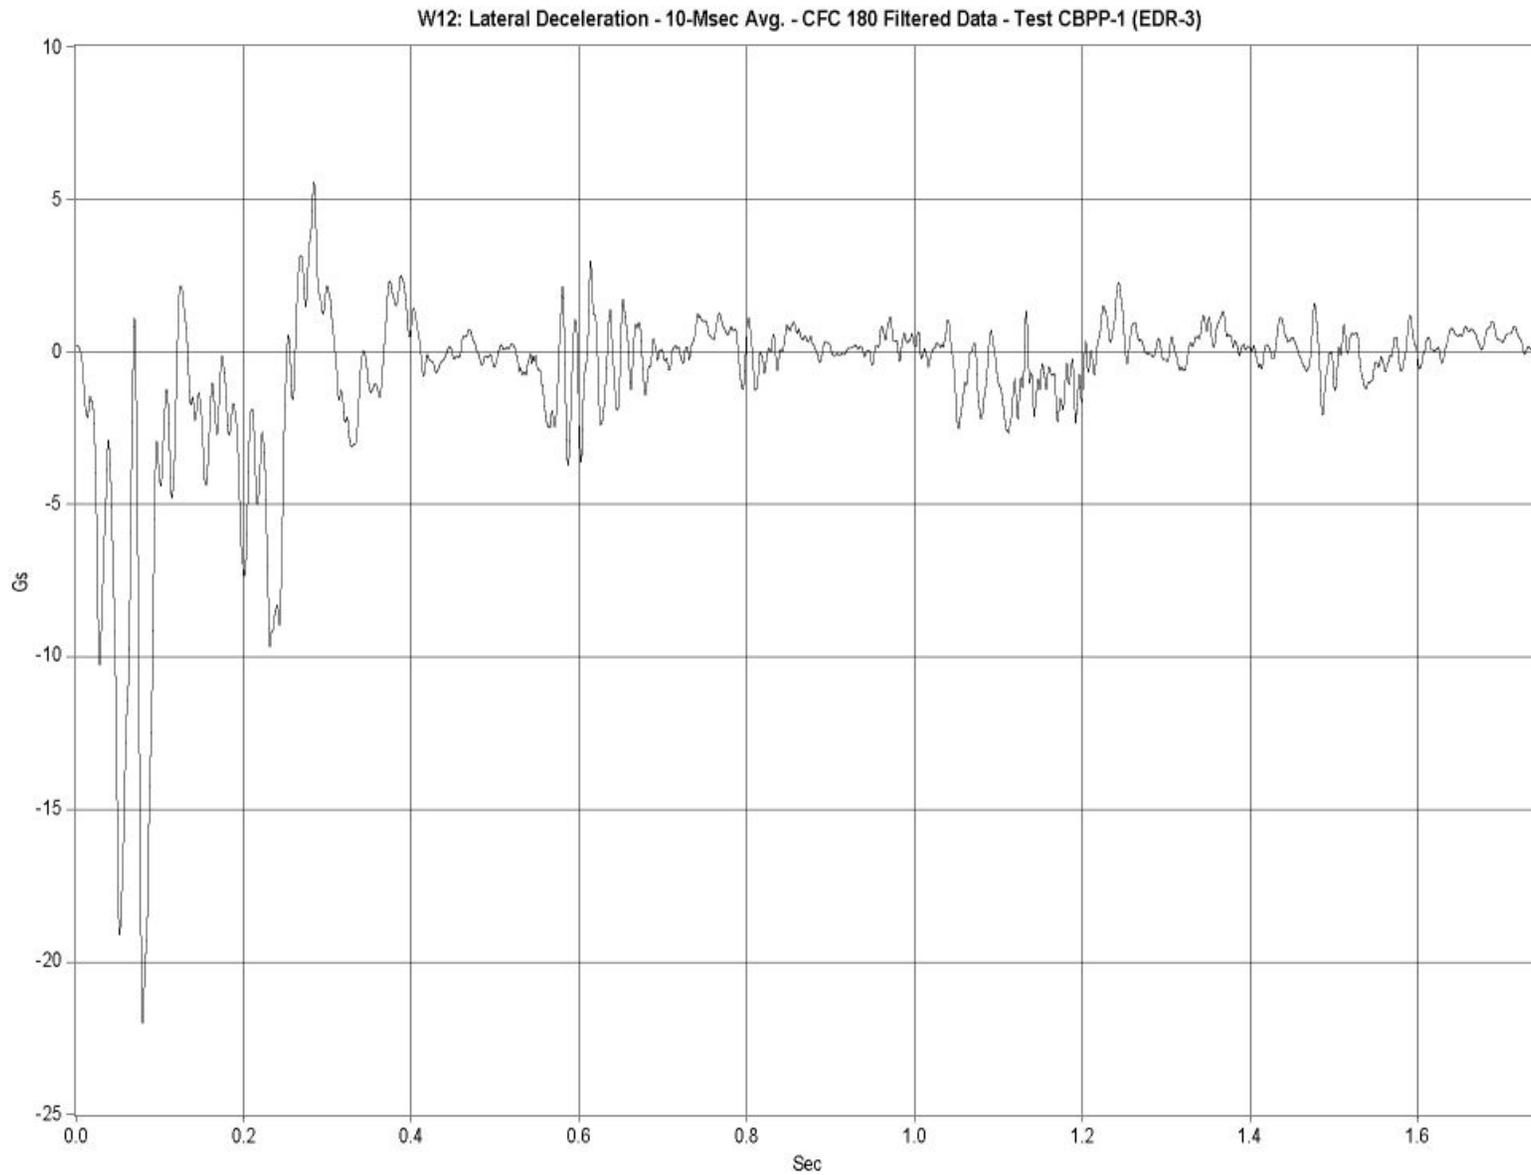
Figure F-4. Graph of 10-ms Average Lateral Deceleration, Test CBPP-1
