DEVELOPMENT OF A STAND-ALONE CONCRETE BRIDGE PIER PROTECTION SYSTEM

MwRSF Research Report No. TRP-03-190-08

April 18, 2008

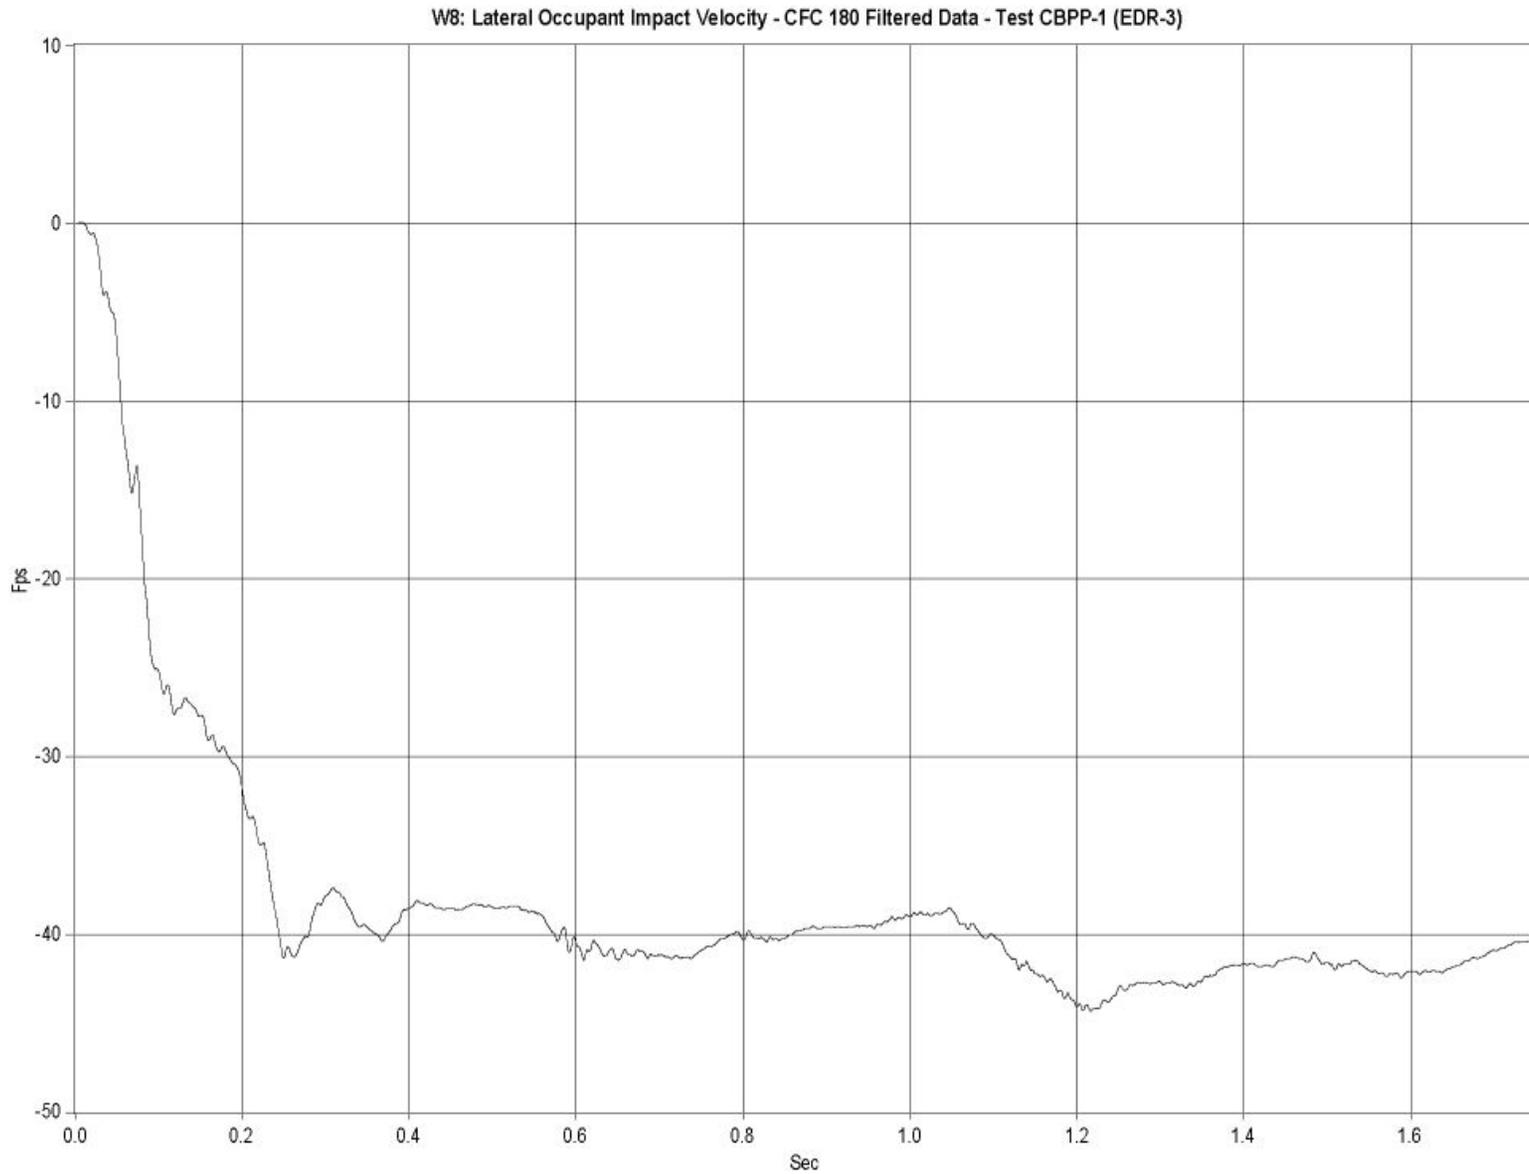
Figure F-5. Graph of Lateral Occupant Impact Velocity, Test CBPP-1

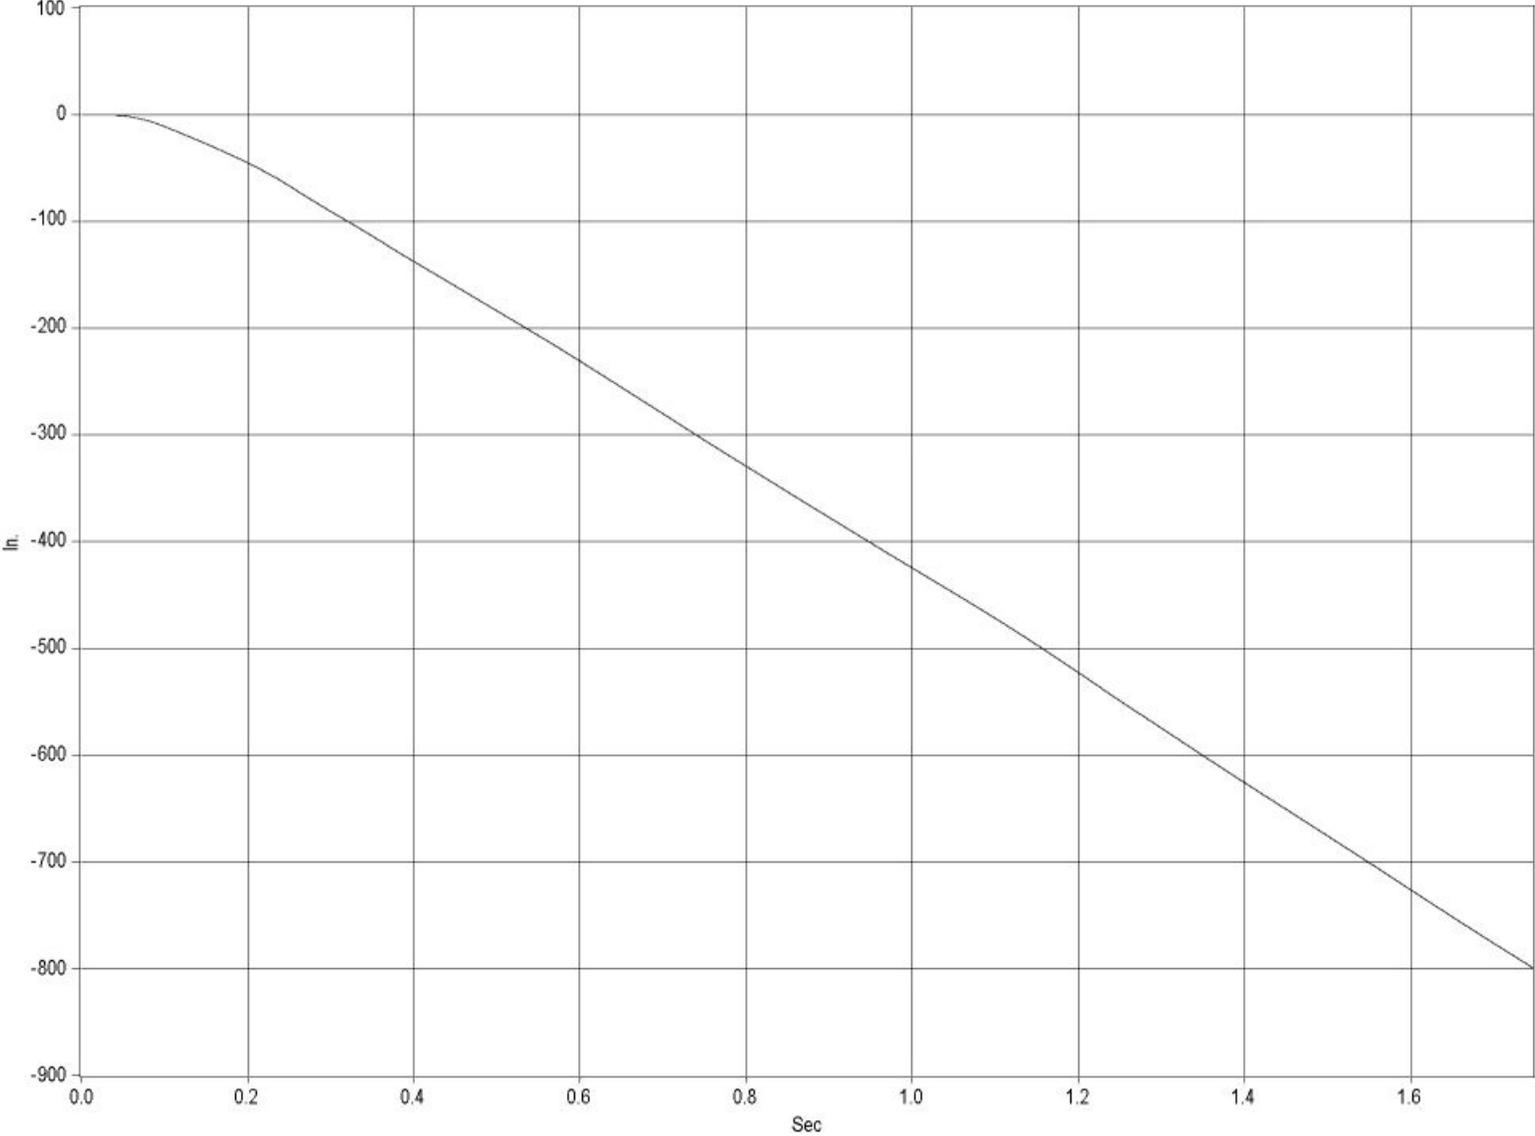
W9: Lateral Occupant Displacement - CFC 180 Filtered Data - Test CBPP-1 (EDR-3)

Figure F-6. Graph of Lateral Occupant Displacement, Test CBPP-1

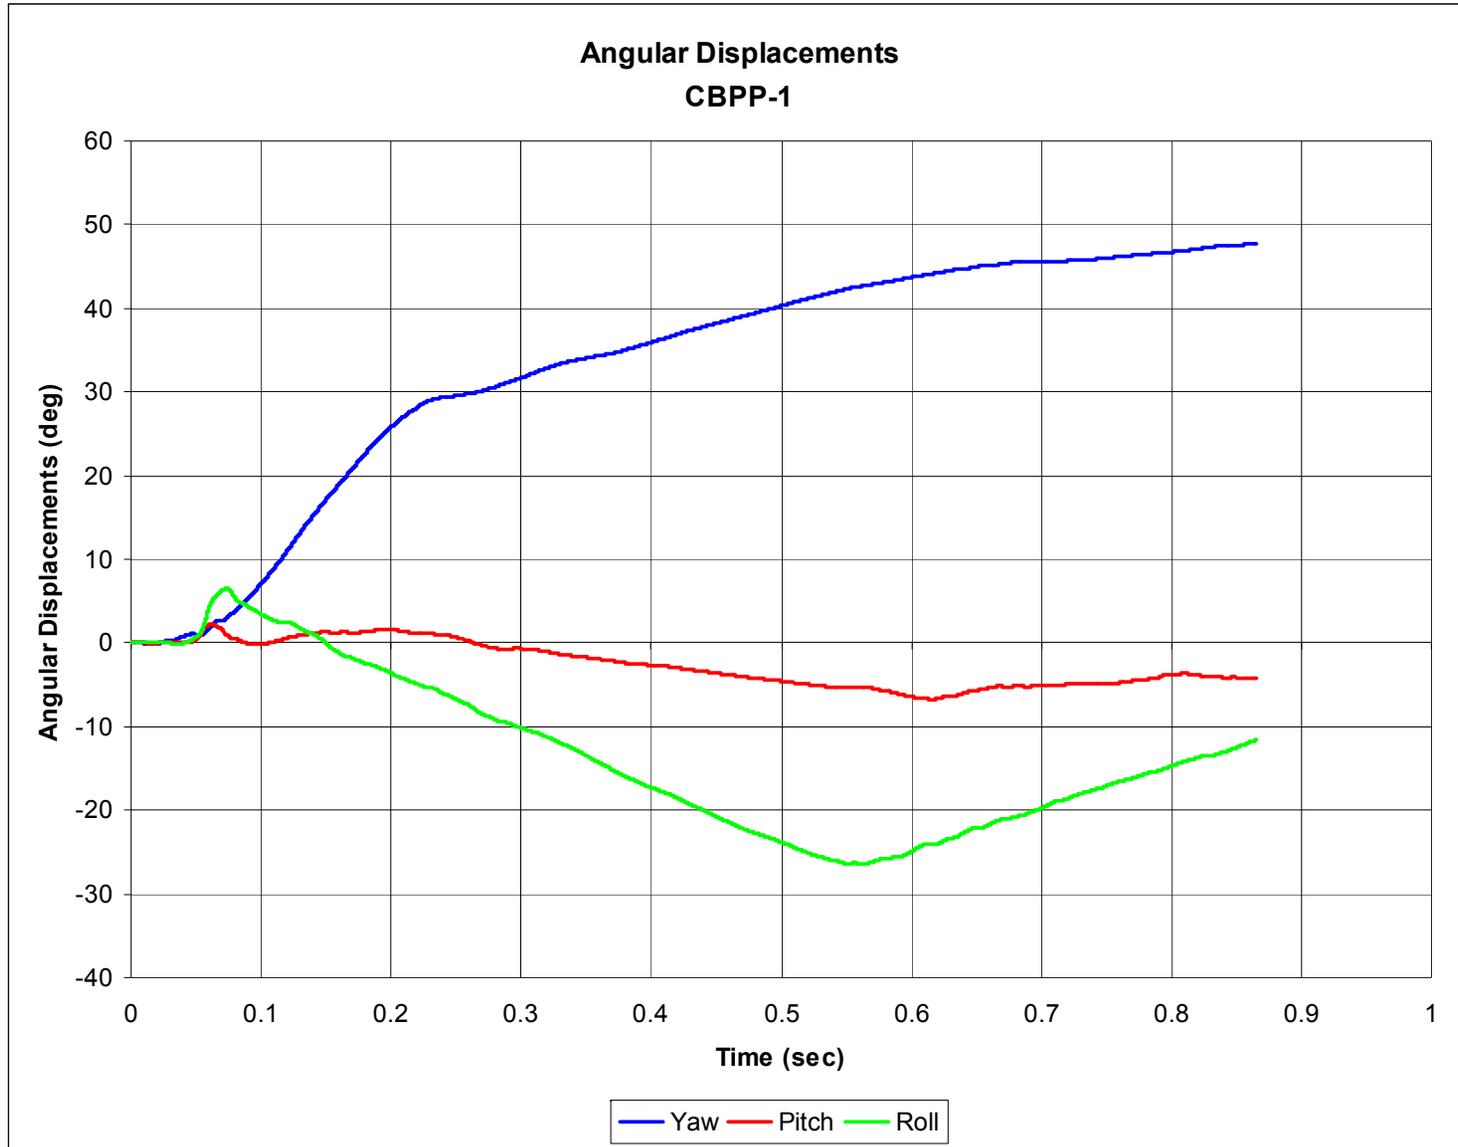
Figure F-7. Graph of Vehicle Roll, Pitch, and Yaw Angular Displacements, Test CBPP-1

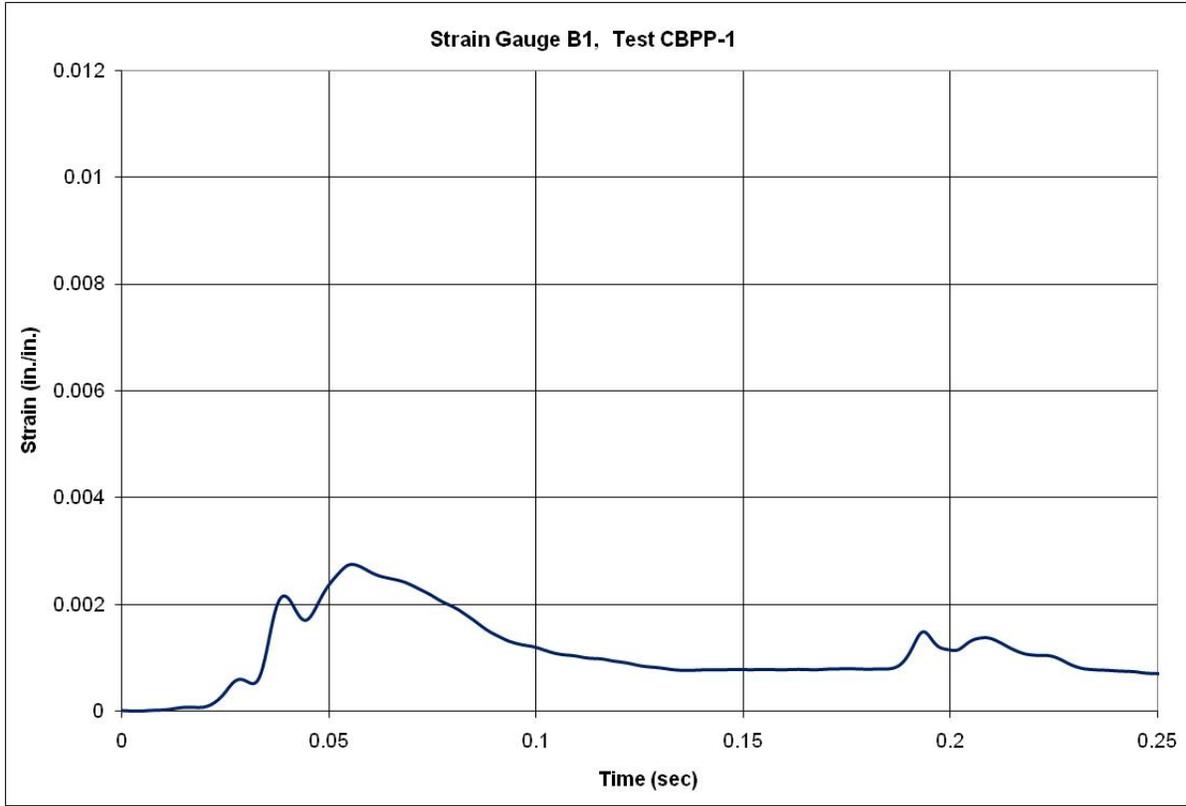
Figure G-1. Results of Strain Gauge B1, Test CBPP-1

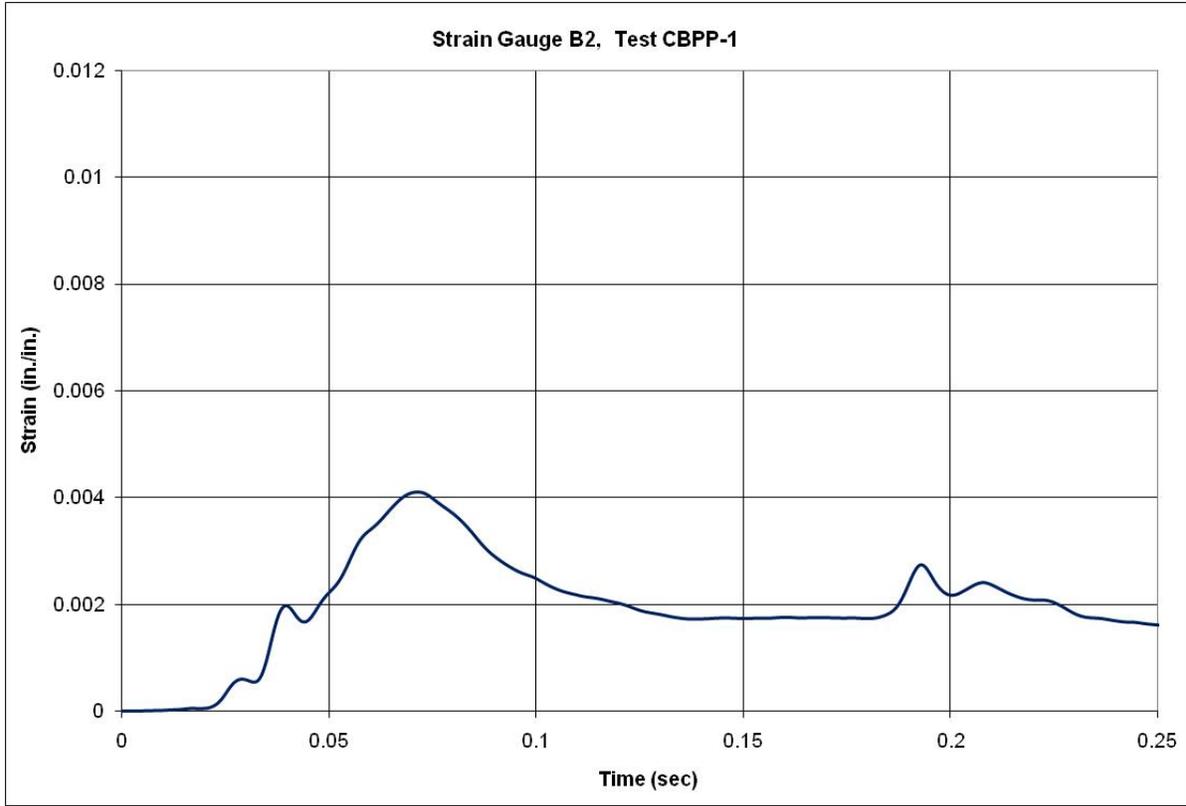
Figure G-2. Results of Strain Gauge B2, Test CBPP-1

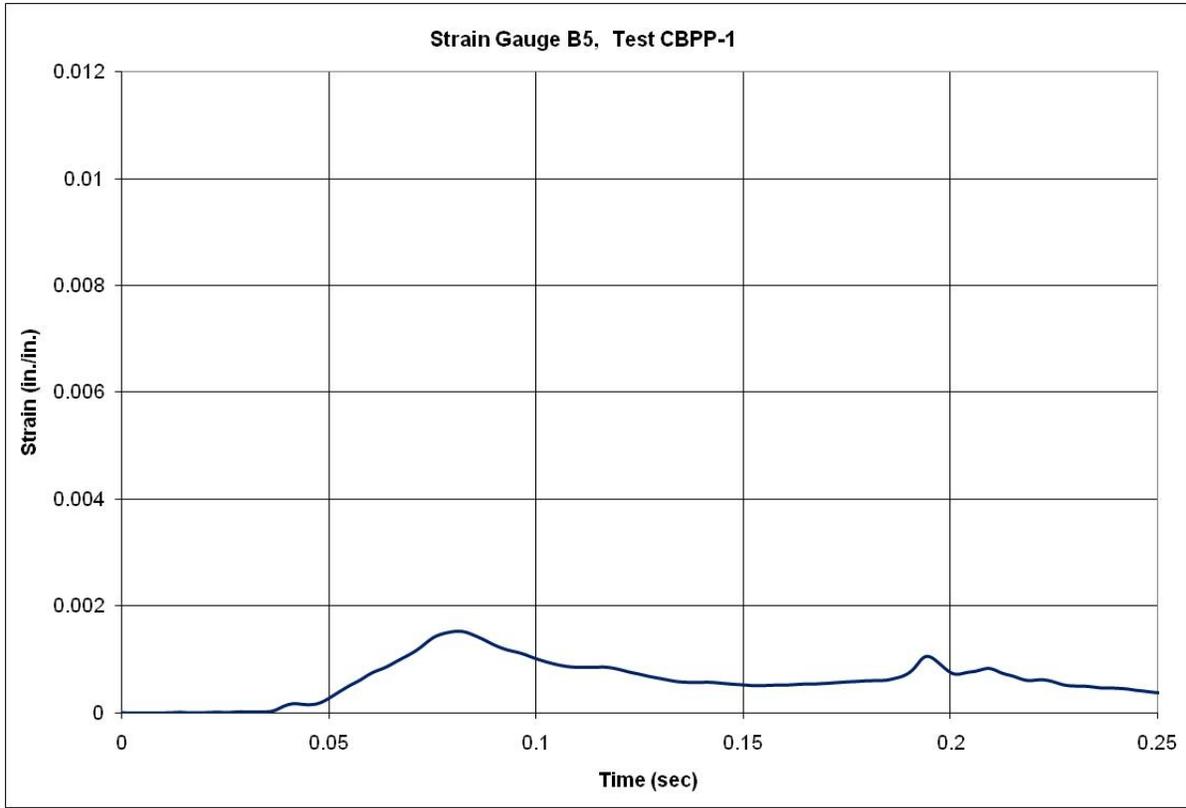
Figure G-5. Results of Strain Gauge B5, Test CBPP-1

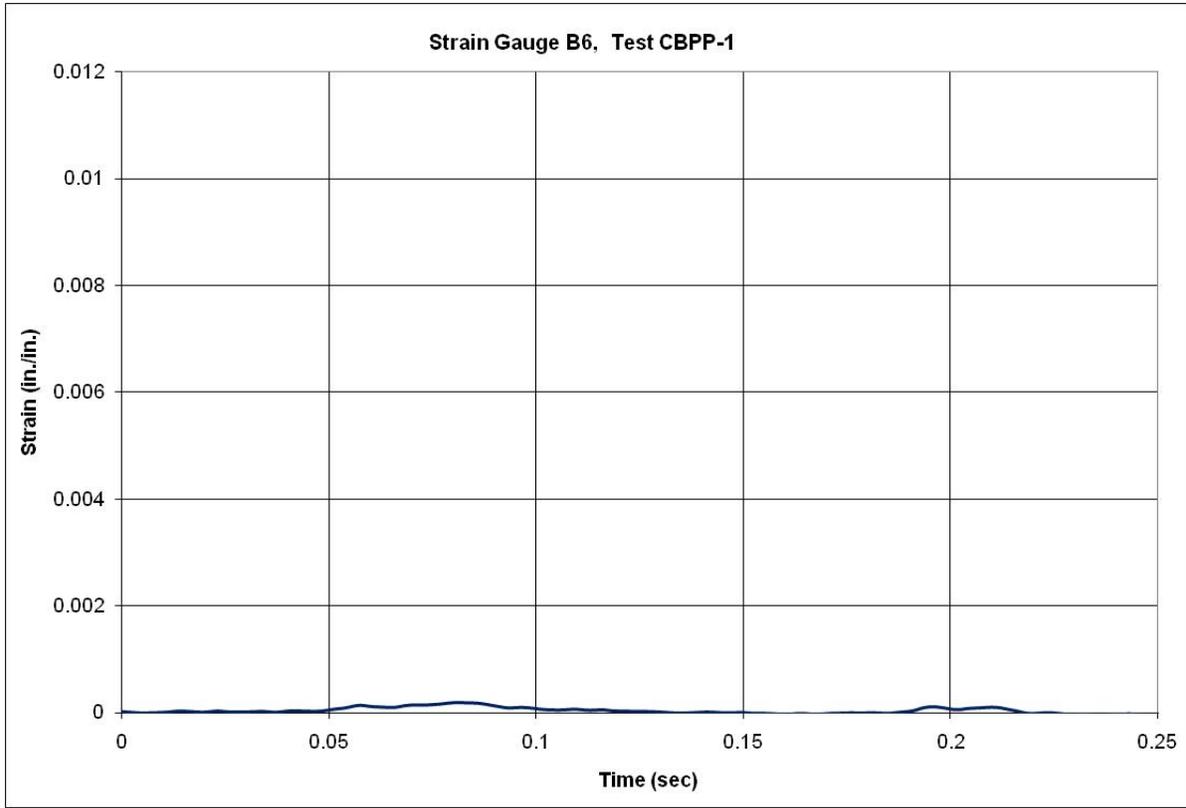
Figure G-6. Results of Strain Gauge B6, Test CBPP-1
