Phase IV Development of a Short-Radius Guardrail for Intersecting Roadways

MwRSF Research Report No. TRP-03-199-08

February 29, 2008

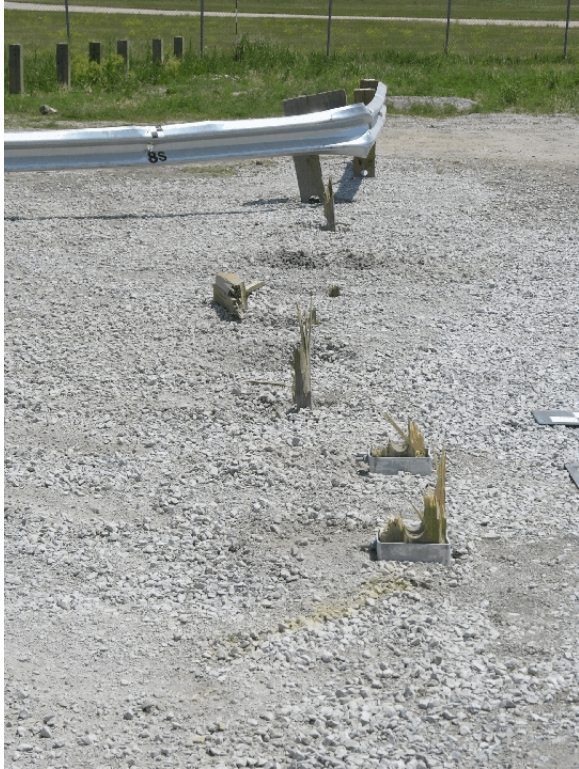
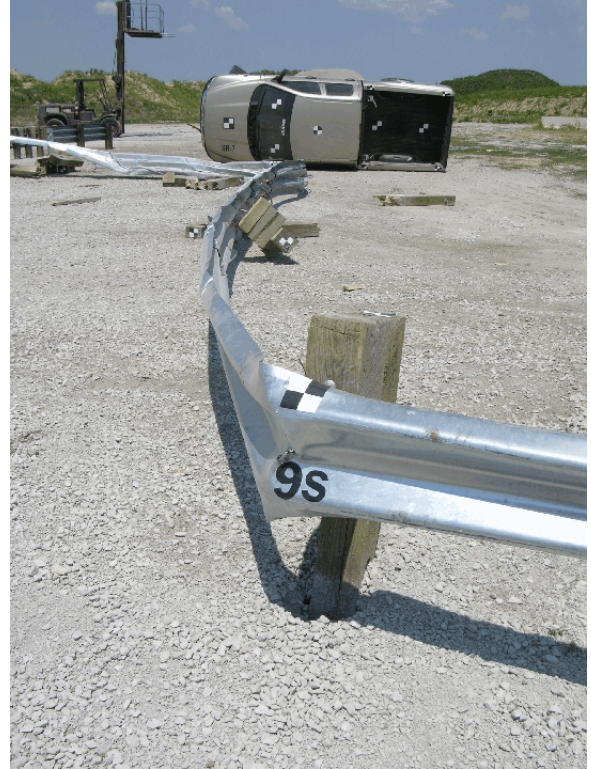
Figure 44. System Damage, Test SR-7

Barrier damage was extensive, as shown in Figures 43 through 58. Damage consisted mostly of fractured posts, fractured blockouts, damaged cable anchor hardware, and flattened and deformed guardrail.

Post nos. 1P, 1S and 2S fractured at the foundation tubes. The foundation tube at post no. 2S was dented and bent along the bolt centerline. Post nos. 2P through 10P fractured and disengaged from the rest of the system. Post no. 11P rotated backwards in the soil and cracked at the groundline. Post nos. 12P and 13P rotated backwards in the soil. Post nos. 1S and 2S fractured in the foundation tubes and were disengaged from the rest of the system. Post nos. 3S through 8S fractured at ground level and disengaged from the rest of the system. Post no. 9S rotated backwards in the soil and cracked through the transverse CRT hole, but remained in the ground.

The blockouts at post nos. 2P through 10P deformed and were damaged around the bolt holes. The blockout at post no. 11P twisted on the bolt and the front face was deformed. The blockout at post no. 9S was compressed on the traffic-side face and the upstream top edge of the traffic face was chipped.

Contact marks were found between the nose section of the rail and post no. 8P. The guardrail was flattened and deformed between post nos. 5P and 3S. Rail buckling was observed in the nose section and between post nos. 1P through 13P and 1S through 8S. The post bolts pulled through the

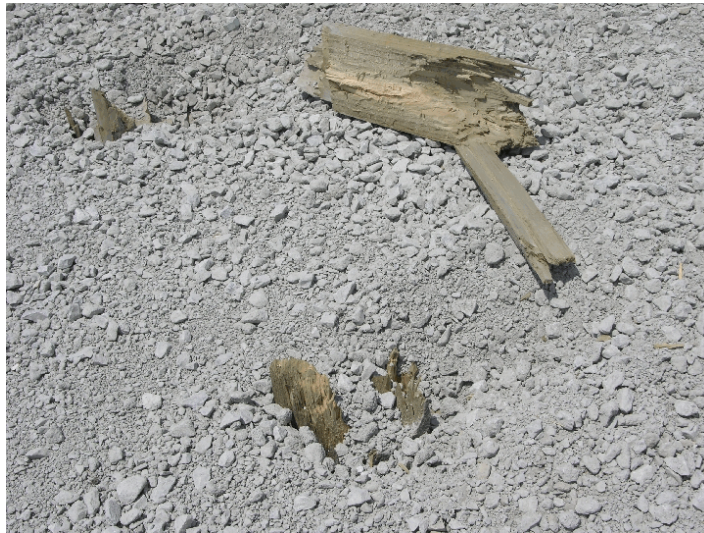
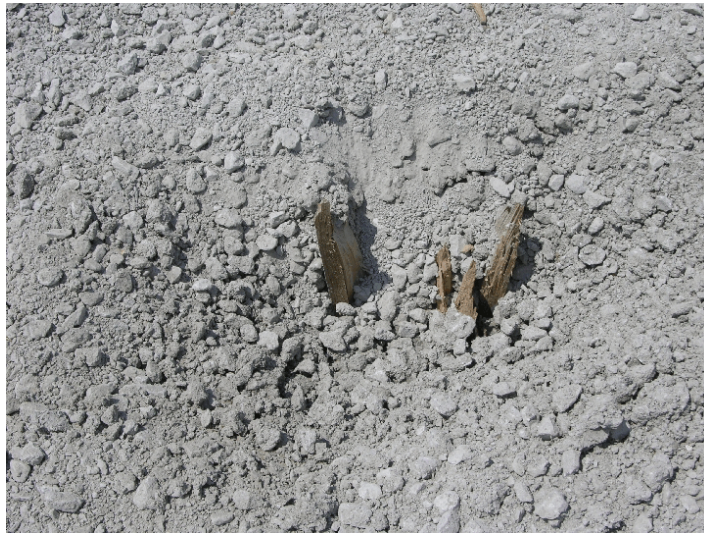
Figure 51. Post Nos. 6S through 8S Damage, Test SR-7

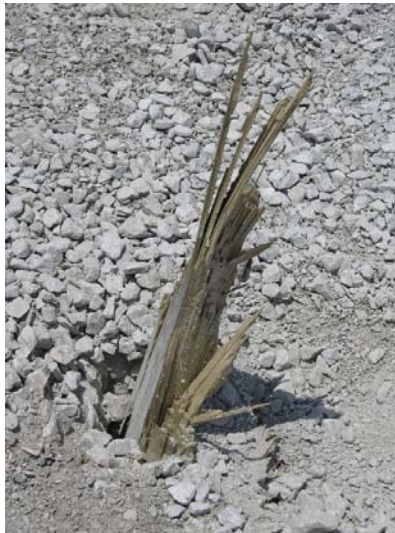
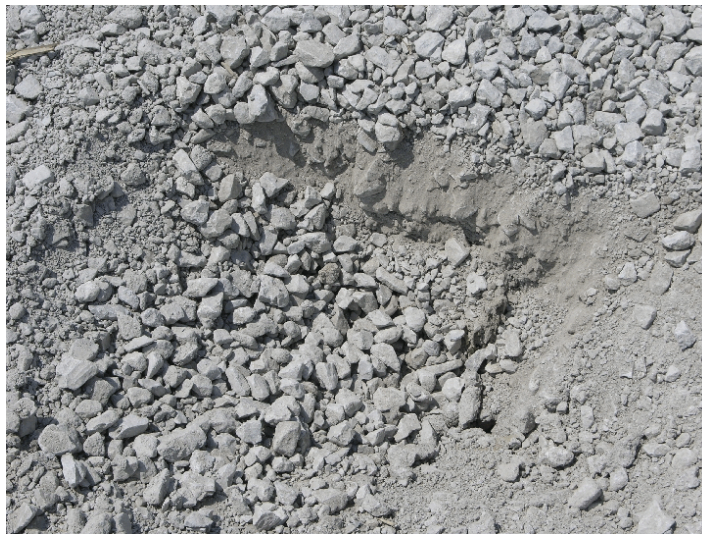
Figure 52. Post Nos. 3S through 5S Damage, Test SR-7

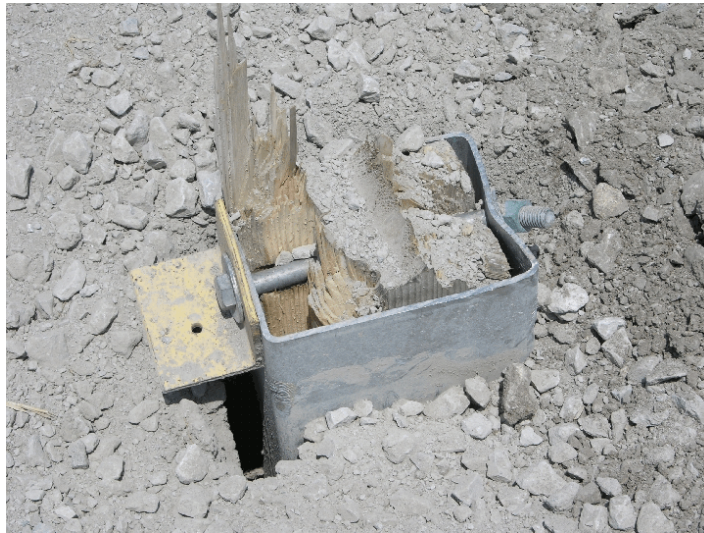
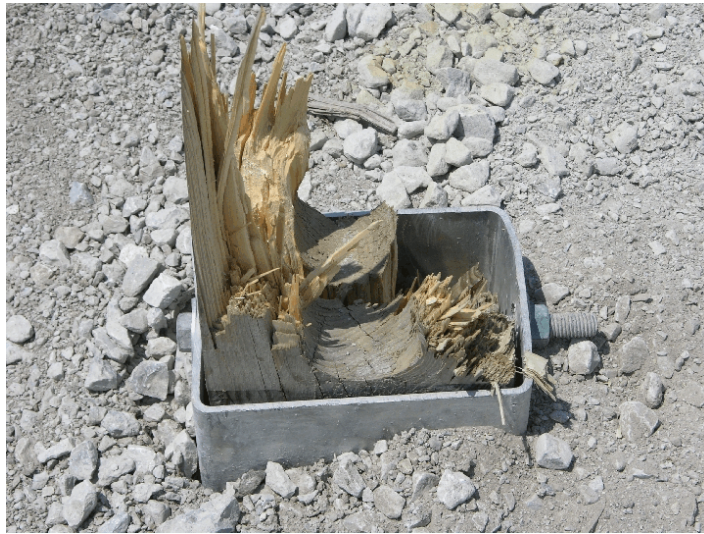
Figure 53. Post Nos. 1P, 1S and 2S Damage, Test SR-7

- (2) Post no. 1S did not fracture completely during the crash test. The poor release of the cable at post no. 1S allowed the cable to propel a broken section of post no. 1S under the wheels of the vehicle, adding to the debris under the wheels and the instability of the vehicle.

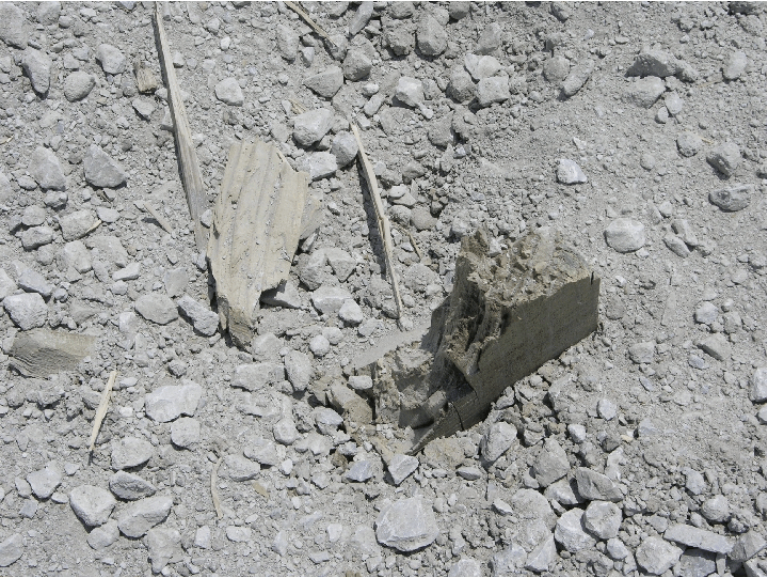
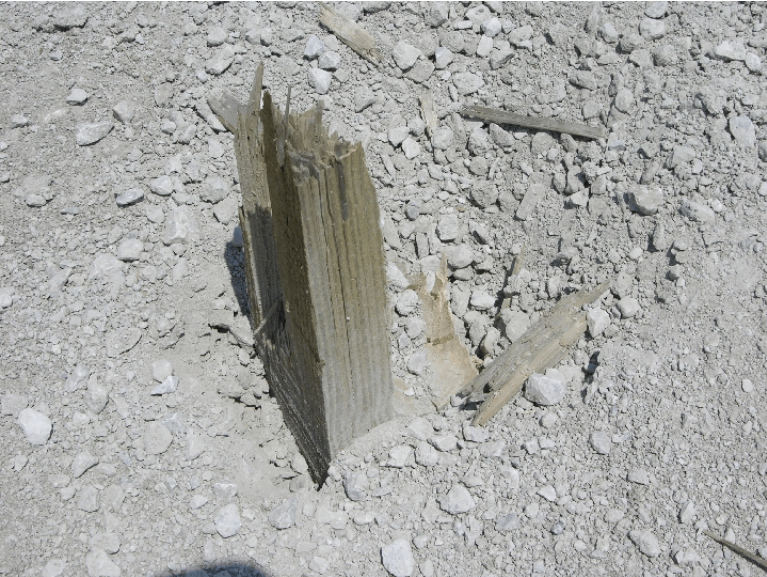
Figure 54. Post Nos. 2P through 4P, Test SR-7

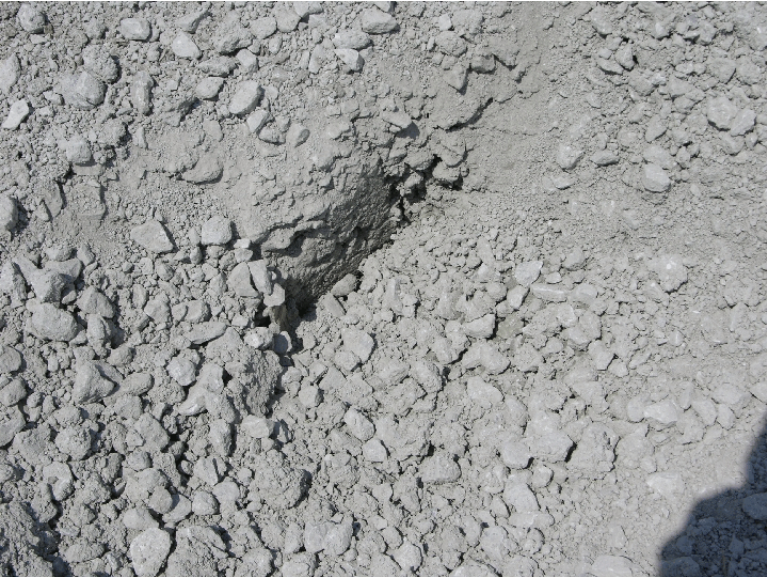
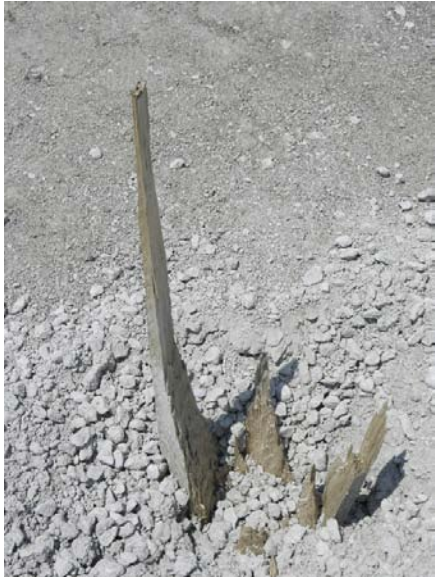
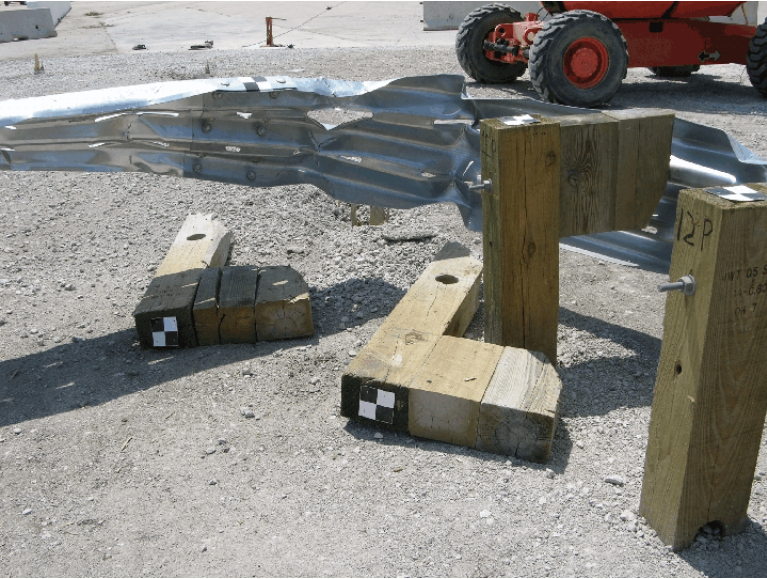
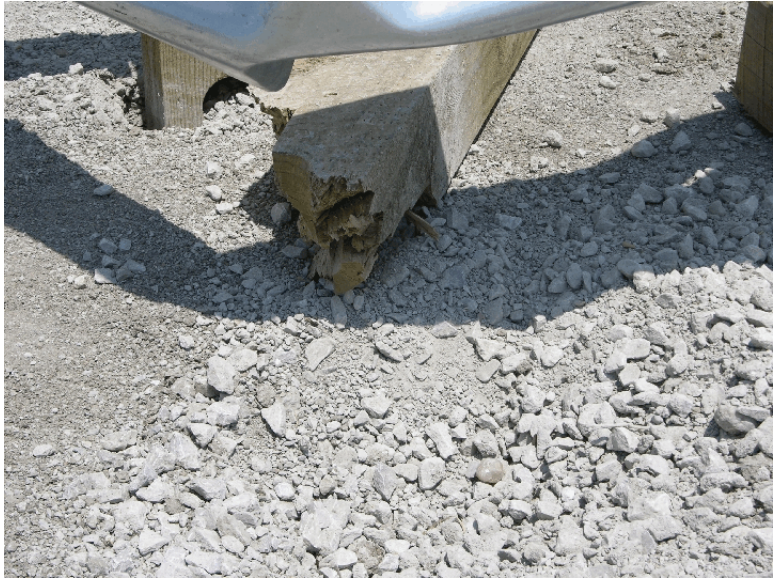
Figure 55. Post Nos. 6P through 9P Damage, Test SR-7

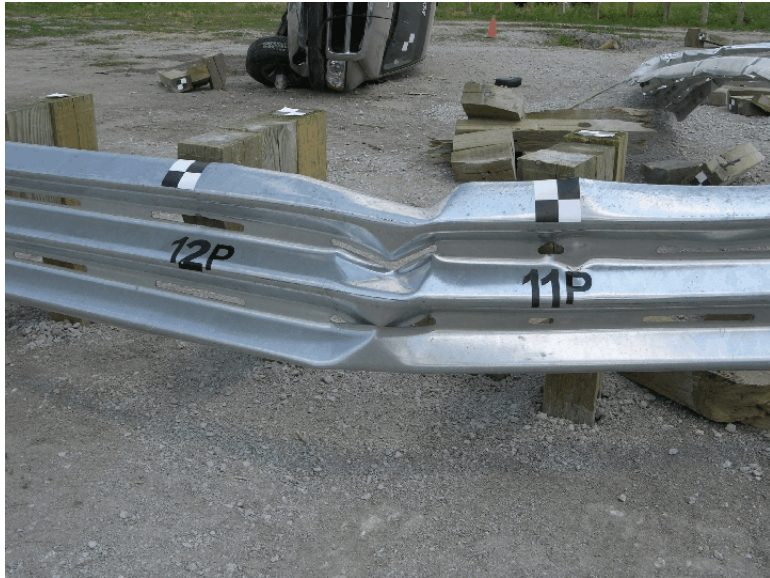
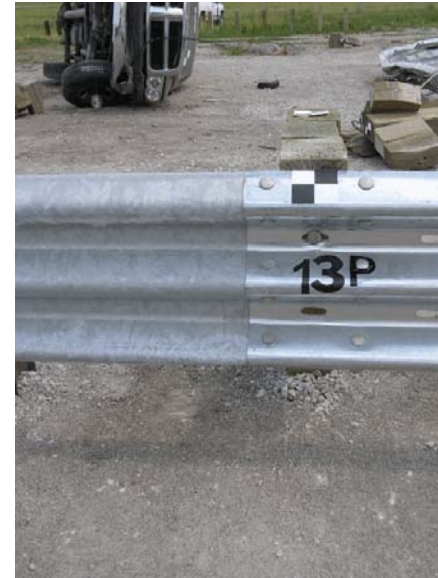
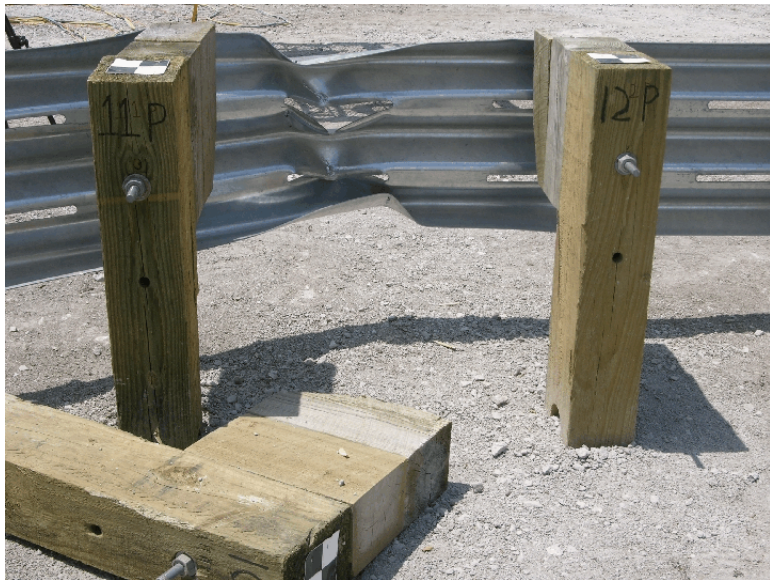
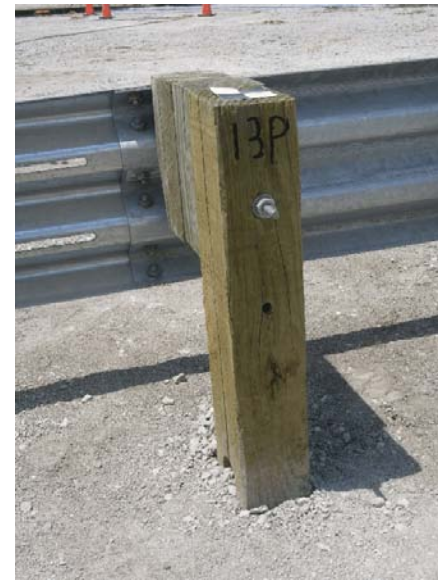
Figure 56. Post Nos. 11P through 13P Damage, Test SR-7

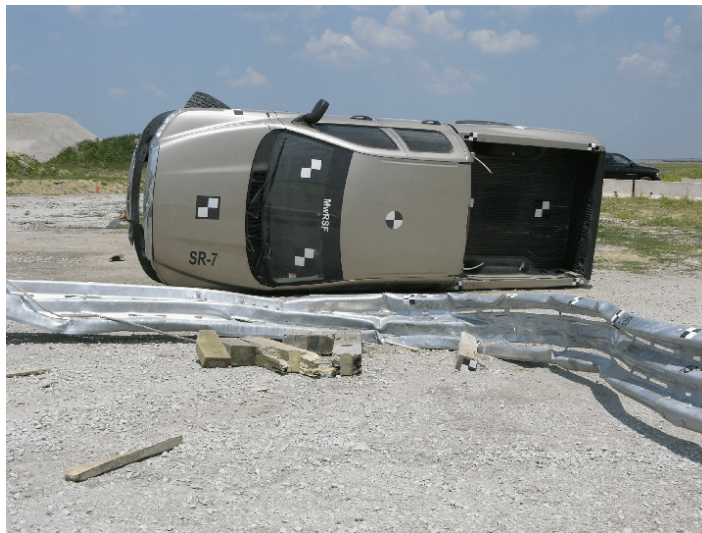
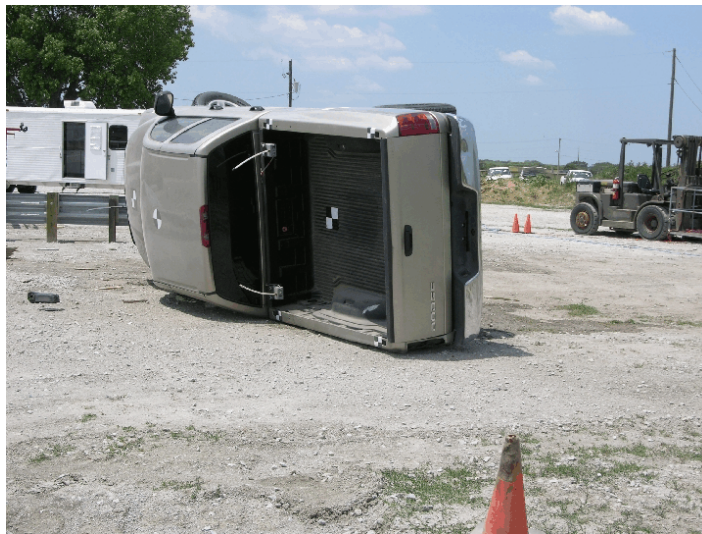
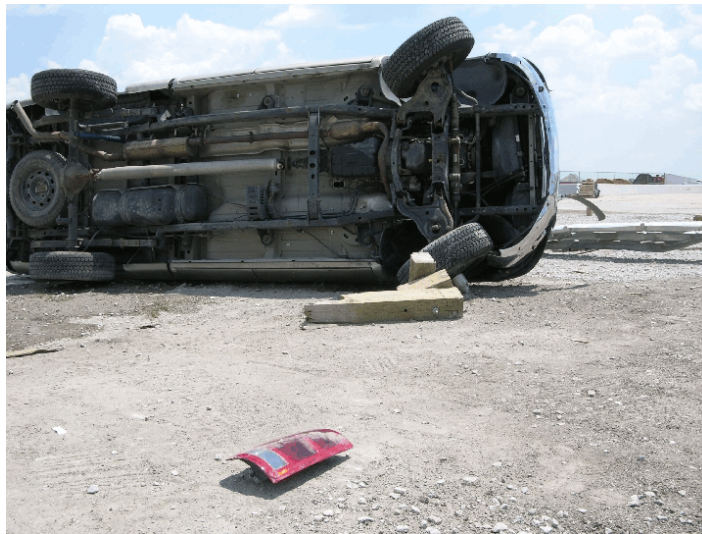
Exterior vehicle damage was moderate, as shown in Figures 59 through 62. Occupant compartment deformations to the right side and center of the floorboard were judged insufficient to cause serious injury to the vehicle occupants. A maximum longitudinal deflection of 13 mm (0.5 in.) was located in the right-front corner of the right-side floor pan. A maximum lateral deflection of 13 mm (0.5 in.) was located at the center of the right side of the right-side floor pan. Maximum vertical deflections of 6 mm (0.25 in.) were located throughout the right-side floor pan. Complete occupant compartment deformations and the corresponding locations are provided in Appendix C.

Figure 59. Vehicle Damage, Test SR-7

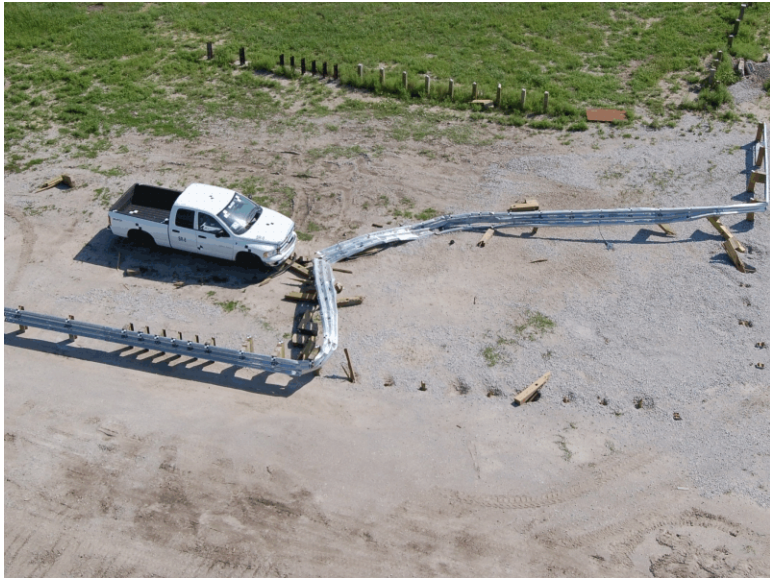
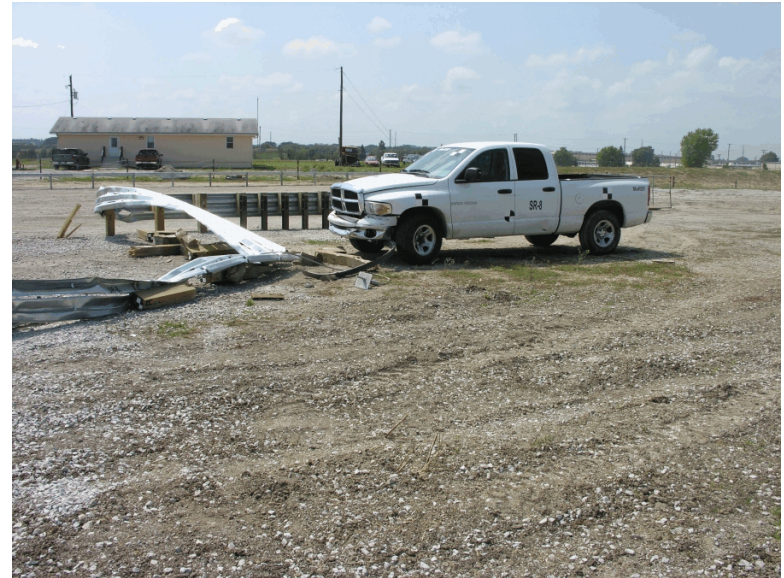
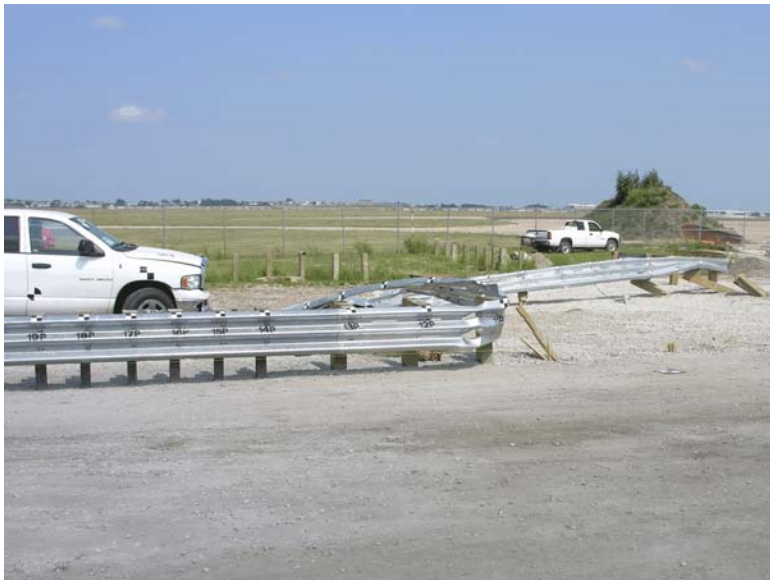
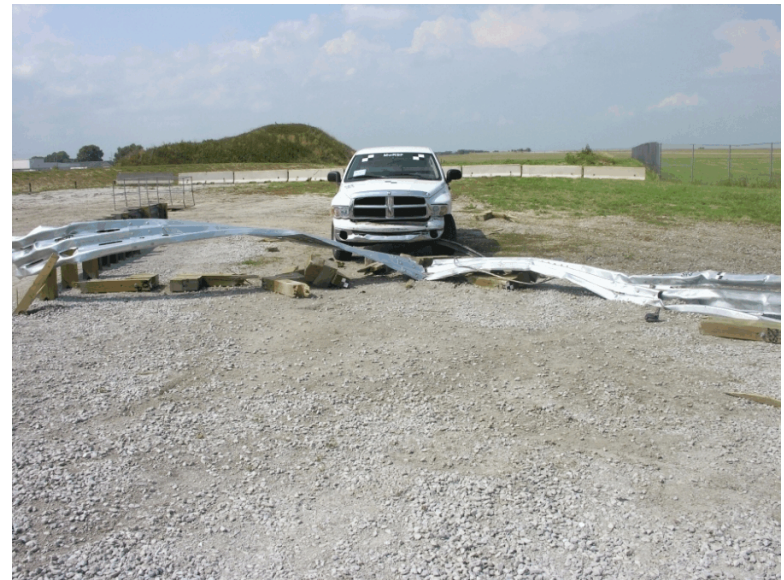
Figure 84. Vehicle Trajectory and Final Position, Test SR-8

Barrier damage was extensive, as shown in Figures 85 through 93. Damage consisted mostly of flattened, deformed and torn guardrail, fractured posts, blockouts, and bolts, and deformed cable anchor hardware. System damage occurred between post nos. 8S and post no. 11P. The maximum permanent set of the guardrail was 6,518 mm (21 ft - 4.5 in.) from the primary side and 8,448 mm (27 ft - 9 in.) from the secondary side, measured to the center of the nose.

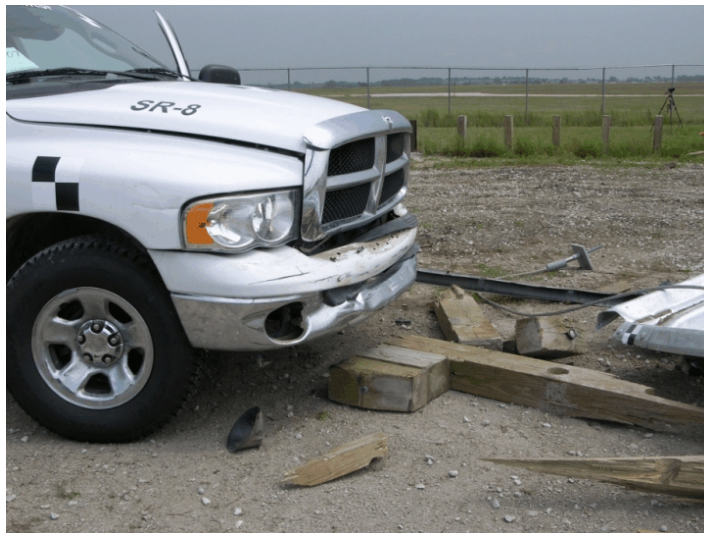
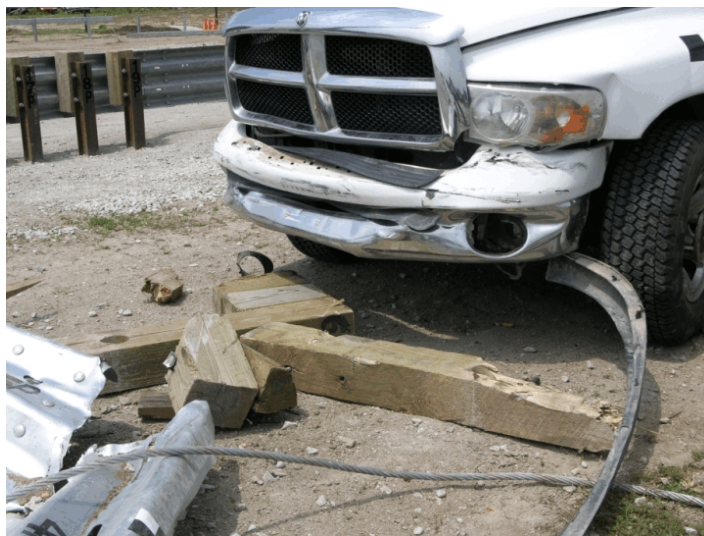
Figure 94. Vehicle Damage, Test SR-8

Exterior vehicle damage was minimal, as shown in Figures 94 through 96. Occupant compartment deformations to the right side and front of the floorboard were deemed insufficient to cause injury to the vehicle occupants. Maximum longitudinal displacements of 6 mm (0.25 in.) occurred throughout the right side of the floorboard. Maximum lateral displacements of 19 mm (0.75 in.) occurred at the left-front corner of the right-side floorboard. Maximum vertical displacements of 6 mm (0.25 in.) were located throughout the right-side floorpan. Complete occupant compartment deformations and the corresponding locations are provided in Appendix G.
